Ph.D. Thesis

Analysis of unreinforced and TRM-strengthened brick masonry walls subjected to eccentric axial load

Experimental data annex

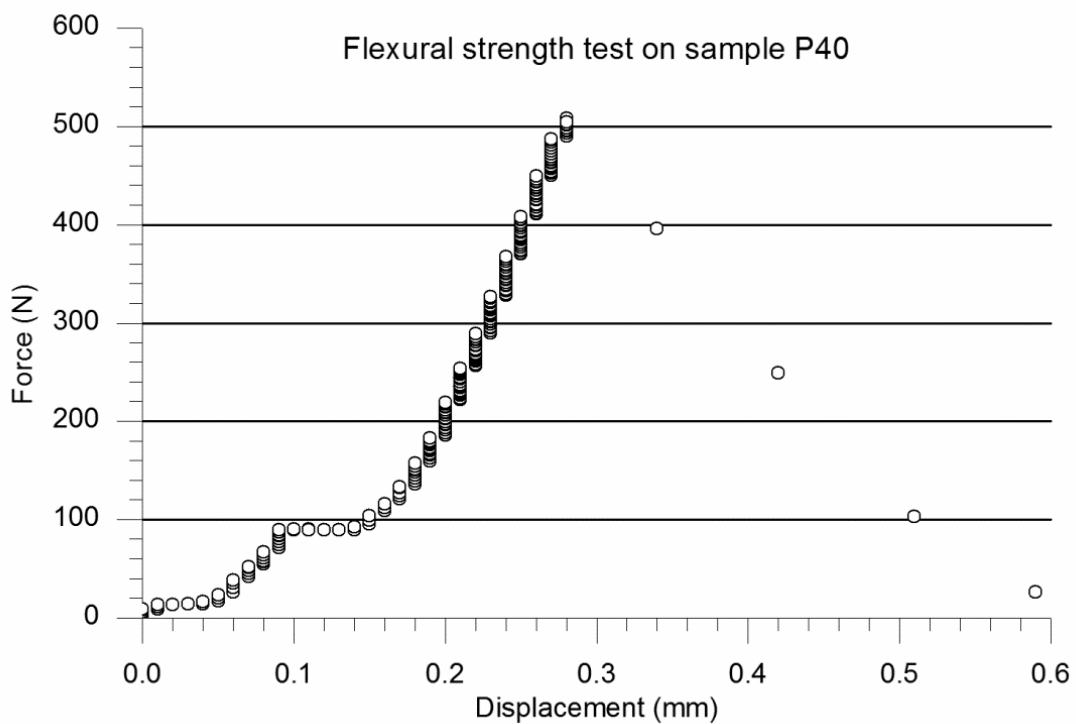
Figure A1. 14 Result of the flexural strength test on a typical Popamsa M7,5 mortar sample

Both flexural and compressive tests showed a linear behaviour up to a brittle failure for all mortars as can be observed in the typical force-displacement graphs (Figure A1. 14 to Figure A1. 23) presented below for each combination of type of mortar and test.

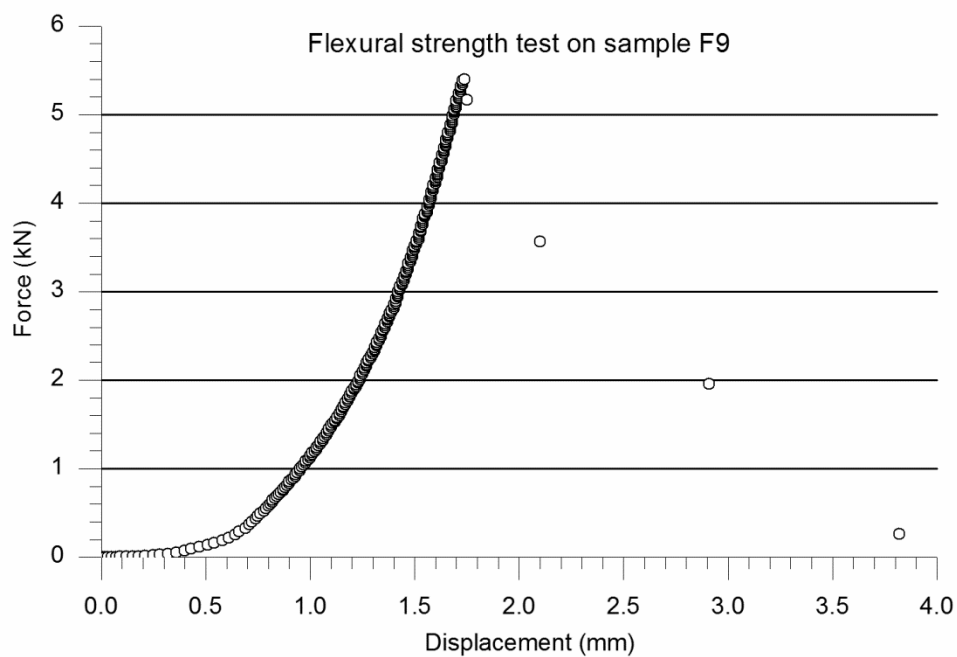
Figure A1. 31 Result of the flexural strength test on a typical brick sample

The behaviour of these tests was linear up to a fragile failure of the brick with one big centred crack, except for the starting stage in which the sample settlement causes a less stiff behaviour. Figure A1. 31 shows a typical flexure test on a brick.

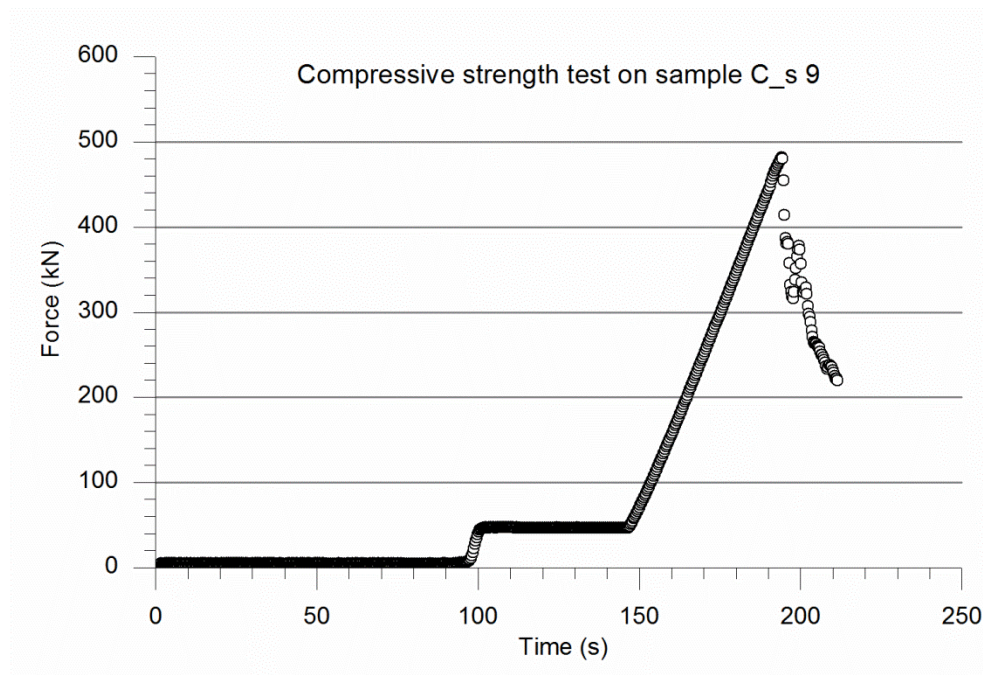
Figure A1. 32 Result of the compressive strength test on a typical brick sample

The typical behaviour of a compressive test on a brick is shown in Figure A1. 32. The fragile behaviour in failure at constant increasing force rate could be highlighted. The first horizontal stage corresponds to the free movement of the press until it reaches the contact with the specimen. Once the contact is produced, the load suddenly increases up to 45kN for a testing machine limitation in control. After the initial settlement has been assured the loading rate was changed to 10kN/s to begin the testing phase. At this rate the second and longer ramp of the graph is recorded up to failure.

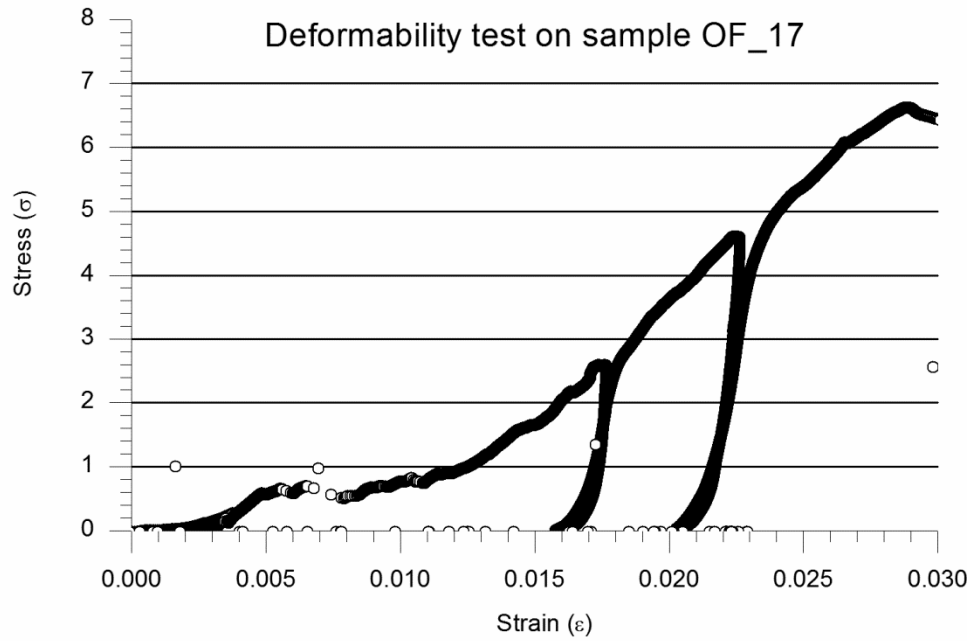
Figure A1. 38 Typical response of a masonry deformability test carried out

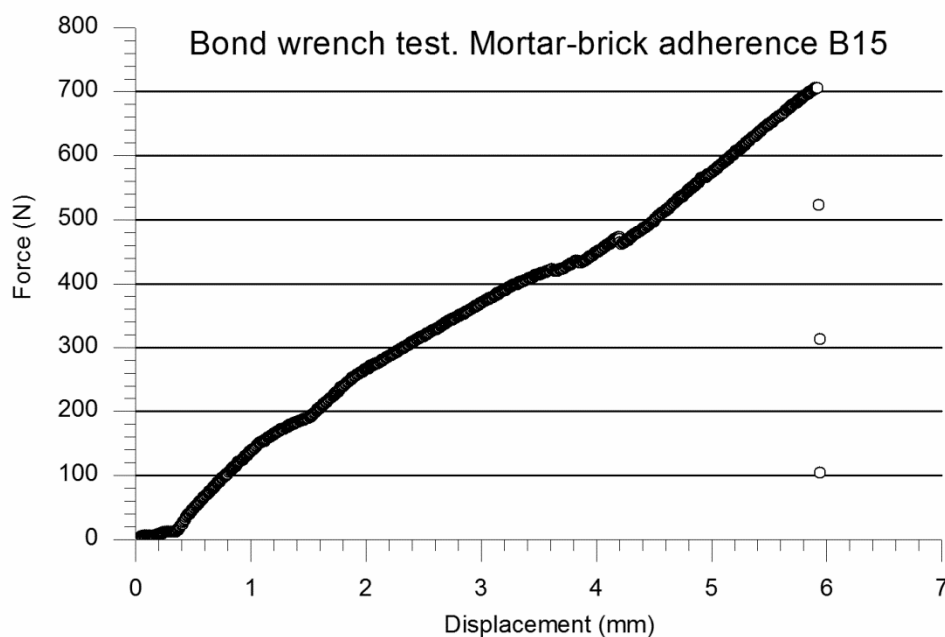
Figure A1. 41 Typical response of a bond wrench test. Mortar-brick adherence experiment B15

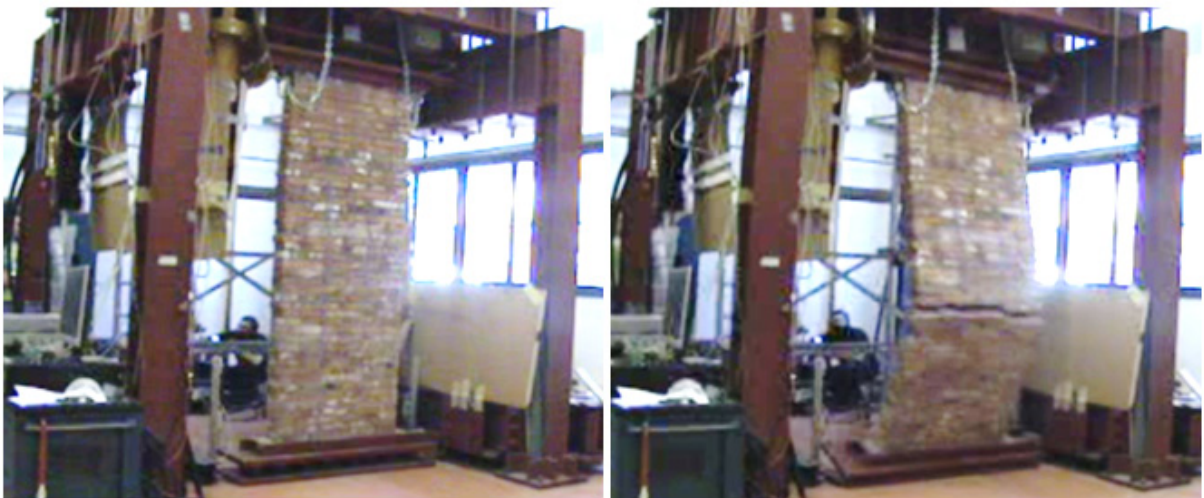
Figure A1. 110 Wall W#1 at the beginning of the test (left) and failing (right)

In fact, the failure seemed to be caused by the rotation of the upper loading system (geometric instability) which led to the rotation of the wall (turn over). Then the wall laid on the horizontal restraining tools that suddenly stopped it causing the flexion breaking that was captured by the cameras.

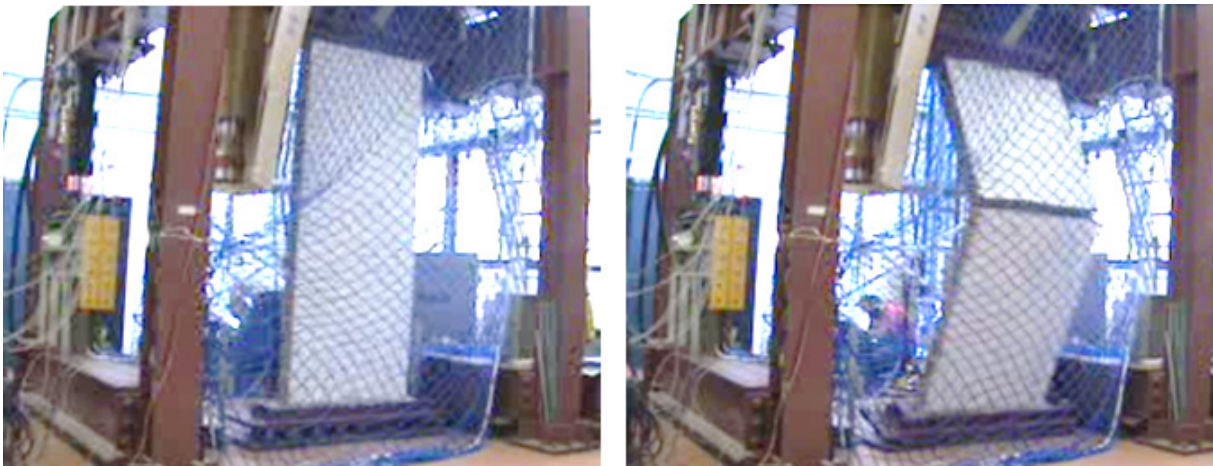
Figure A1. 114 Wall W#2 at the beginning of the test (left) and failing (right)

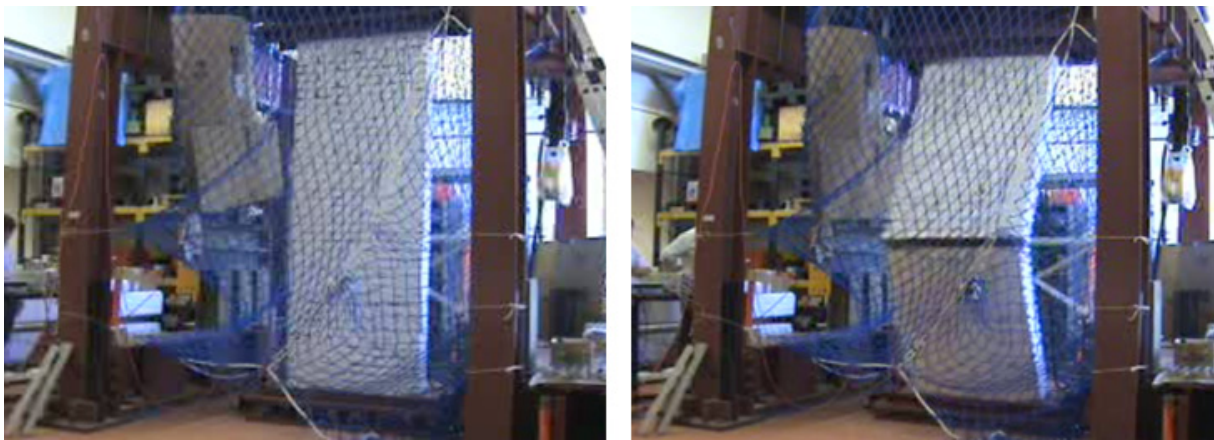
Figure A1. 118 Wall W#3 at the beginning of the test (left) and failing (right)

In contrast with wall W#2, W#3 had the side with the completely mortar filled joints at the compression side. This may allow better using the thickness of the wall.

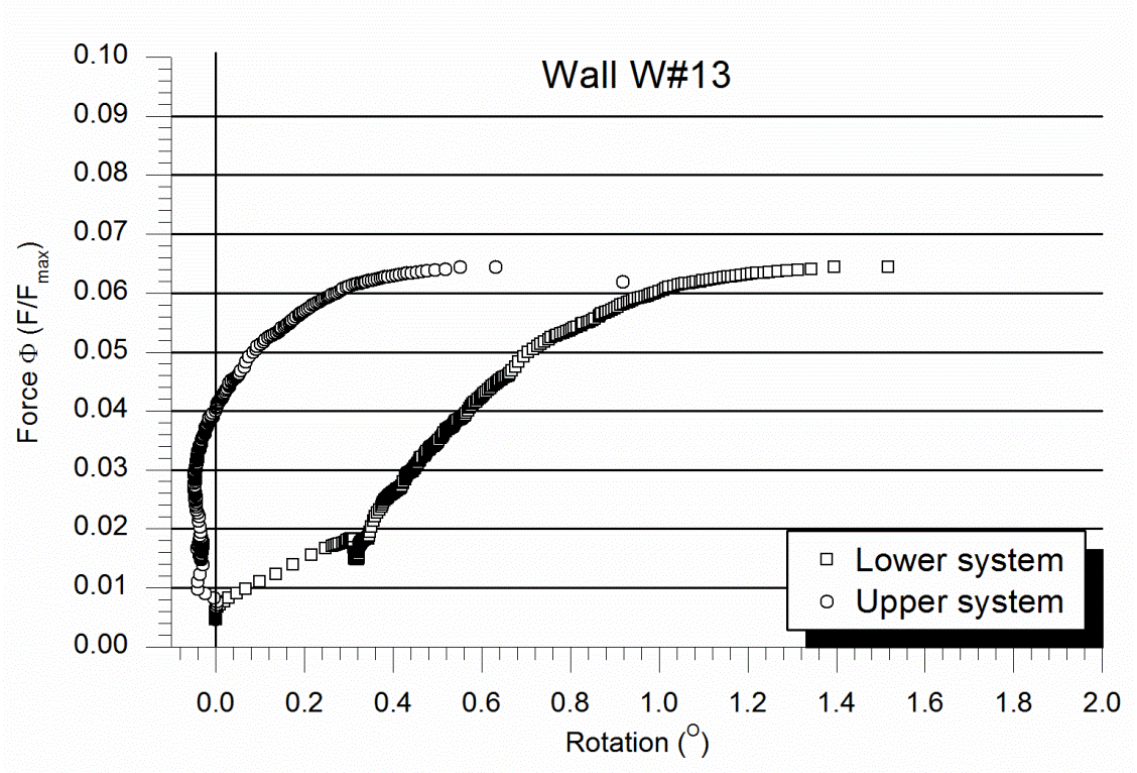
Figure A1. 160 Rotation at wall's endings for wall W#13

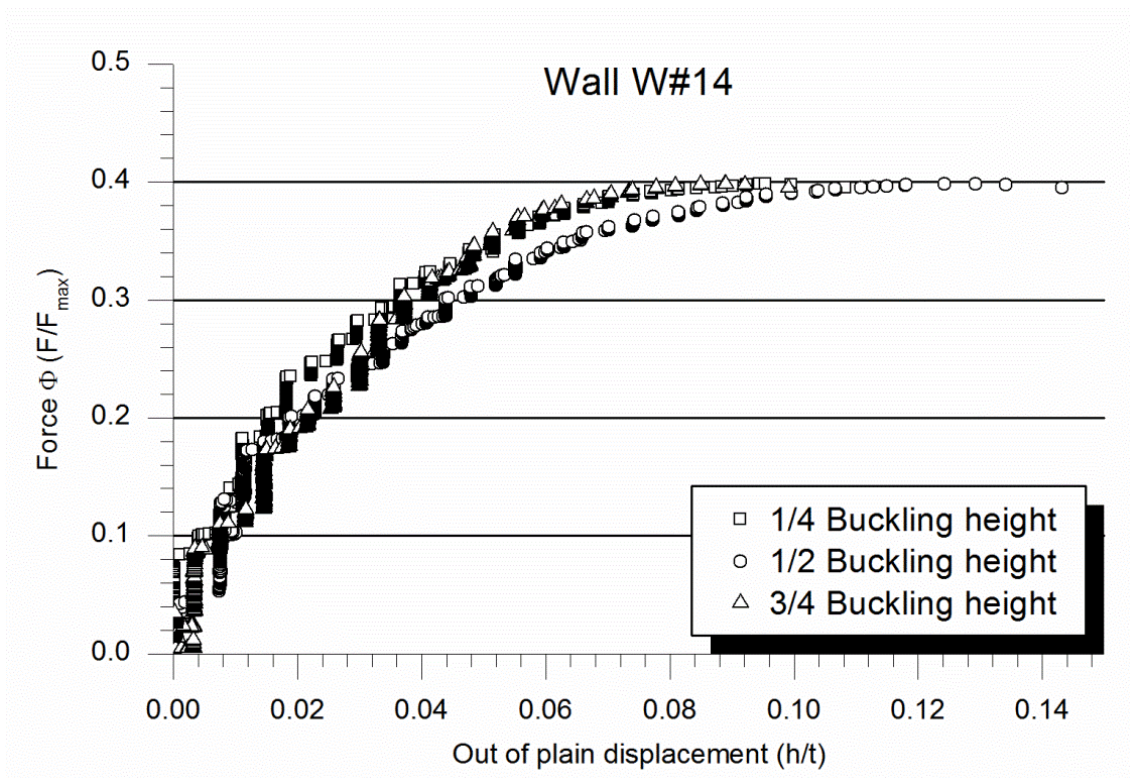
Figure A1. 164 Out-of-plane response of wall W#14

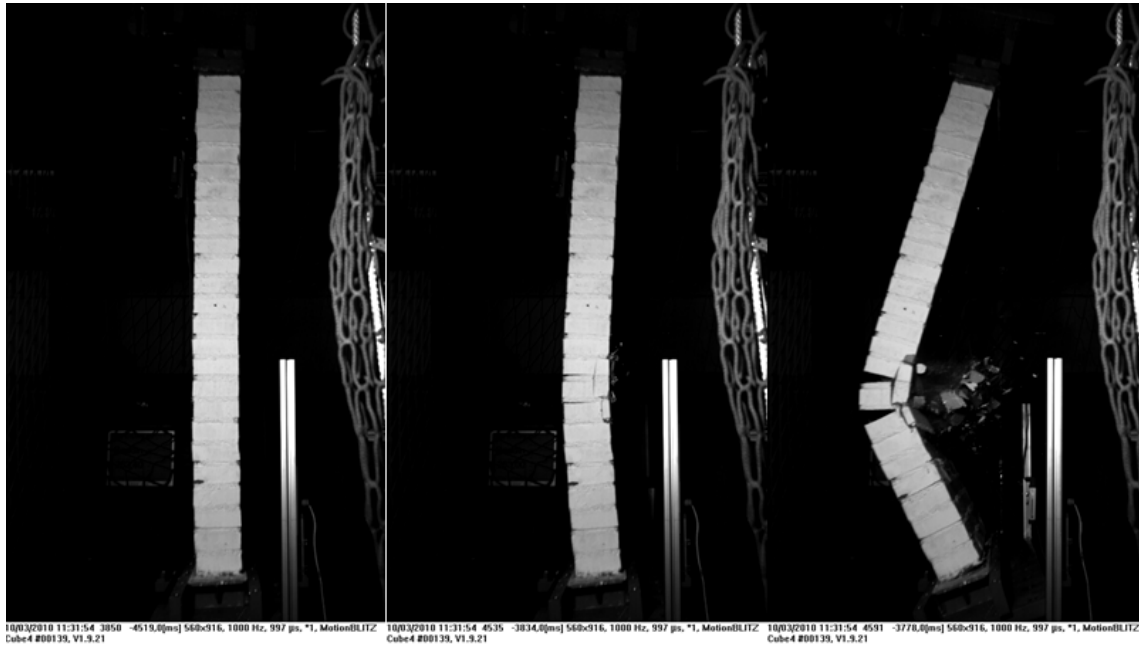
Figure A1. 166 Failure of the wall W#14. Crushing at compression side and opening of a horizontal joint

The three previous graphs showed a change in the wall response from 80% of the maximum load. The failure process of wall W#14 was different from the rest of the walls of the M series because a crushing-buckling mixed mode was observed (see Figure A1. 166). The collapse was sudden.

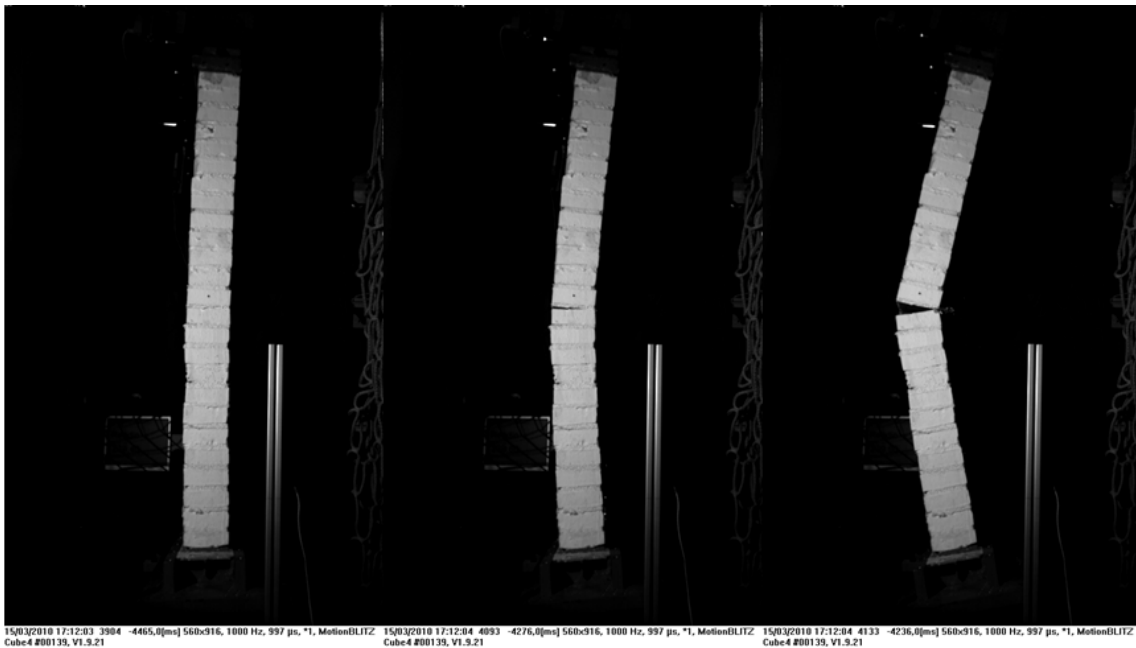
Figure A1. 170 Failure of the wall W#15. Opening of a horizontal joint at mid-height.

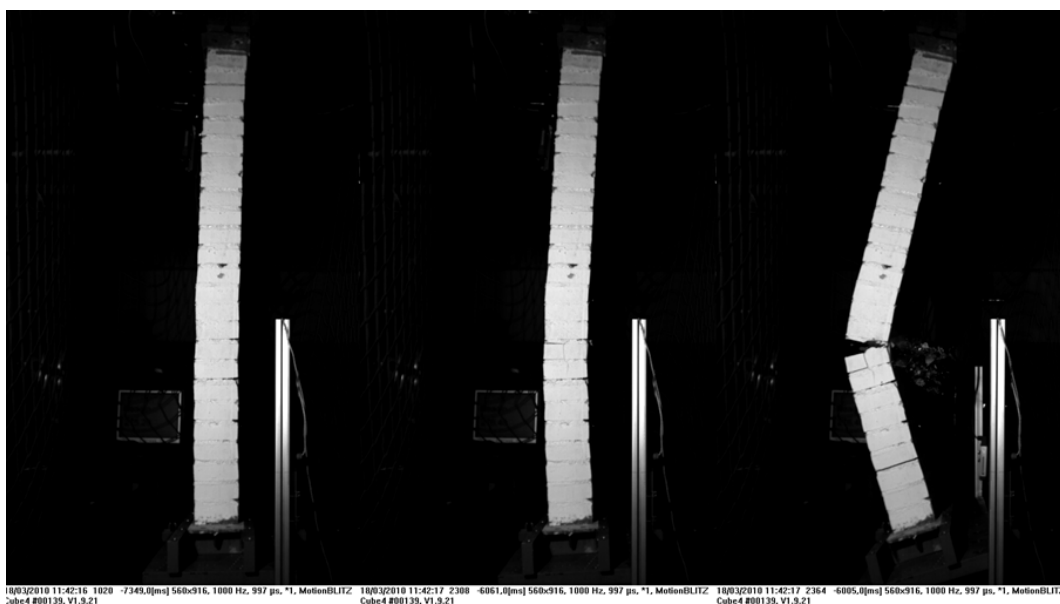
Figure A1. 174 Failure of the wall W#16. Opening of a horizontal joint at 1/3 of the height.

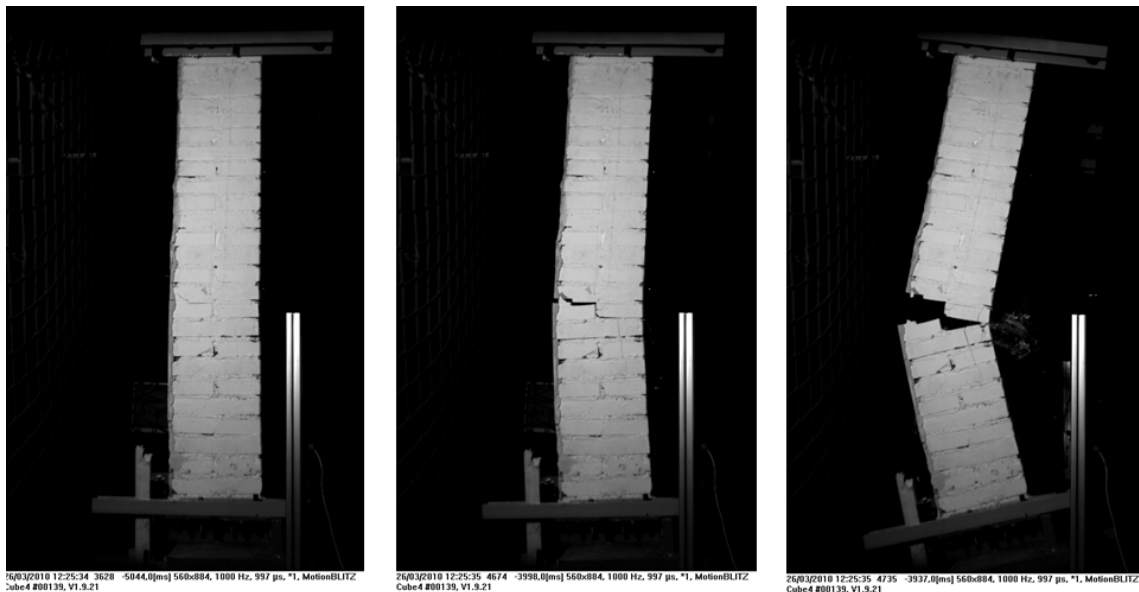
Figure A1. 178 Failure mode of wall W#17. Beginning with tensile cracking and final masonry crushing.

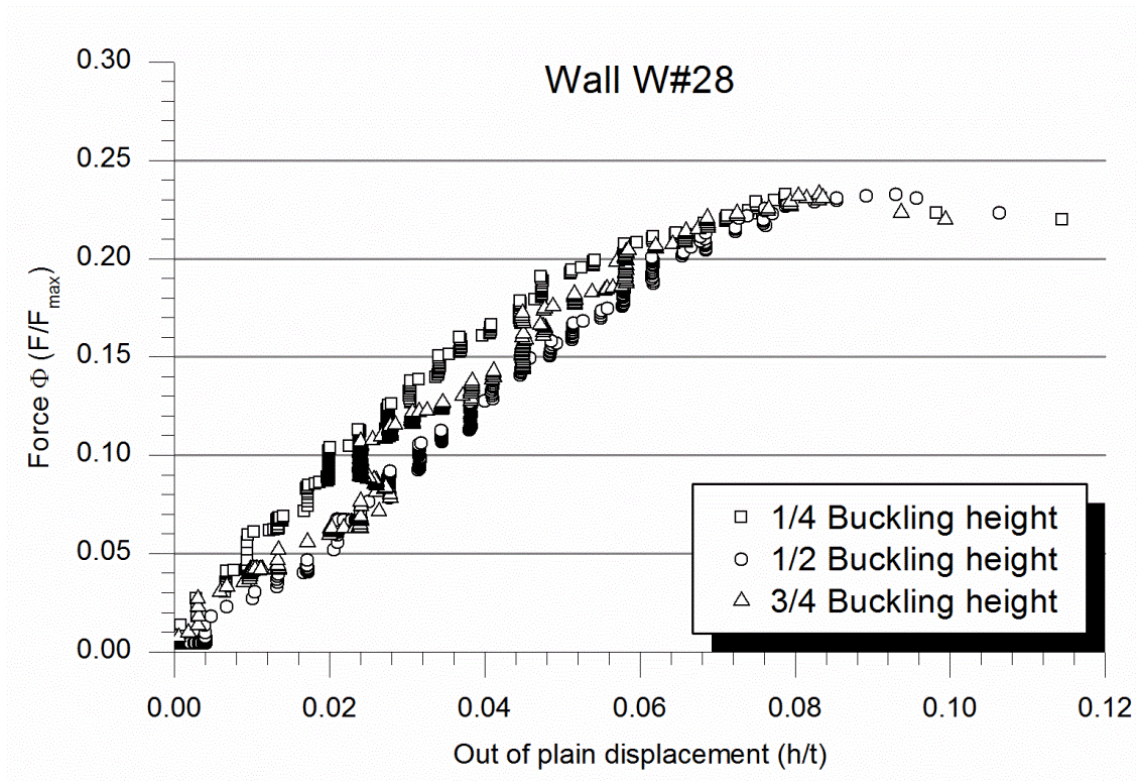
Figure A1. 232 Out-of-plane response of wall W#28
