Experimental and numerical study of the structural effects of steel corrosion in continuous RC beams

Doctoral Thesis
Ignasi Fernandez Perez

Universitat Politècnica de Catalunya - Barcelona Tech
Departament d'Enginyeria de la Construcció

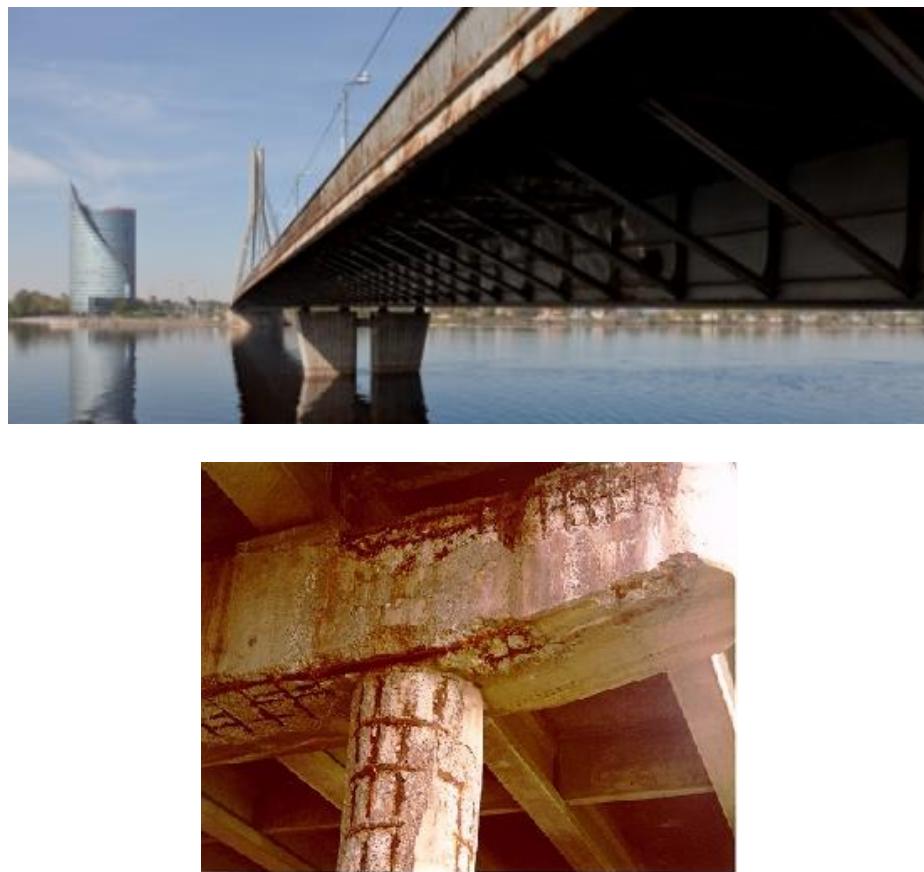
Figure I-1. Structure deterioration due to steel corrosion

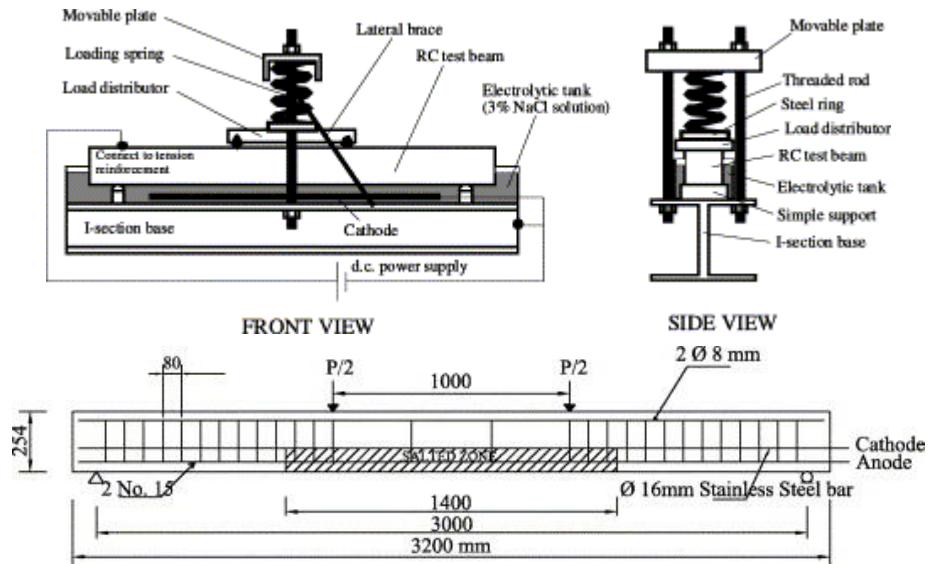
Figure I-2. Test setup of different studies carried out

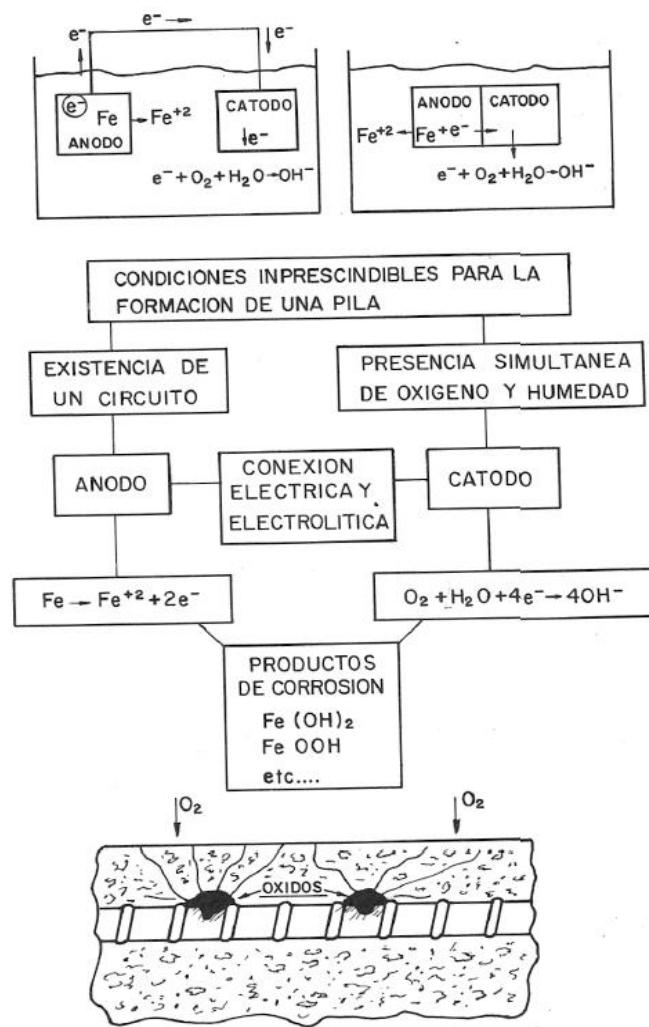
Ilustración II-2. Proceso de deterioro de armaduras – pila de oxidación [5]

El proceso se puede definir como se ve en la Ilustración II-2.

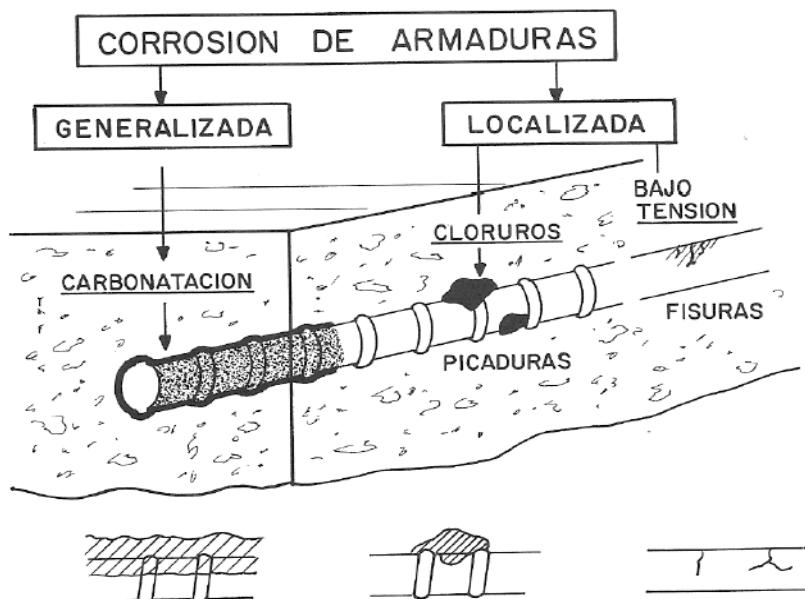
Ilustración II-5. Tipos de corrosión de armaduras [5]

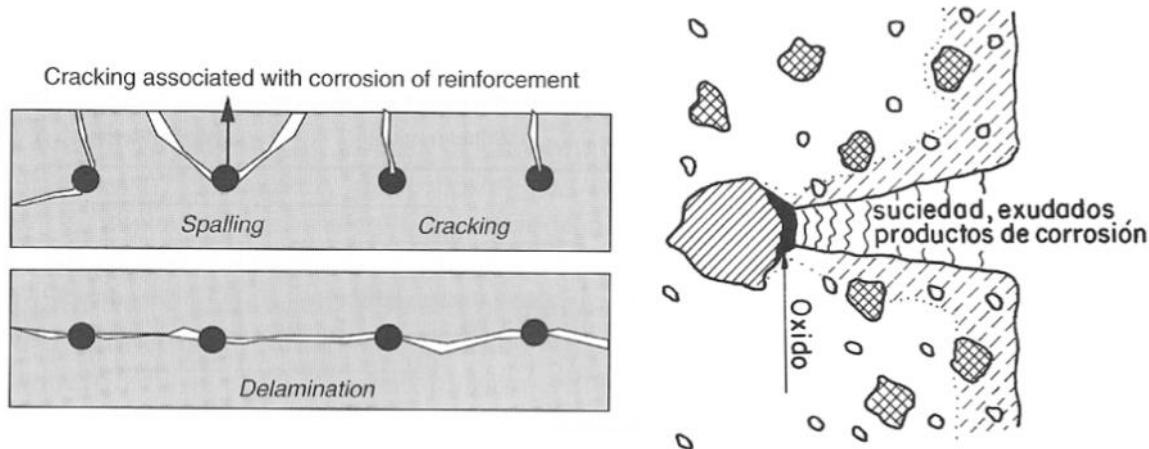
Ilustración II-7. Tipos de fisuración por corrosión de armaduras [21]

En la Ilustración II-7 se pueden observar los diferentes patrones de fisuración del recubrimiento debido al proceso de corrosión de las barras.

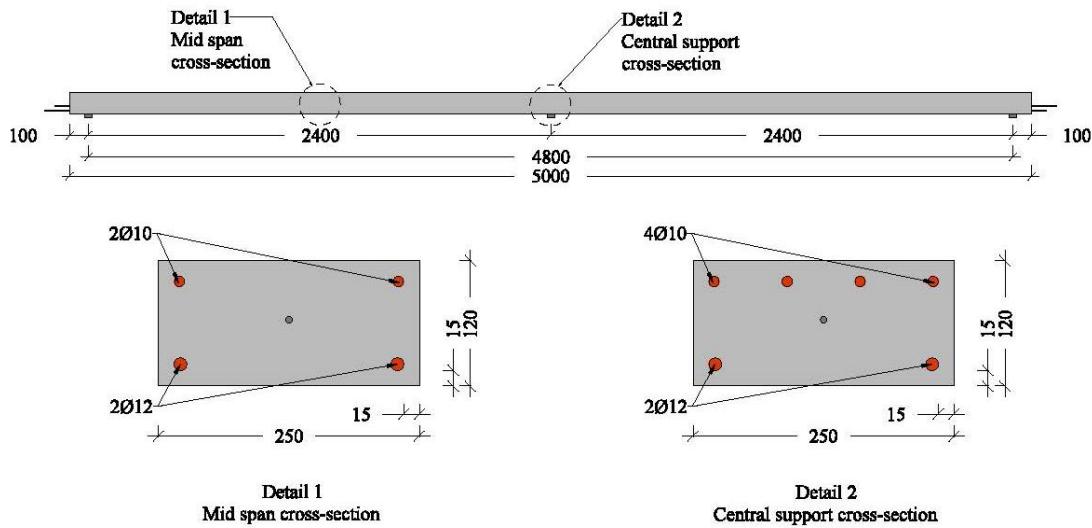
Figure III-2 describes the geometrical specifications of the specimens, steel disposition of the reinforcement and the cross-section definition.

Figure III-2. Geometrical specs of the specimens

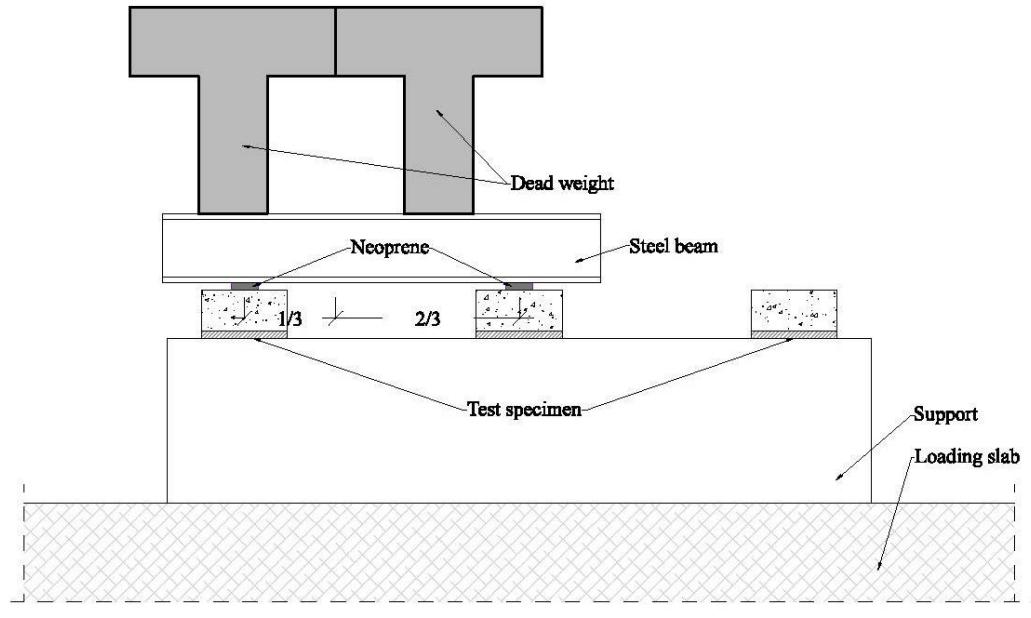
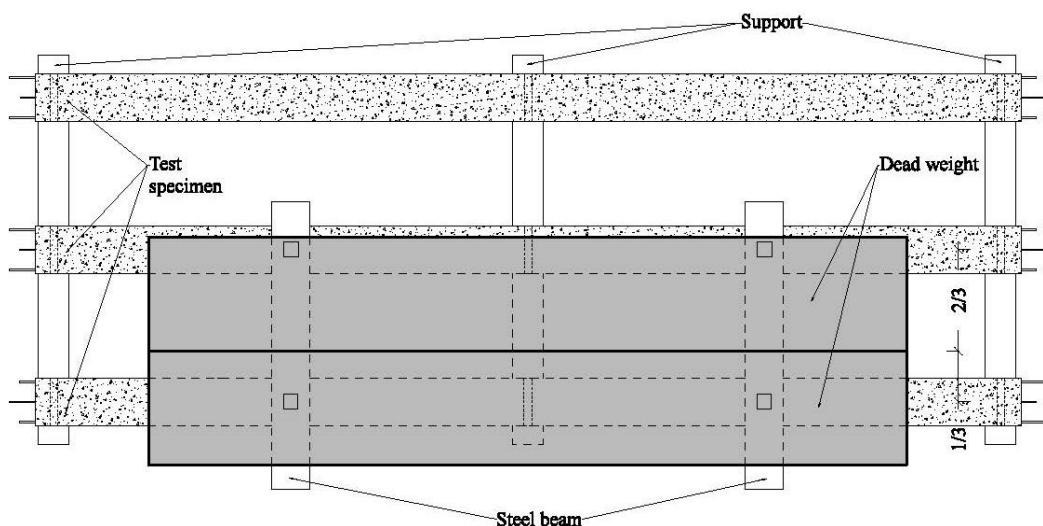
Figure III-3 describes the test setup where it can be seen how the permanent load is applied over each beam. Table III-4 describes the final load values for each specimen.

Figure III-3. Test configuration during corrosion procedure

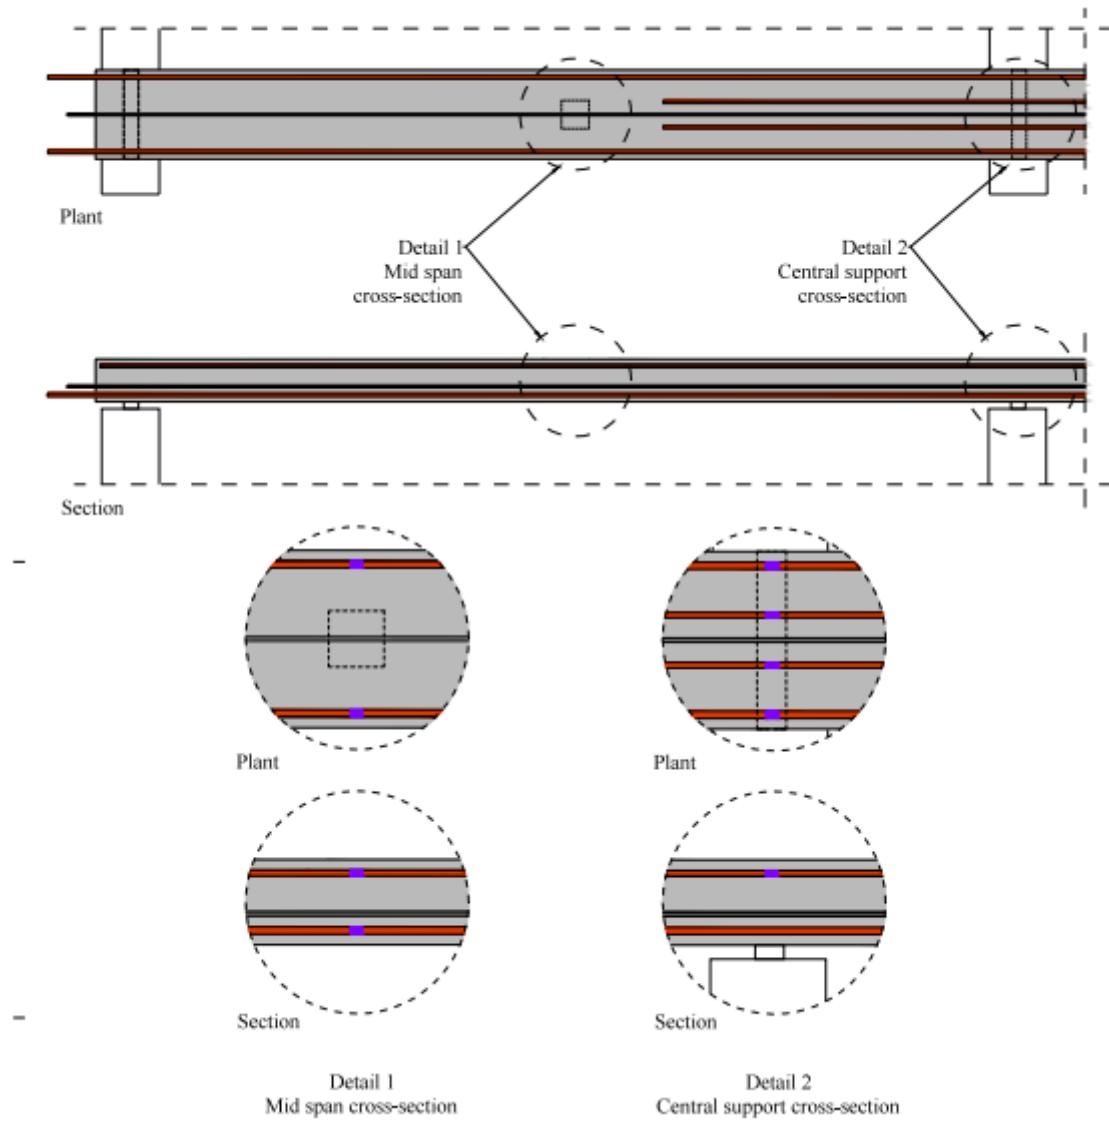
The steel stress/strain redistribution due to the corrosion process was supposed to be registered by means of resistive strain gauges glued on the steel bars at different points of the beam. Tensile and compressive steel stress in mid-span cross-section and tensile steel stress in middle-support cross-section were measured. However, the extremely aggressive medium due to NaCl and the applied current in addition to water made data acquisition difficult. Many gauges became useless in a few days, some other read few data but anyone resisted the whole corrosion procedure. Figure III-6 shows the strain gauges placed onto the steel reinforcement bars.

Figure III-6. Placed strain gauges

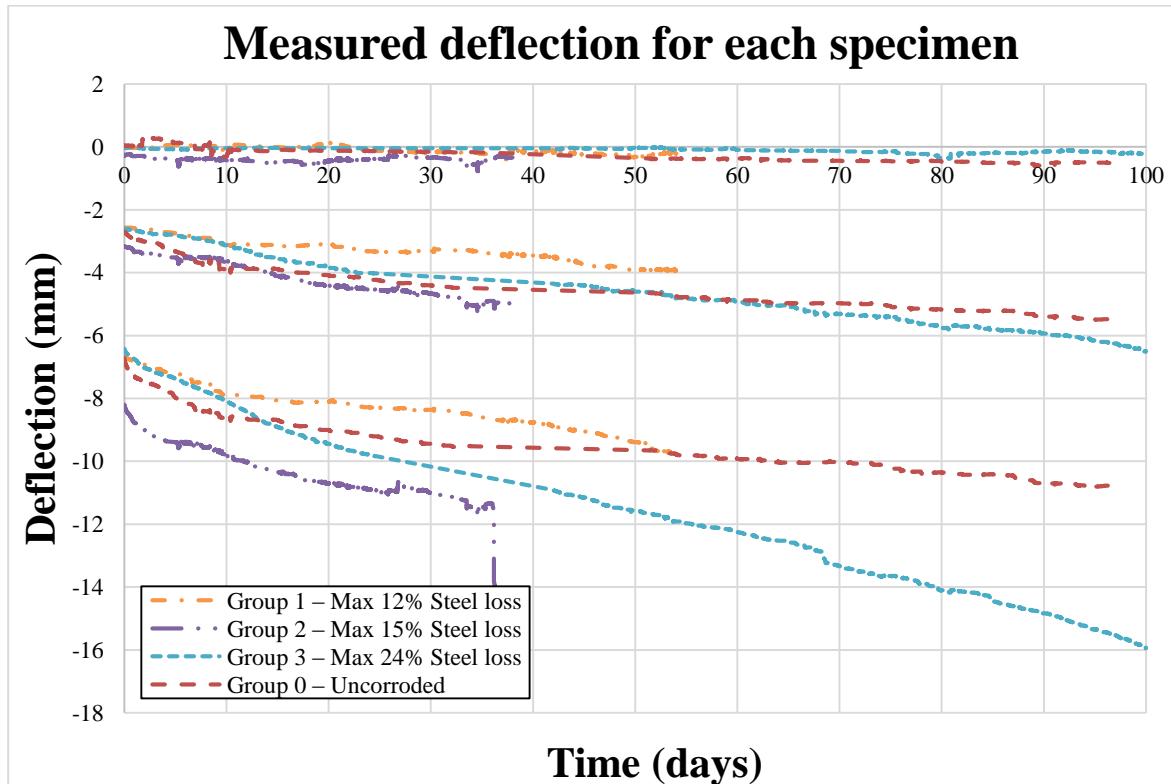
Figure III-10 depicts the measured deflection for all the tested specimens. It is possible to observe the three groups and the behaviour of each one during the corrosion exposure time.

Figure III-10. Registered deflections for all tested beams

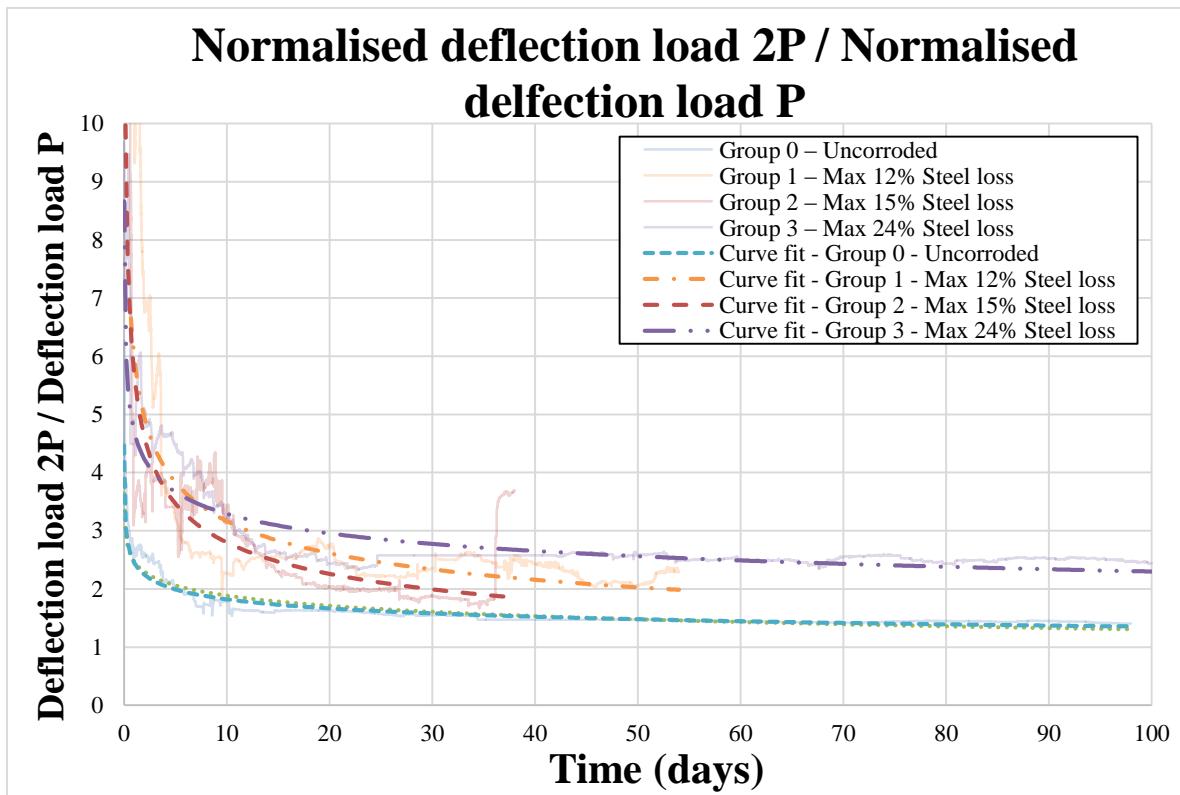
The following procedure has been used to study the effect of load level on the corrosion process. Firstly, for each load level, a normalized deflection value is obtained by dividing total deflection by instantaneous deflection. Then, the ratio between normalized deflection under load $2P$ and normalized deflection under load P is computed. This ratio is obtained for each corrosion group, and the results are plotted in Figure III-11. It can be seen that deferred deflections are more pronounced in the groups, which underwent corrosion. Also, deferred deflection amplification due to corrosion is greater in the case of $2P$ -loaded specimens than in P -loaded specimens. In the long term, it seems that trend shapes for all groups tend to be similar.

Figure III-11. Deflection ratio: evolution of normalized deflection under $2P$ load divided by normalized deflection under P load, with respect to time

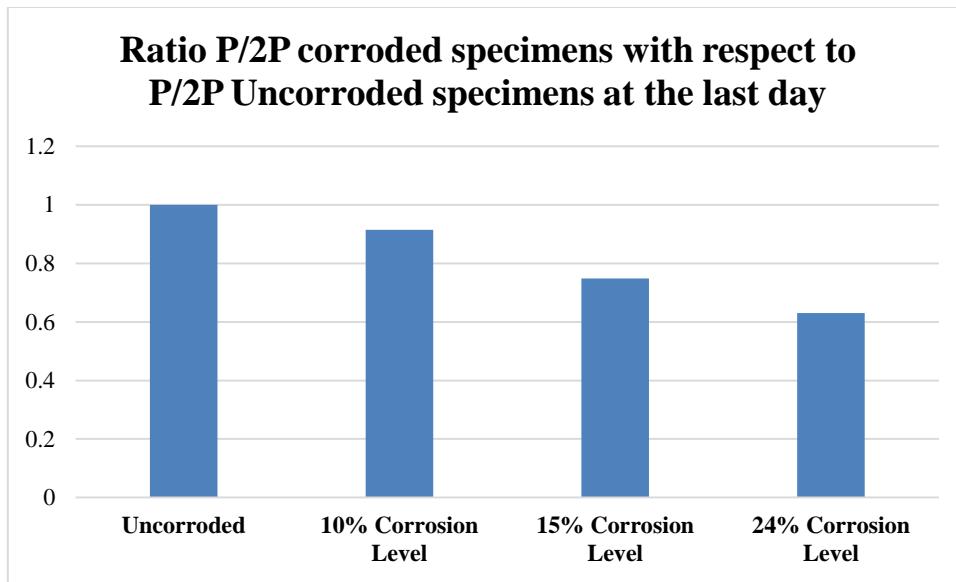
Figure III-12 shows a summary of the aforementioned effect. The normalized deflection ratio for each group of beams, as measured at the end of their respective corrosion processes, is compared to the normalized deflection ratio for uncorroded beams. It can be seen that the ratio is significantly higher for all groups, with an increase between 20% and 40% against the uncorroded beam, depending on the corrosion level attained.

Figure III-12. Comparison of the deflection ratio (deflection under 2P load divided by normalized deflection under P load) of corroded beam groups against uncorroded beam group at the end of their respective corrosion processes time

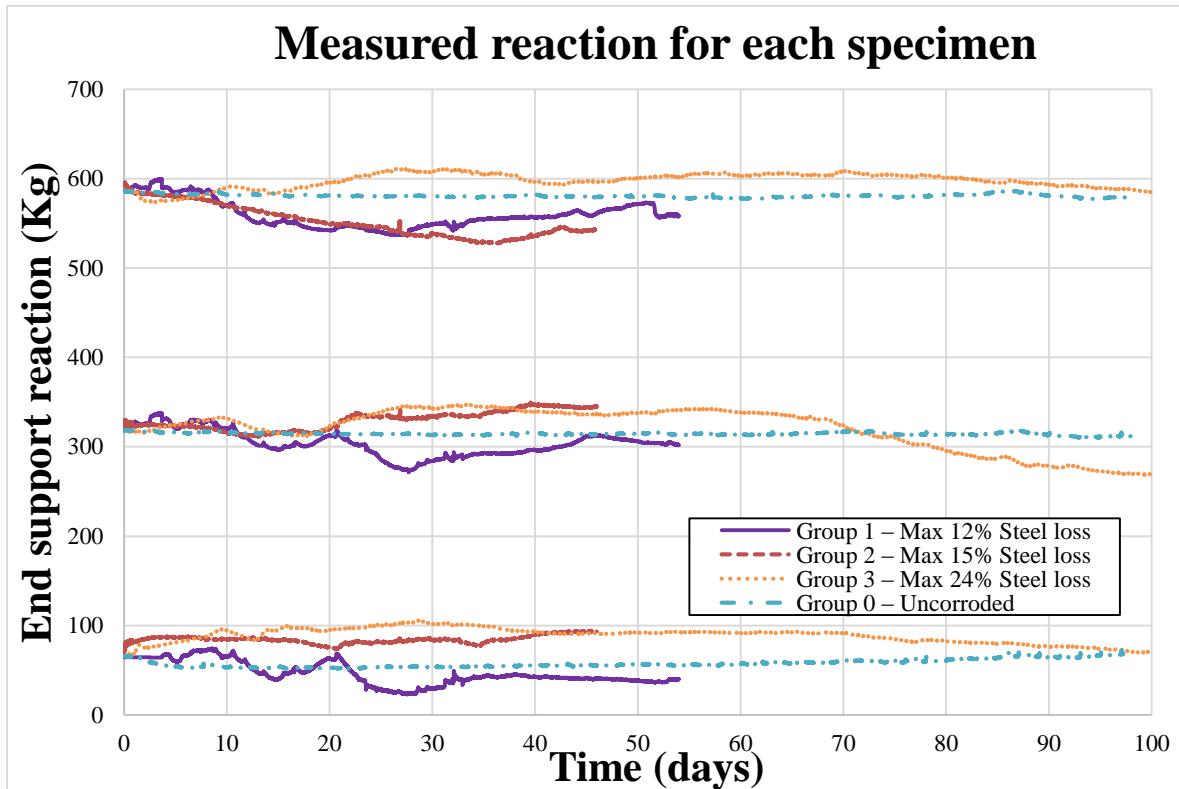
All beams showed load redistribution between the central support and the end support reactions in both directions. However, as expected, uncorroded specimens only presented redistribution at very early time because of the initial effect of creep and shrinkage; after that, each reaction remained almost constant over time. Figure III-13 depicts the average registered reaction at the beam-ends for all specimens. All graphs have been translated so that the reaction value at day 0 is the same for each load level and, therefore, the evolution of redistribution is more easily interpreted.

Figure III-13. Overall evolution of reaction forces for all the specimens

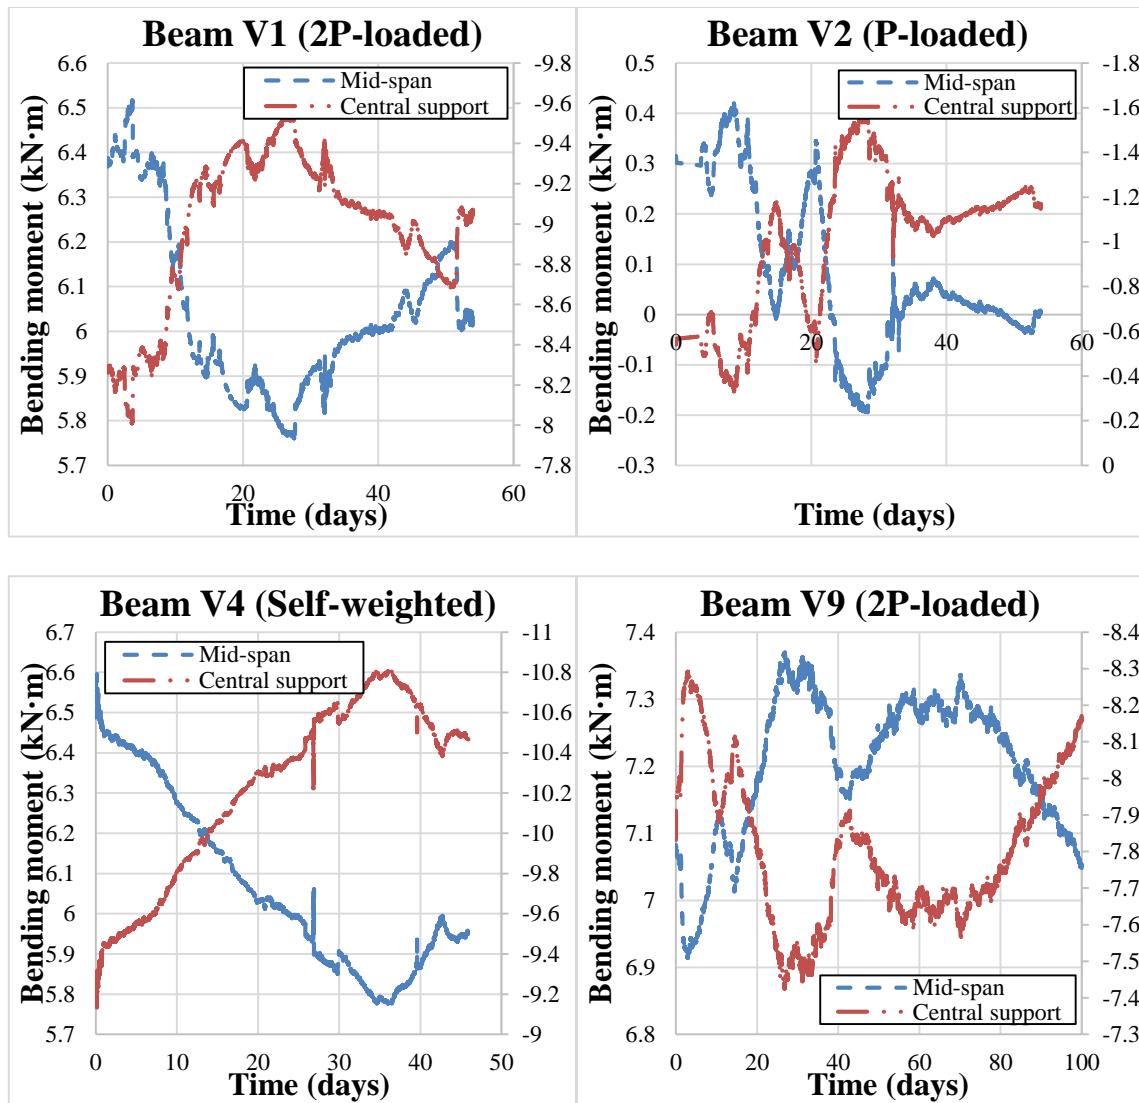
The observed load redistribution directly influenced the bending moment distribution in the beams. Using load balance calculations, it was possible to obtain the bending moment at the critical cross-sections (midspans and central support), which represented the maximum positive and the highest negative bending moment respectively. Figure III-14 describes the evolution of the bending moment at the aforementioned sections. It seems that the relative effect of redistribution was actually lower at higher loads. Despite this, all the beams presented some bending moment redistribution. It can be seen that the evolution of the bending moment did not follow a constant trend, but instead increased and decreased over time. Table III-6 describes maximum and minimum redistribution values at the central cross-section (shown as a percentage of load redistribution with respect to initial load) for all specimens, comparing the maximum and minimum bending moment observed.

Figure III-14. Bending moment evolution at mid-span and central support cross-sections. . A) Beam V1 (2P-loaded) b) Beam V2 (P-loaded) c) Beam V4 (self-weighted) d) uncorroded beam V9 (2P-loaded)

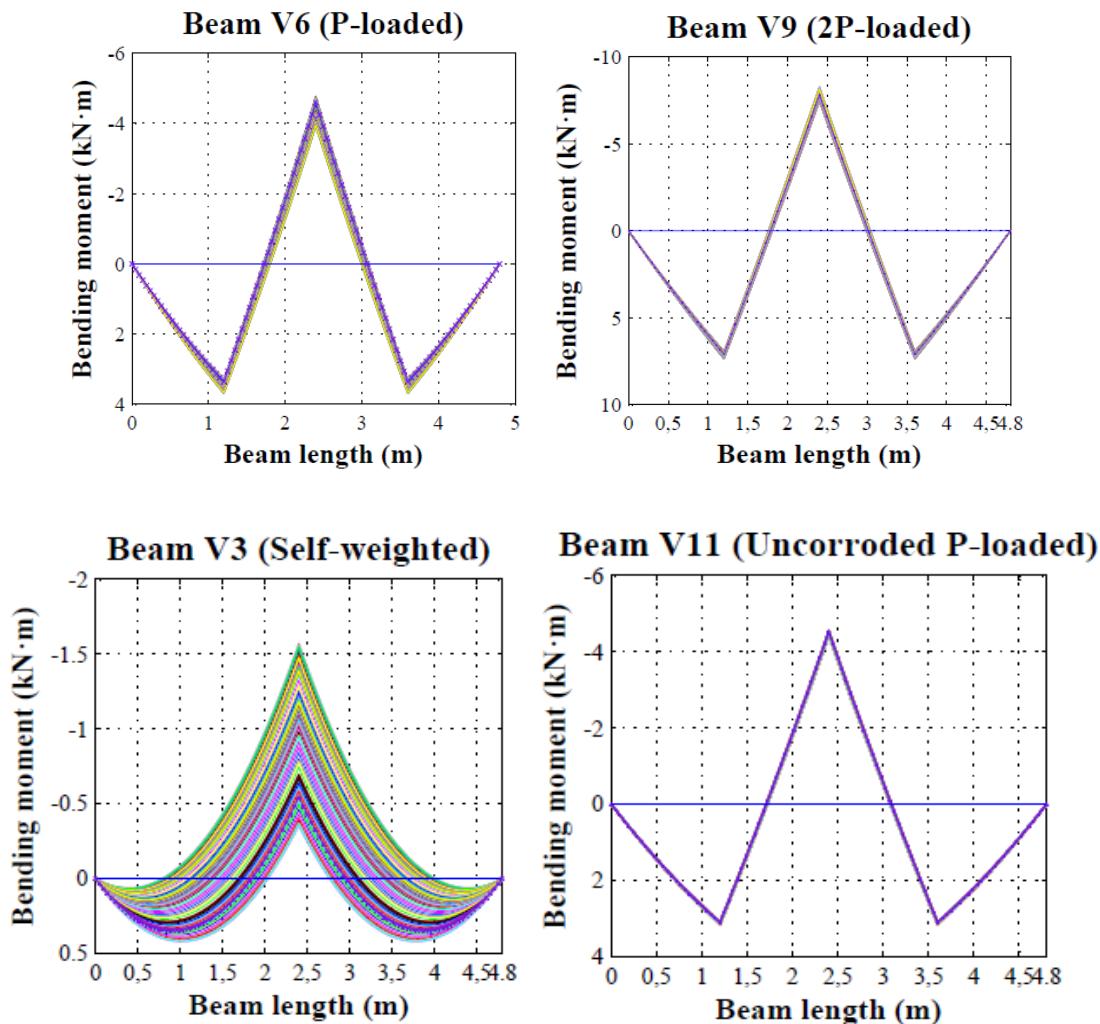
Figure III-15. Bending moment distribution along the beam. A) Beam V6 (Load P) b) Beam V9 (Load 2P) c) Beam V3 (self-weight only) d) Beam V11, uncorroded (Load P)

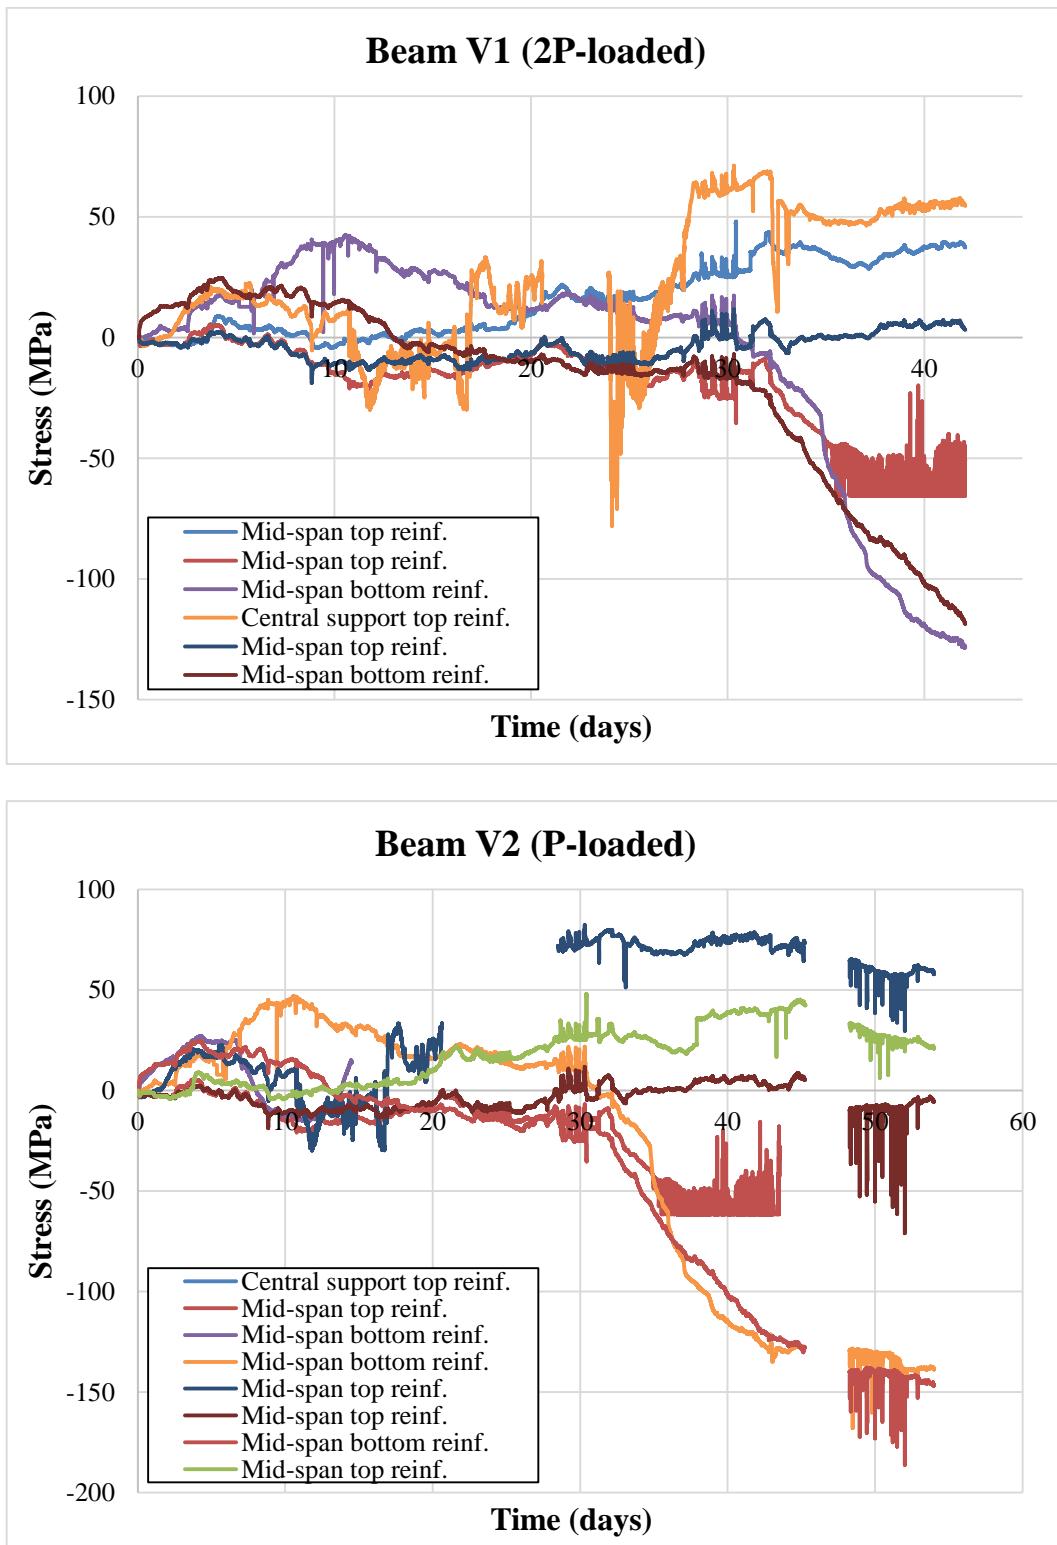
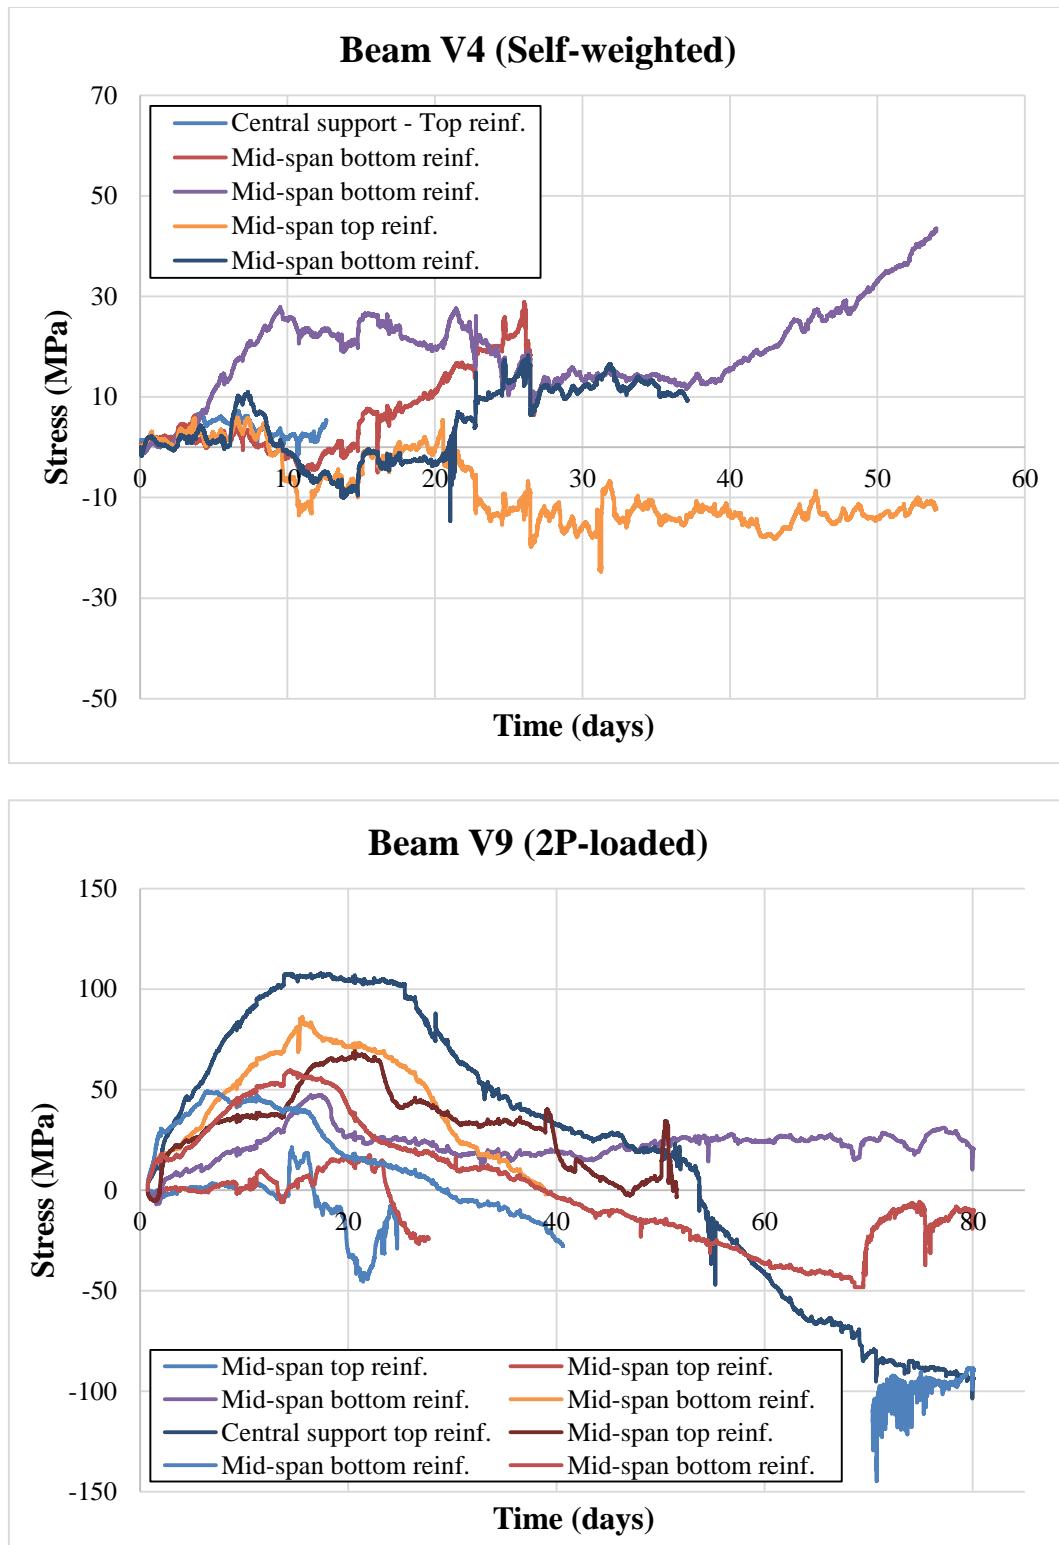
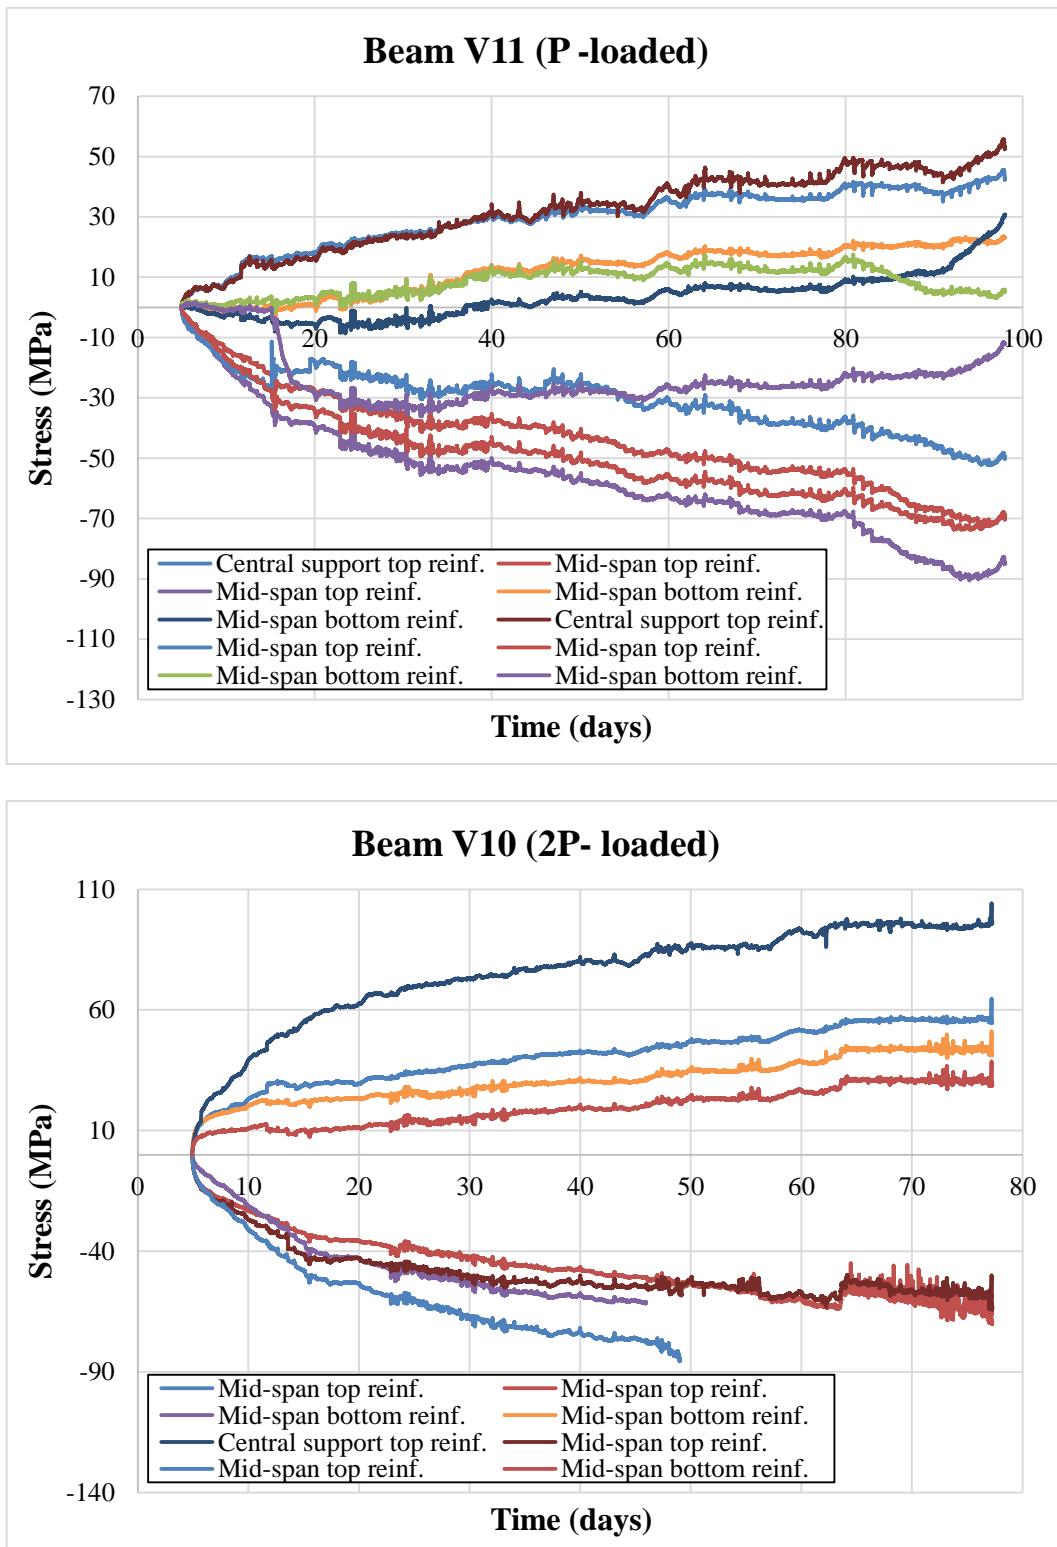
Some of the gauges recorded information about the steel strains despite the extremely aggressive environmental conditions due to the NaCl solution and the current itself, although all the gauges stop working before the end of the test. With the data that were actually registered, it was possible to observe the steel behaviour due to corrosion. Figure III-16 shows the stress in reinforcement steel for the same sections described in Figure III-14 to make easier to compare effort redistribution, steel stress and corrosion level.

Figure III-16. Steel stress evolution during corrosion procedure

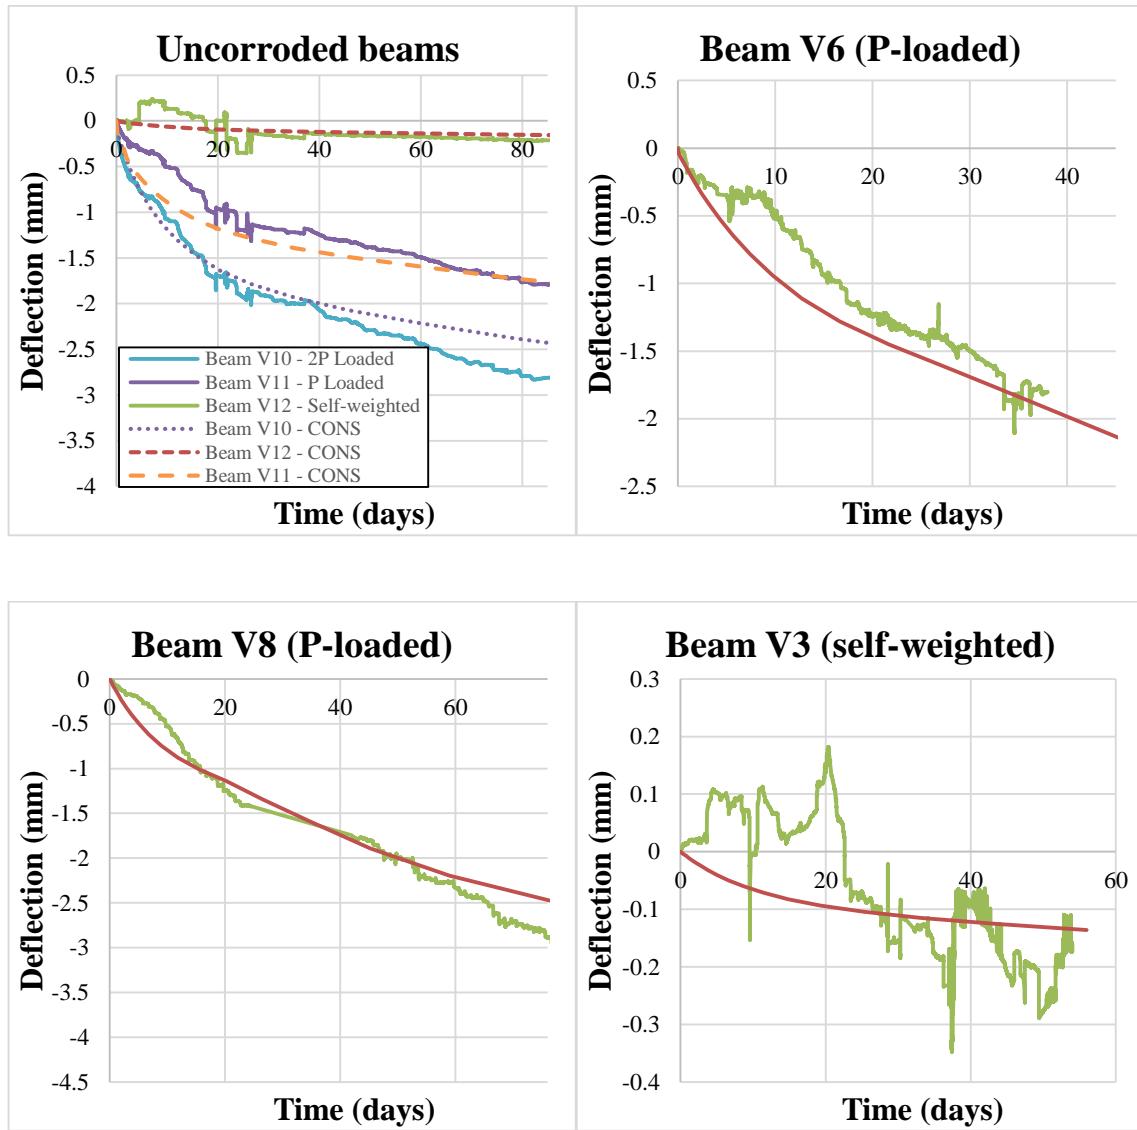
Figure III-17 represents the delayed deflection for uncorroded beams and for Beam V6 (2P-loaded), Beam V8 (P-loaded) and Beam V3 (self-weighted only).

Figure III-17. a) Uncorroded specimens b) Beam V6 (P-loaded) c) Beam V8 (P-loaded) d) Beam V3 (self-weighted only)

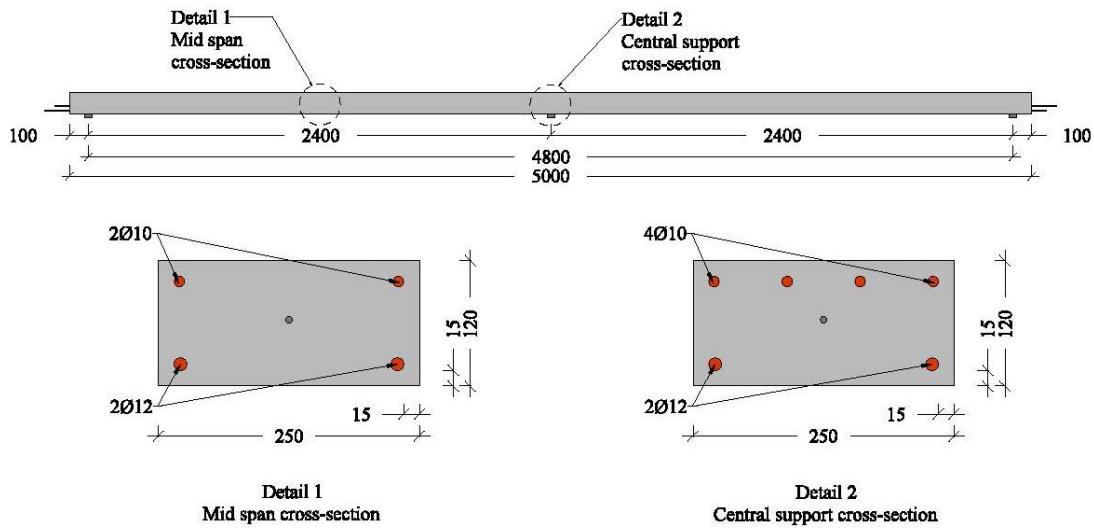
Figure III-18 describes the geometrical specifications of the specimens, steel disposition of the reinforcement and the cross-section definition.

Figure III-18. Geometrical specs of the specimens

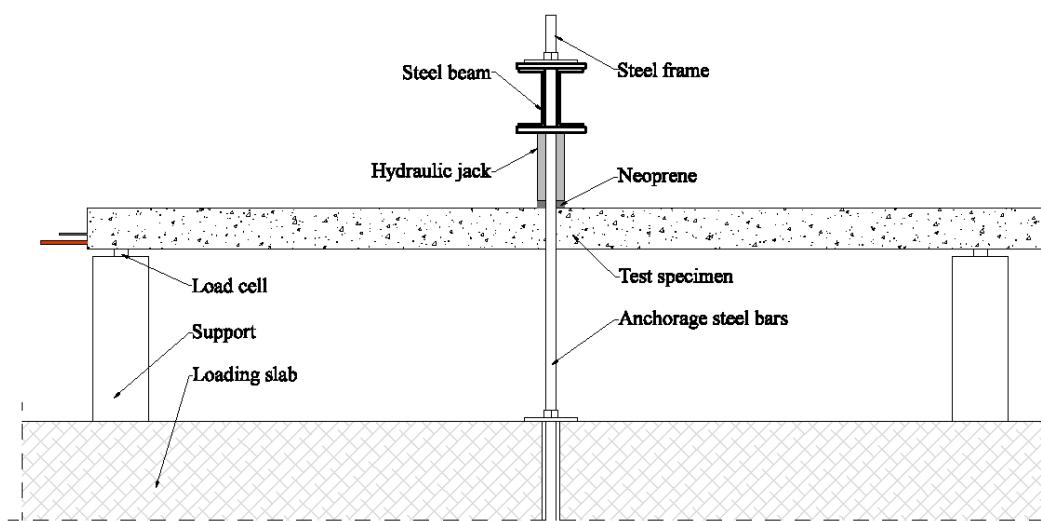
Two load frames affixed to the test slab were disposed over the two mid-span points. Two identical hydraulic jacks were used to introduce the applied load on the beams until failure. The load was applied by means of displacement control of one of the jacks. The same pressure was applied in both load points during the test since both hydraulic jacks were connected to the same pressure supply. The applied load was recorded using two load cells. Figure III-19 shows the loading setup.

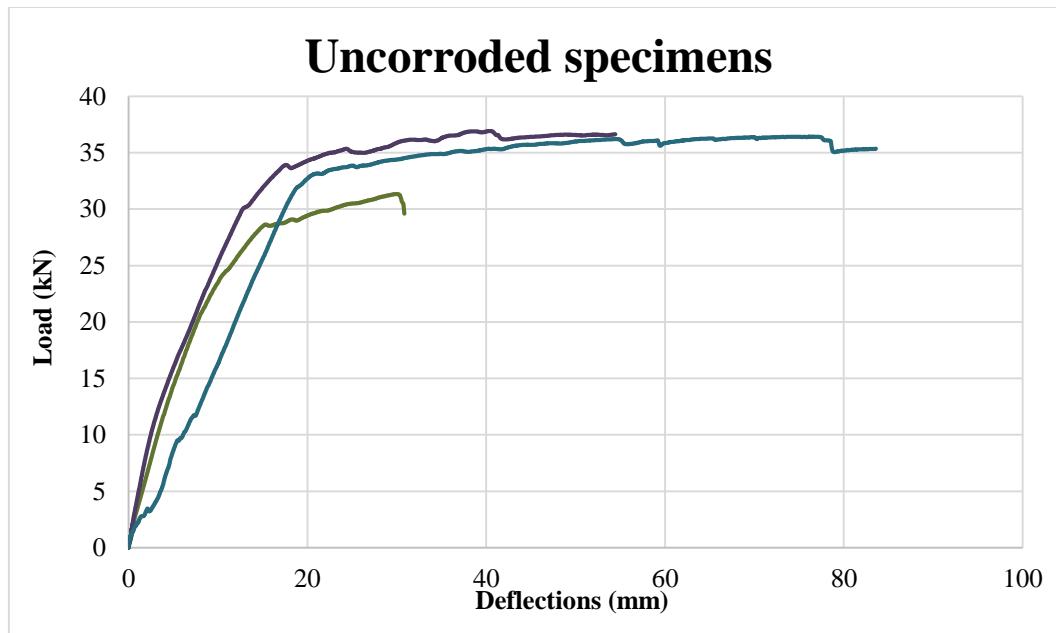
Uncorroded beams presented bending failure. Both the top reinforcement and the bottom reinforcement yielded showing high ductility at failure. The ultimate applied load was around 36 kN. Figure III-25 displays the load - displacement curves for the three uncorroded members.

Figure III-25. Load displacement curves for the three uncorroded specimens

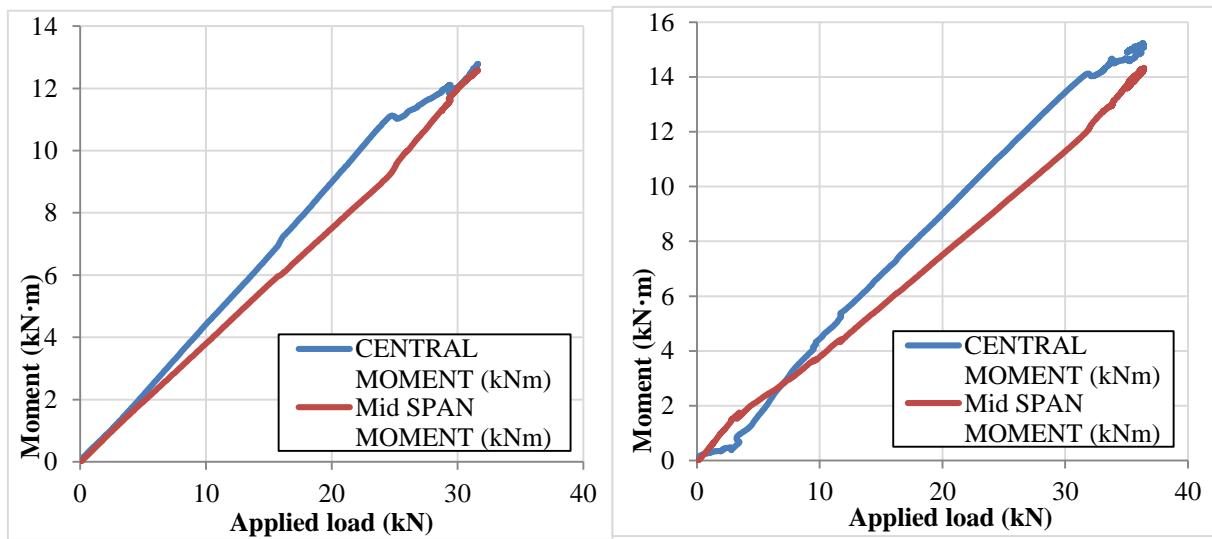
Steel disposed amount made no significant internal forces redistribution between critical cross-sections before failure. Only at the very end of the load process, the specimens showed redistribution, as see in Figure III-26.

Figure III-26. Beam 12 Bending moment – Applied load. Internal forces redistribution at the very end of the applied load
