Experimental and numerical study of the structural effects of steel corrosion in continuous RC beams

Doctoral Thesis
Ignasi Fernandez Perez

Universitat Politècnica de Catalunya - Barcelona Tech
Departament d'Enginyeria de la Construcció

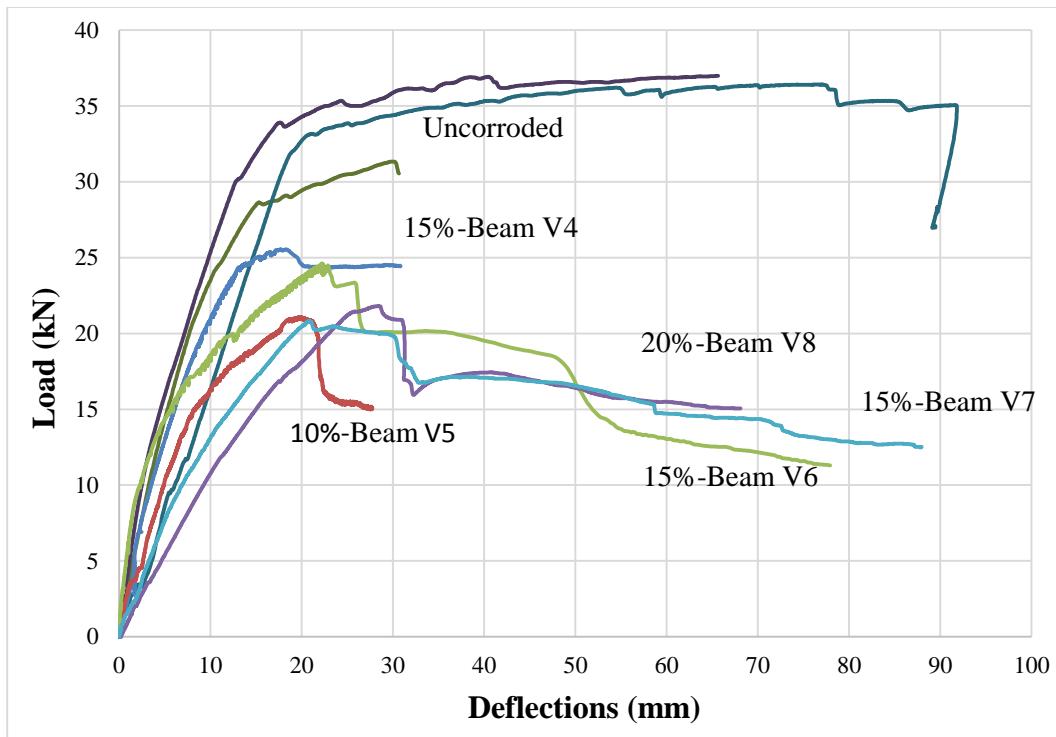
Figure III-28. Load - displacement confined corroded and uncorroded beams.

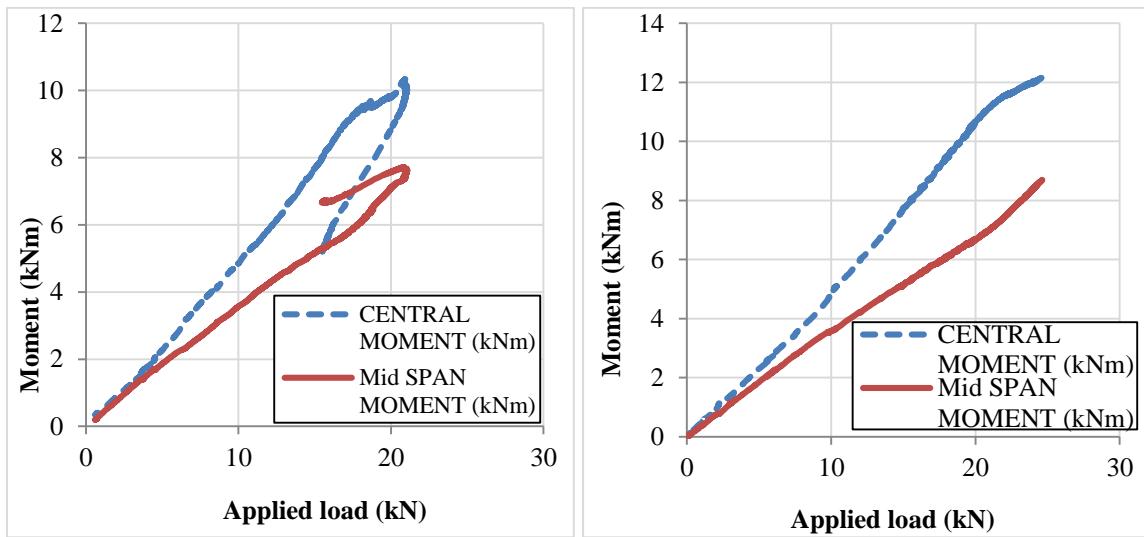
Figure III-29. Bending moment – Applied load. Internal forces redistribution at the very end of the applied load.

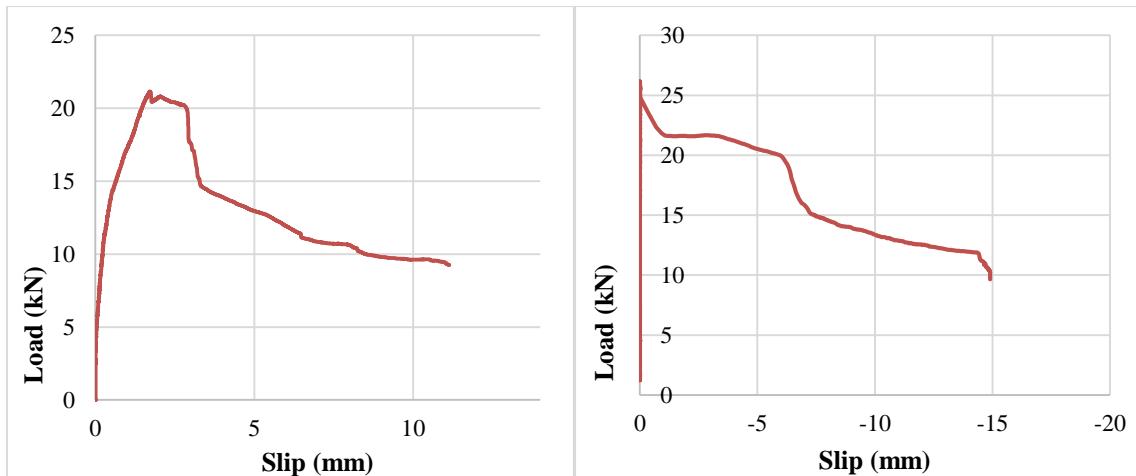
Figure III-30. Slip curves for beams Beam V7 and Beam V6

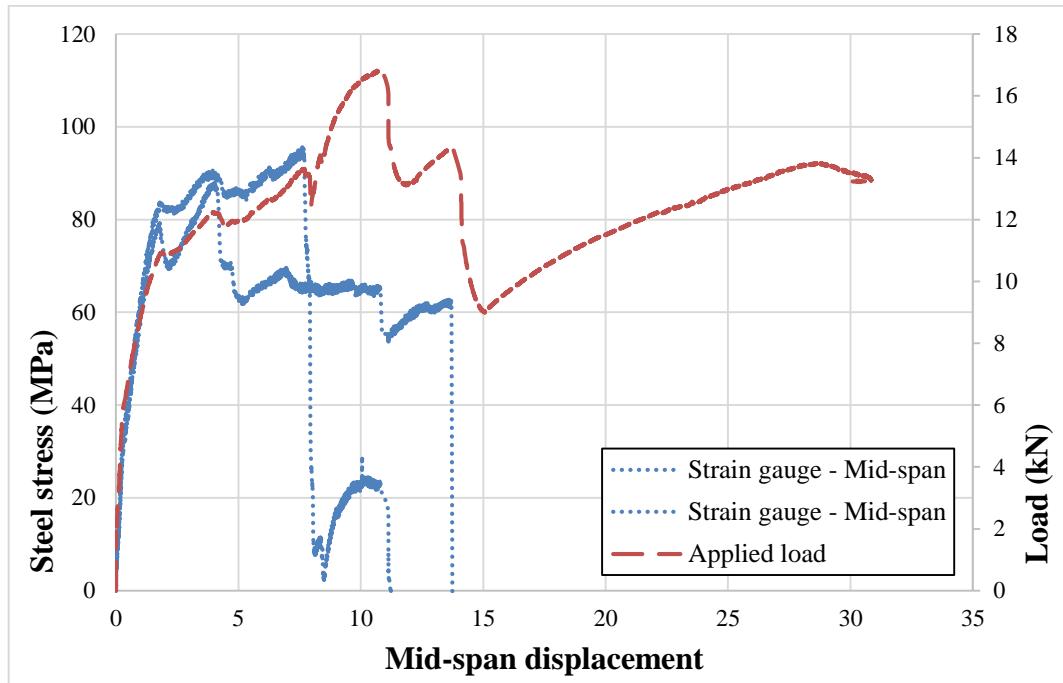
Figure III-32. Beam V2 described failure. Steel stress in left axis and load in right axis vs deflection

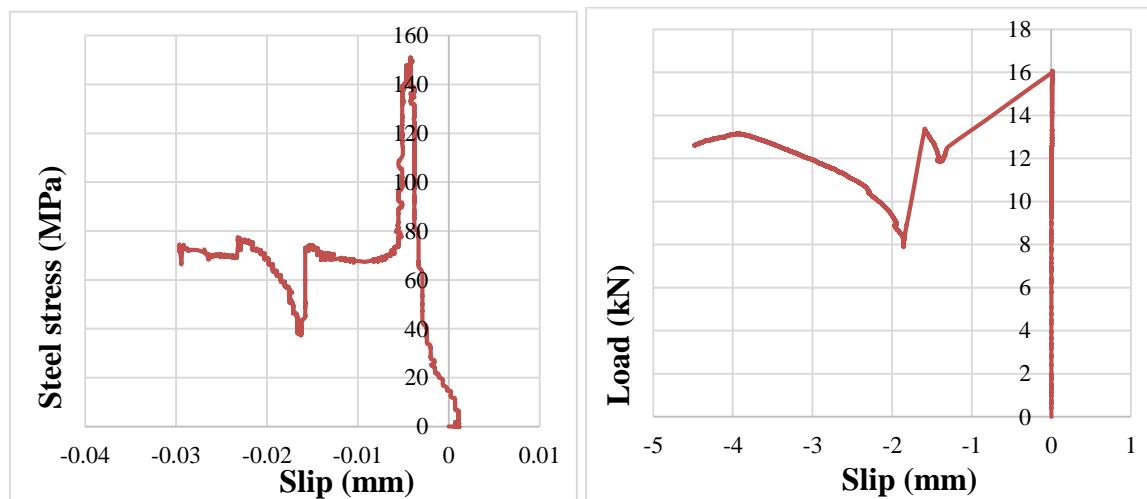
Figure III-33. a) Slip at the end bar vs stress steel, beam 2. B) Slip at the end bar vs applied load, beam 3

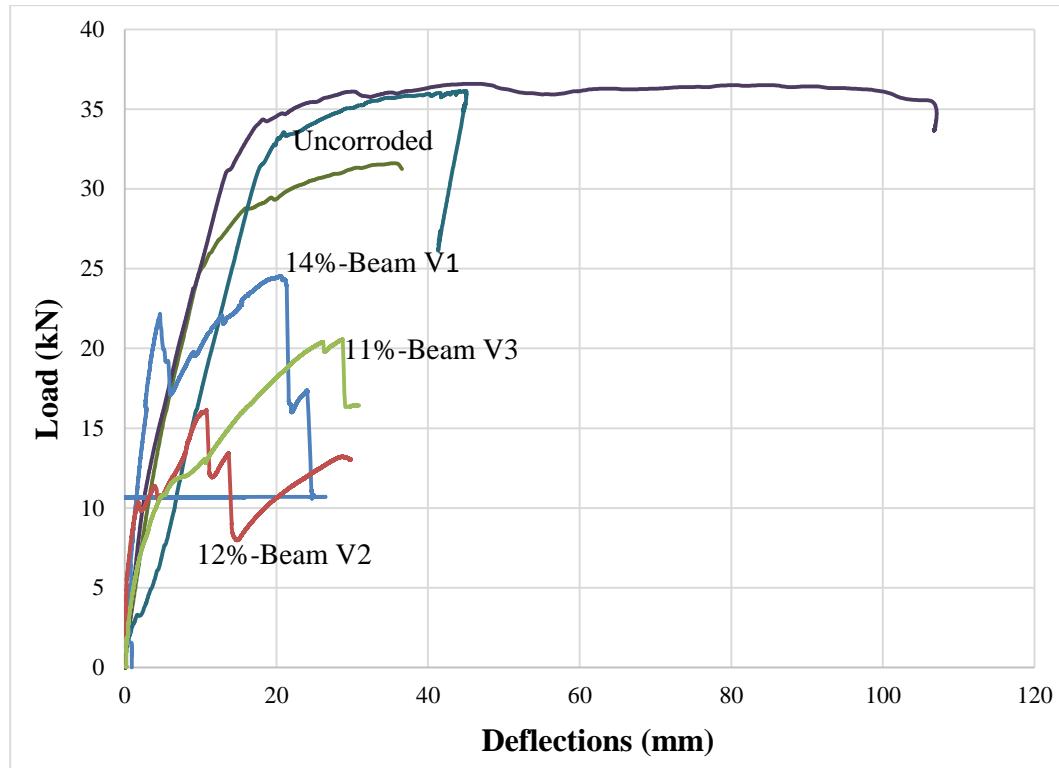
Figure III-34. Load- displacement registered for unconfined specimens as well as uncorroded members

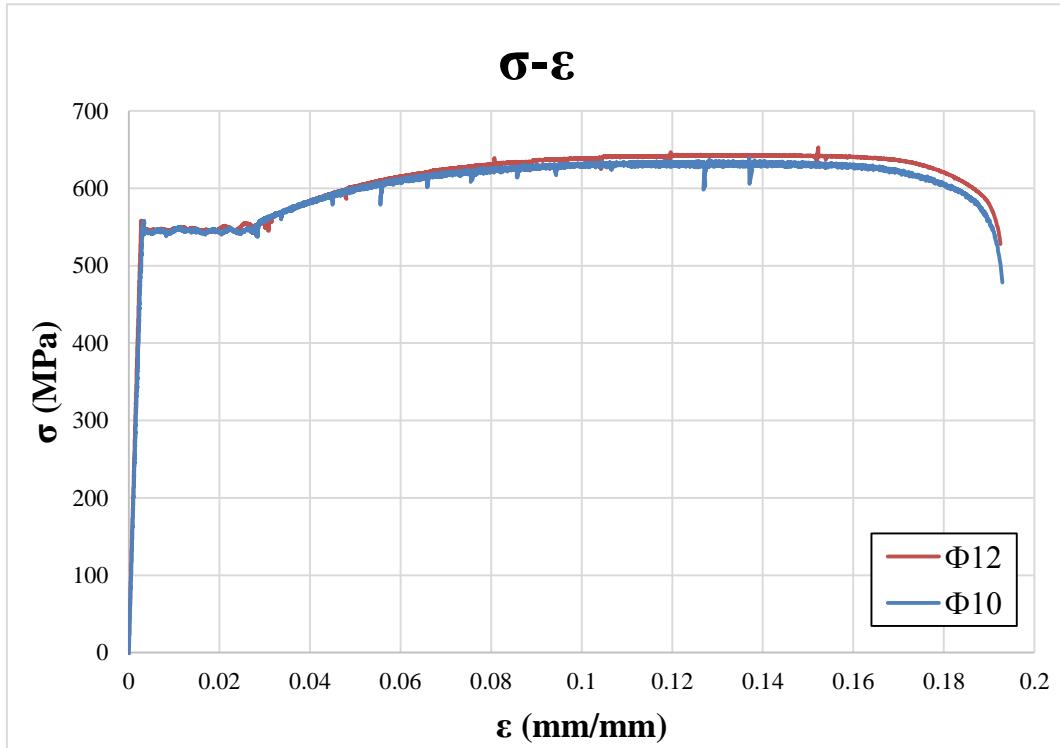
**Figure IV-1. Stress-strain behaviour of uncorroded B500SD bars**

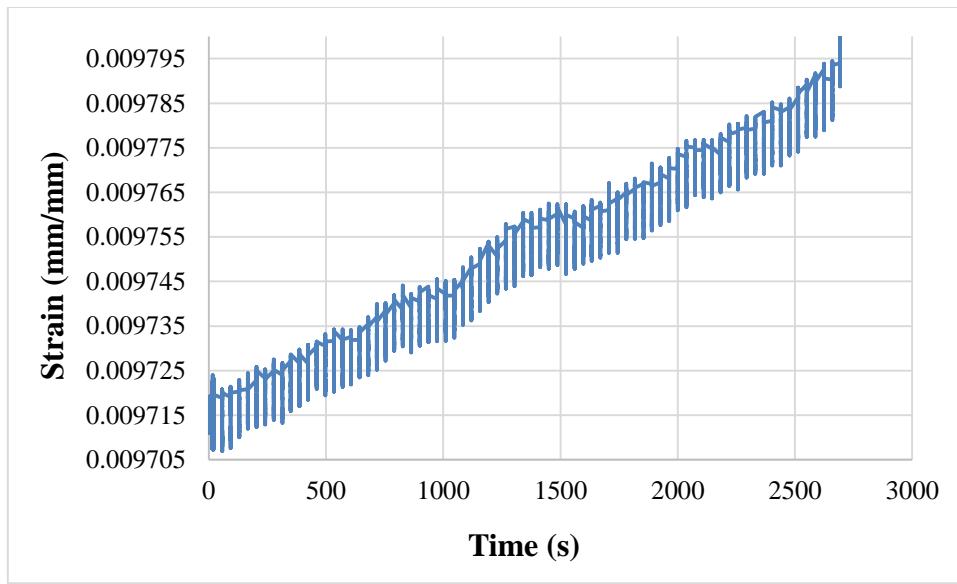
Figure IV-6. Strain recorded vs time by means of the disposed transducer. Accumulative damage on the bar

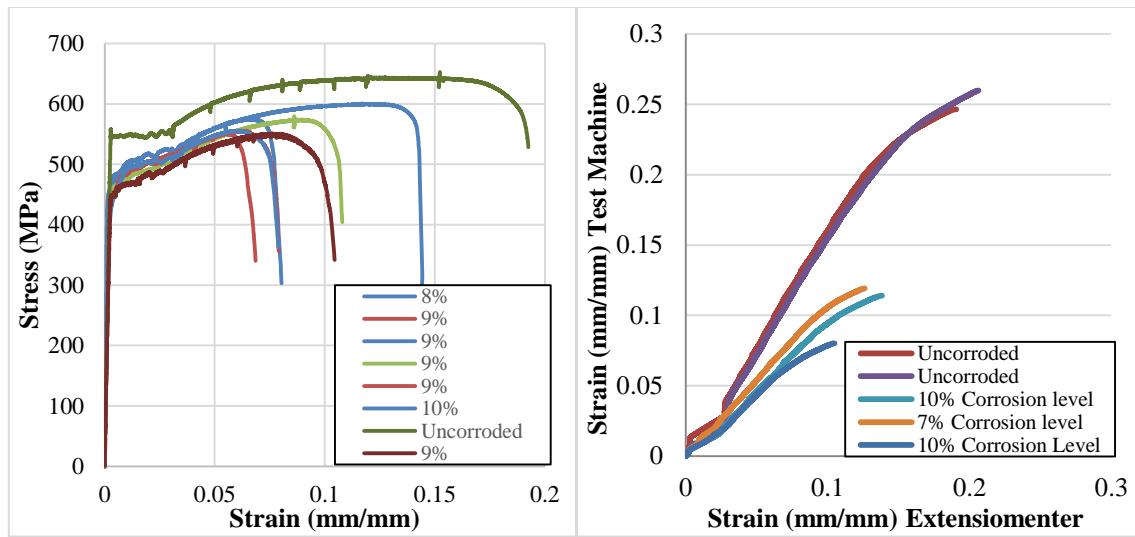
Figure IV-8. a) σ - ϵ curve corroded specimens, b) strains measured,

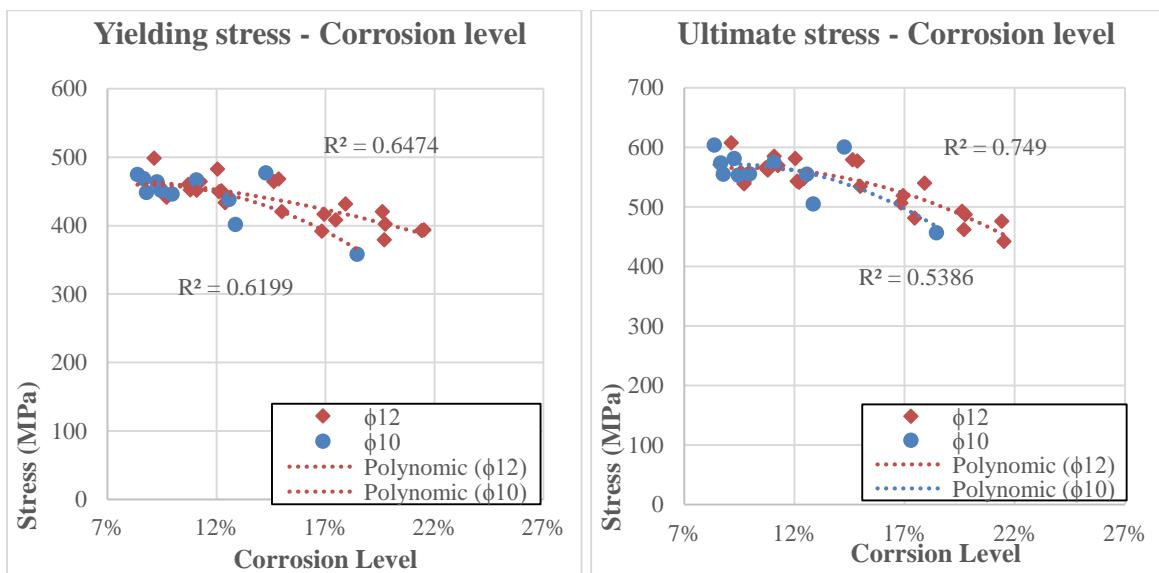
Figure IV-10. Elastic limit load and ultimate load vs. corrosion level

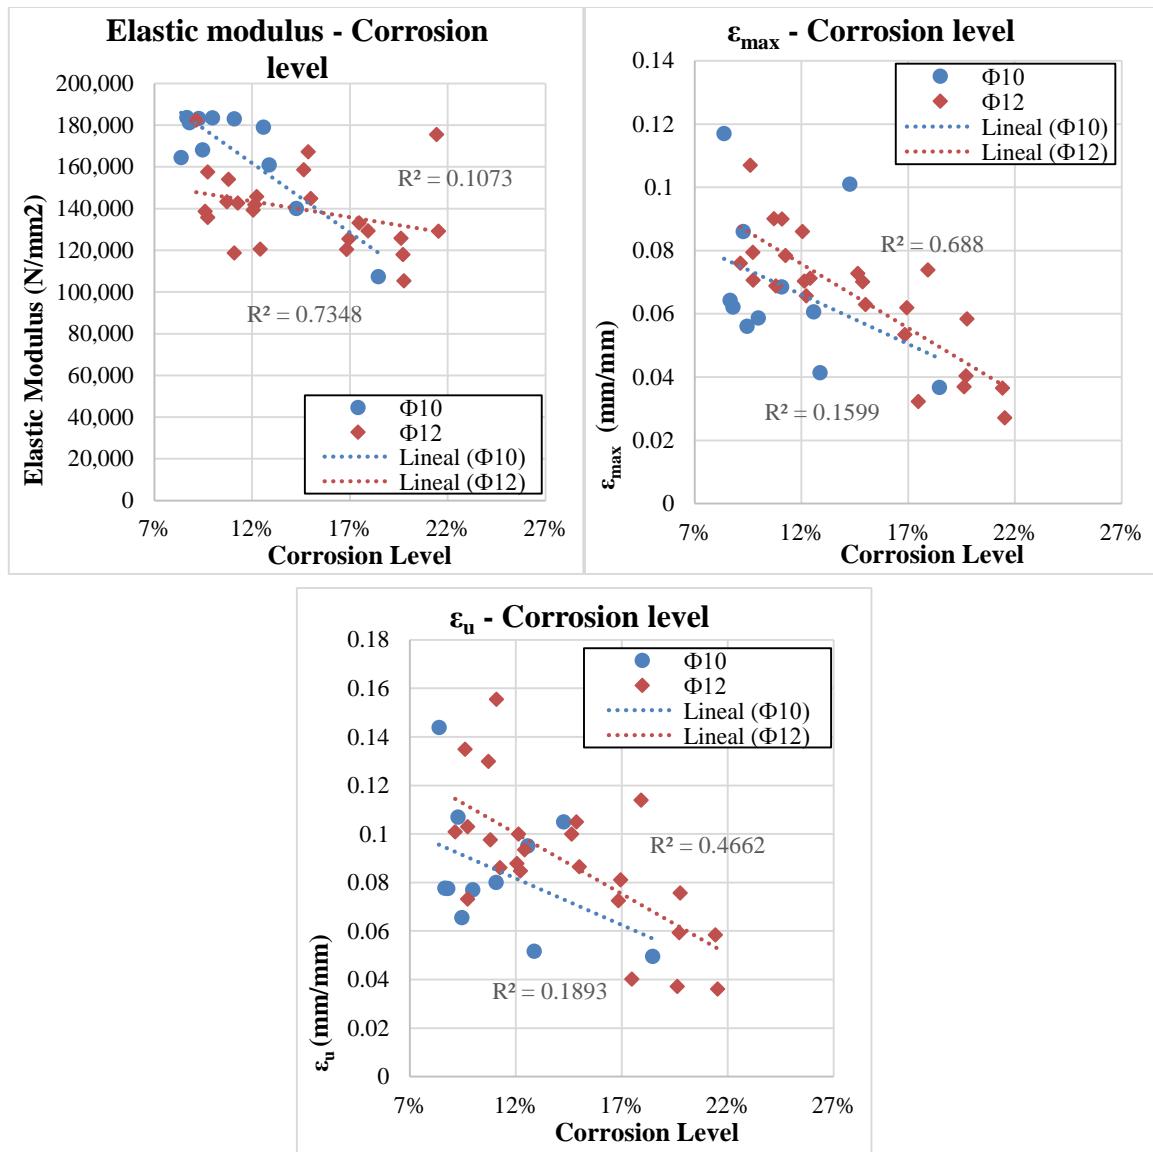
Figure IV-11. Elastic modulus, maximum ε and ultimate ε with respect to the corrosion level

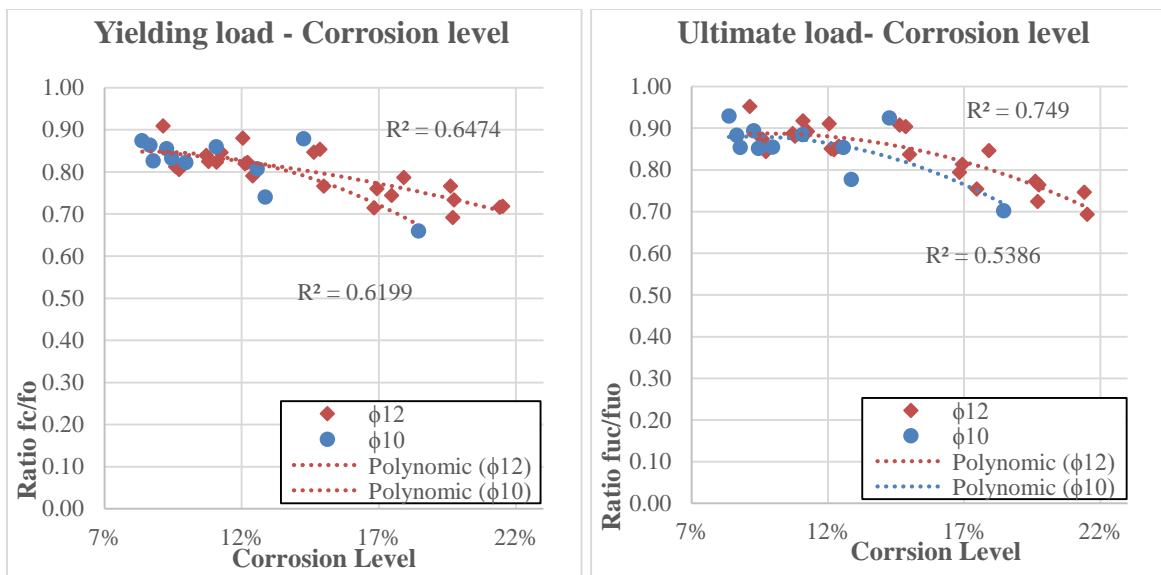
Figure IV-12. Reduction of ultimate stress and yielding stress ratios with respect to those of uncorroded steel and corrosion level for $\phi 12$ and $\phi 10$

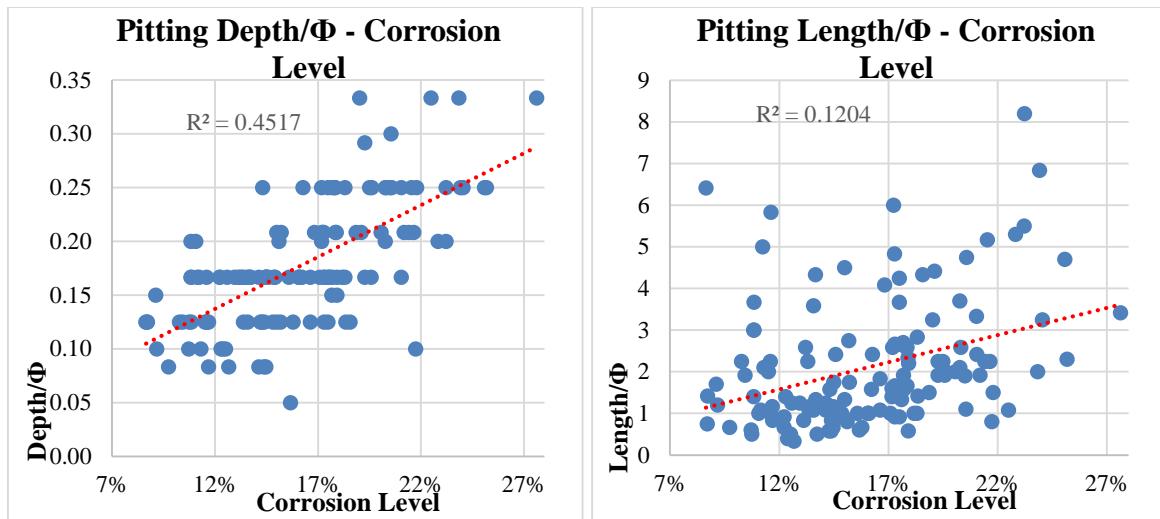
Figure IV-13. Pitting characterization with respect to corrosion level and fatigue life results

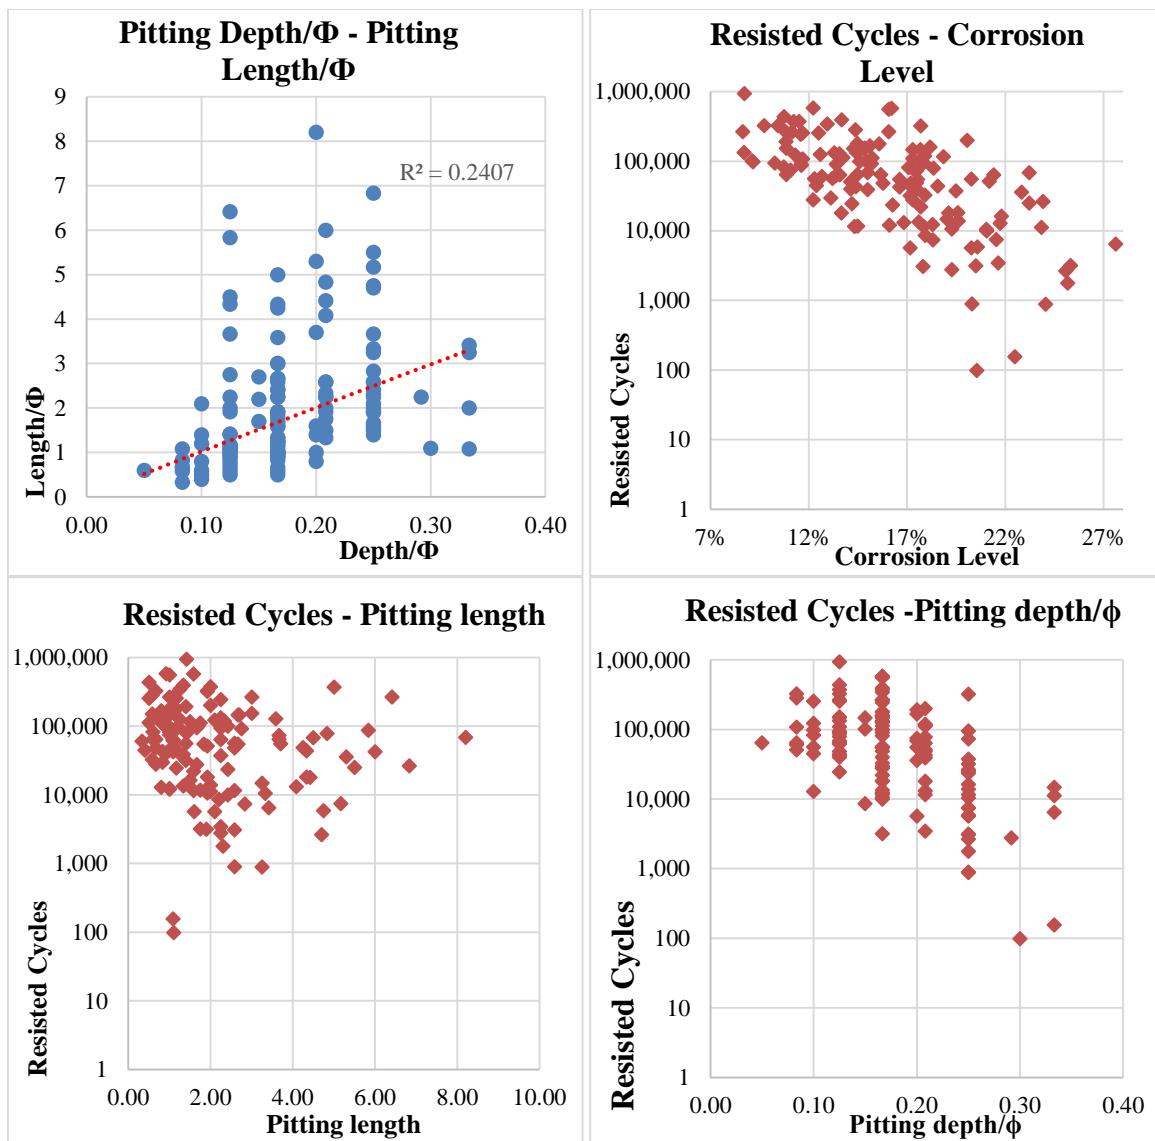
Figure IV-14. Registered fatigue life with respect to pitting parameters

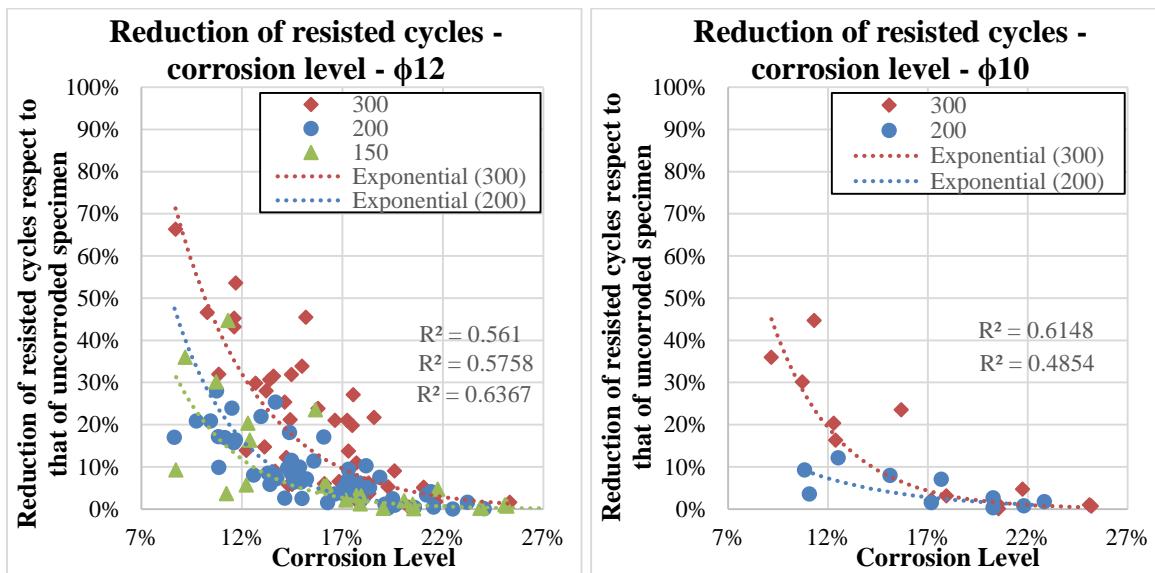
Figure IV-15. Fatigue life of corroded specimens φ12 and φ10 bars

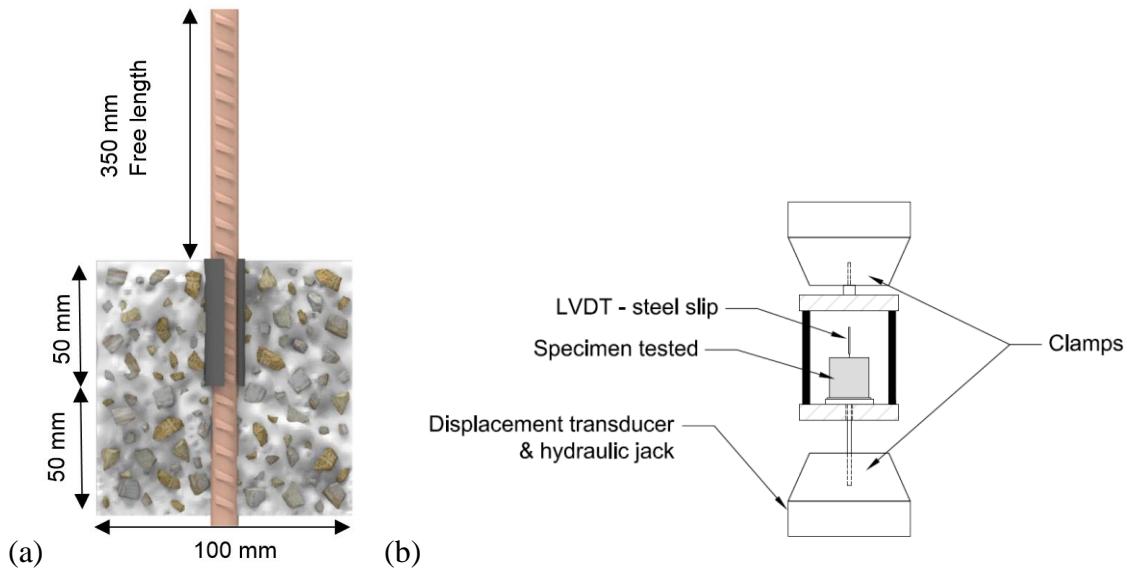
Figure IV-17. (a) Concrete specimen description (phase 1) (b) Test setup, direct pull-out test

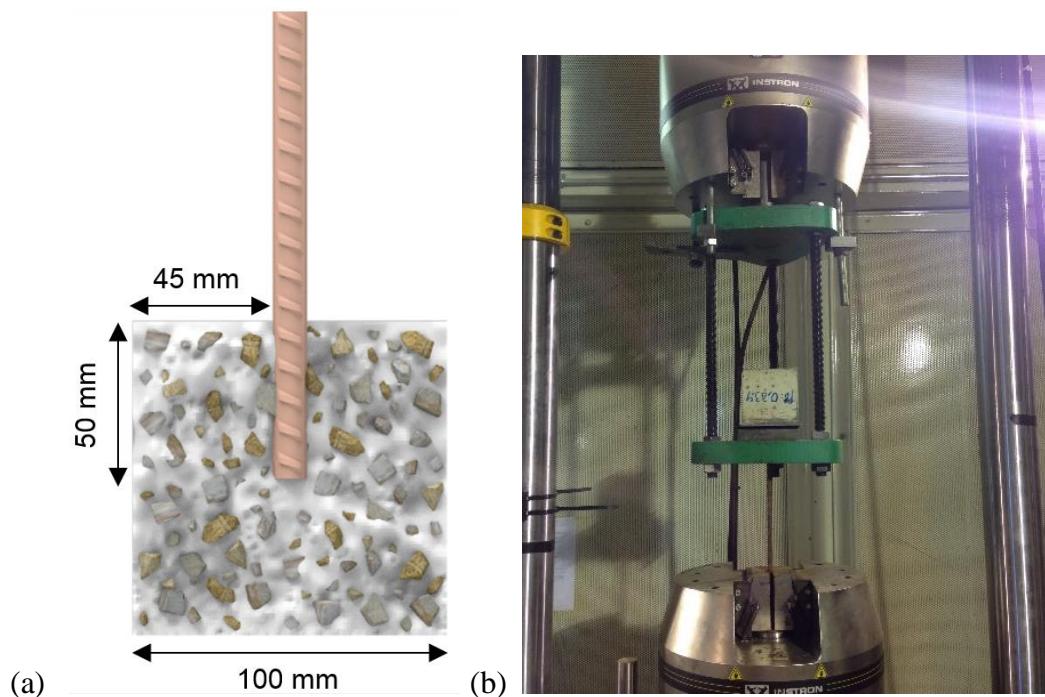
Figure IV-18. (a) Concrete specimens description (Phase 2) (b) Pull-out test setup

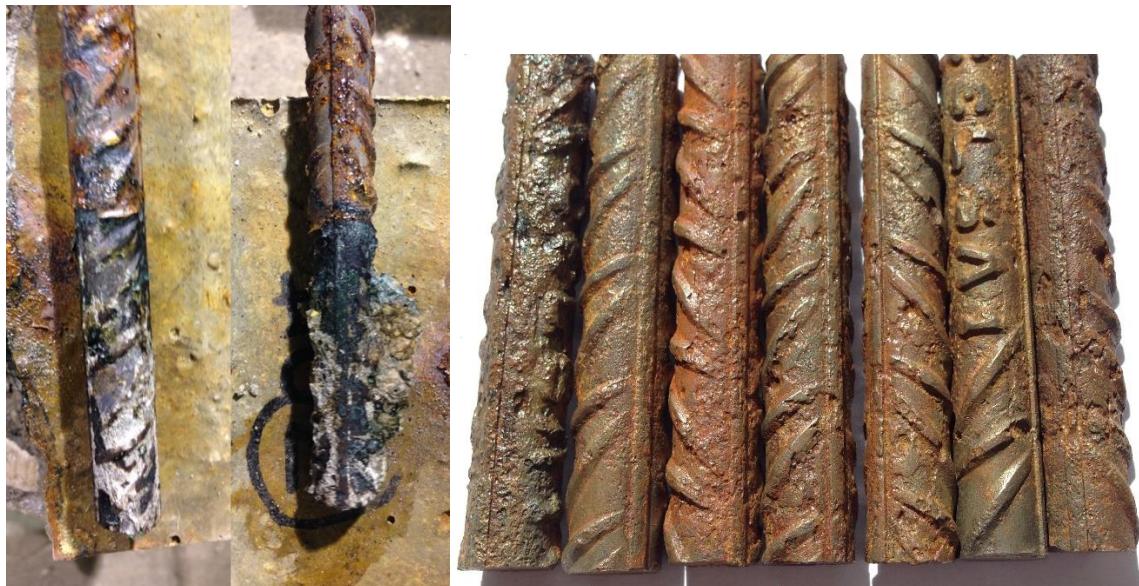
**Figure IV-26. Steel bar specimens before and after cleaning procedure**

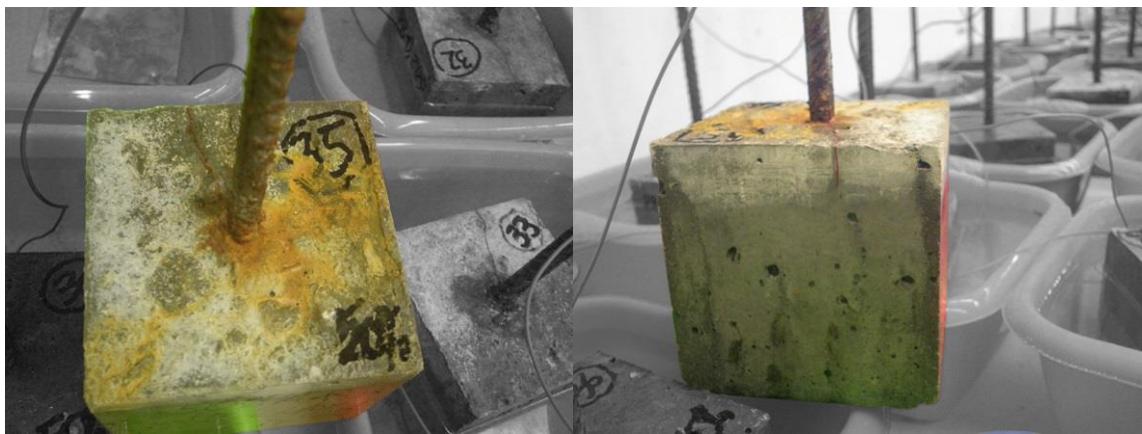
Figure IV-28. Surface cracking of RAC-50 at 5.75% of corrosion level

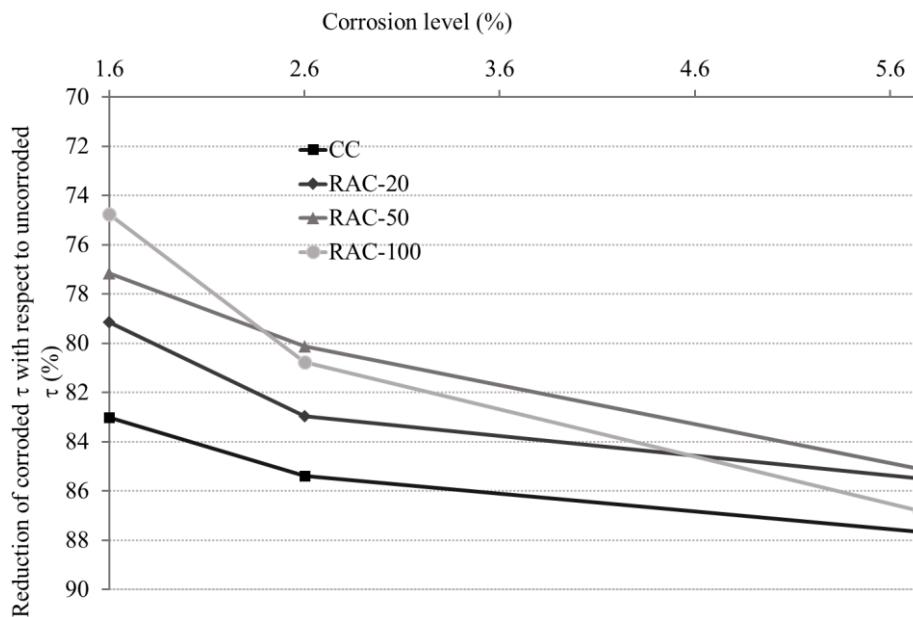
Figure IV-30. Reduction (in %) of τ_{\max} of each concrete at a different corrosion level with respect to its τ_{\max} value when the steel was uncorroded

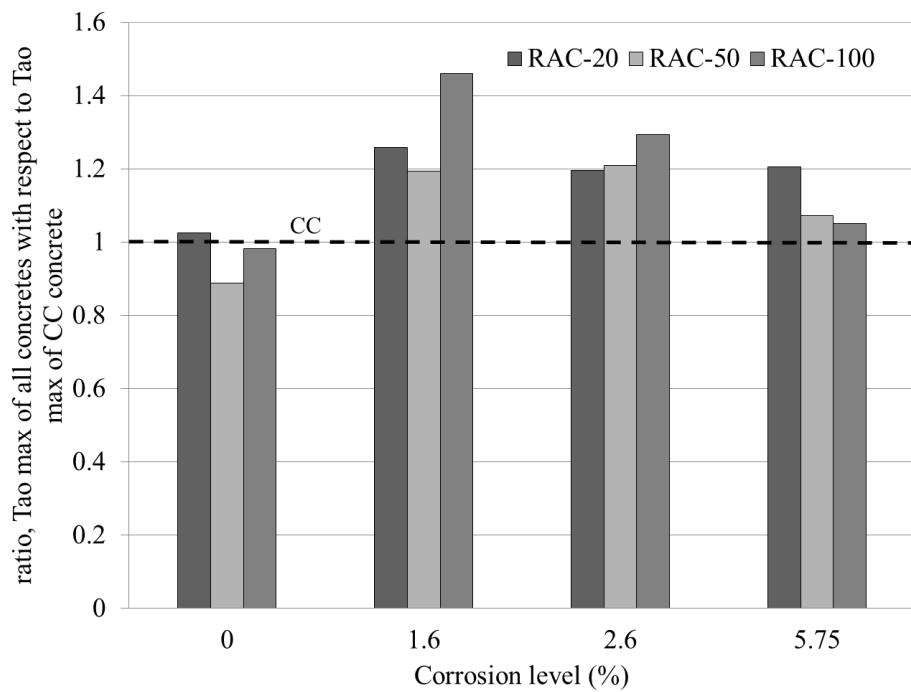
Figure IV-31. Ratio of τ_{max} (phase2) of all the concrete produced with respect to that value of conventional concrete at different corrosion level

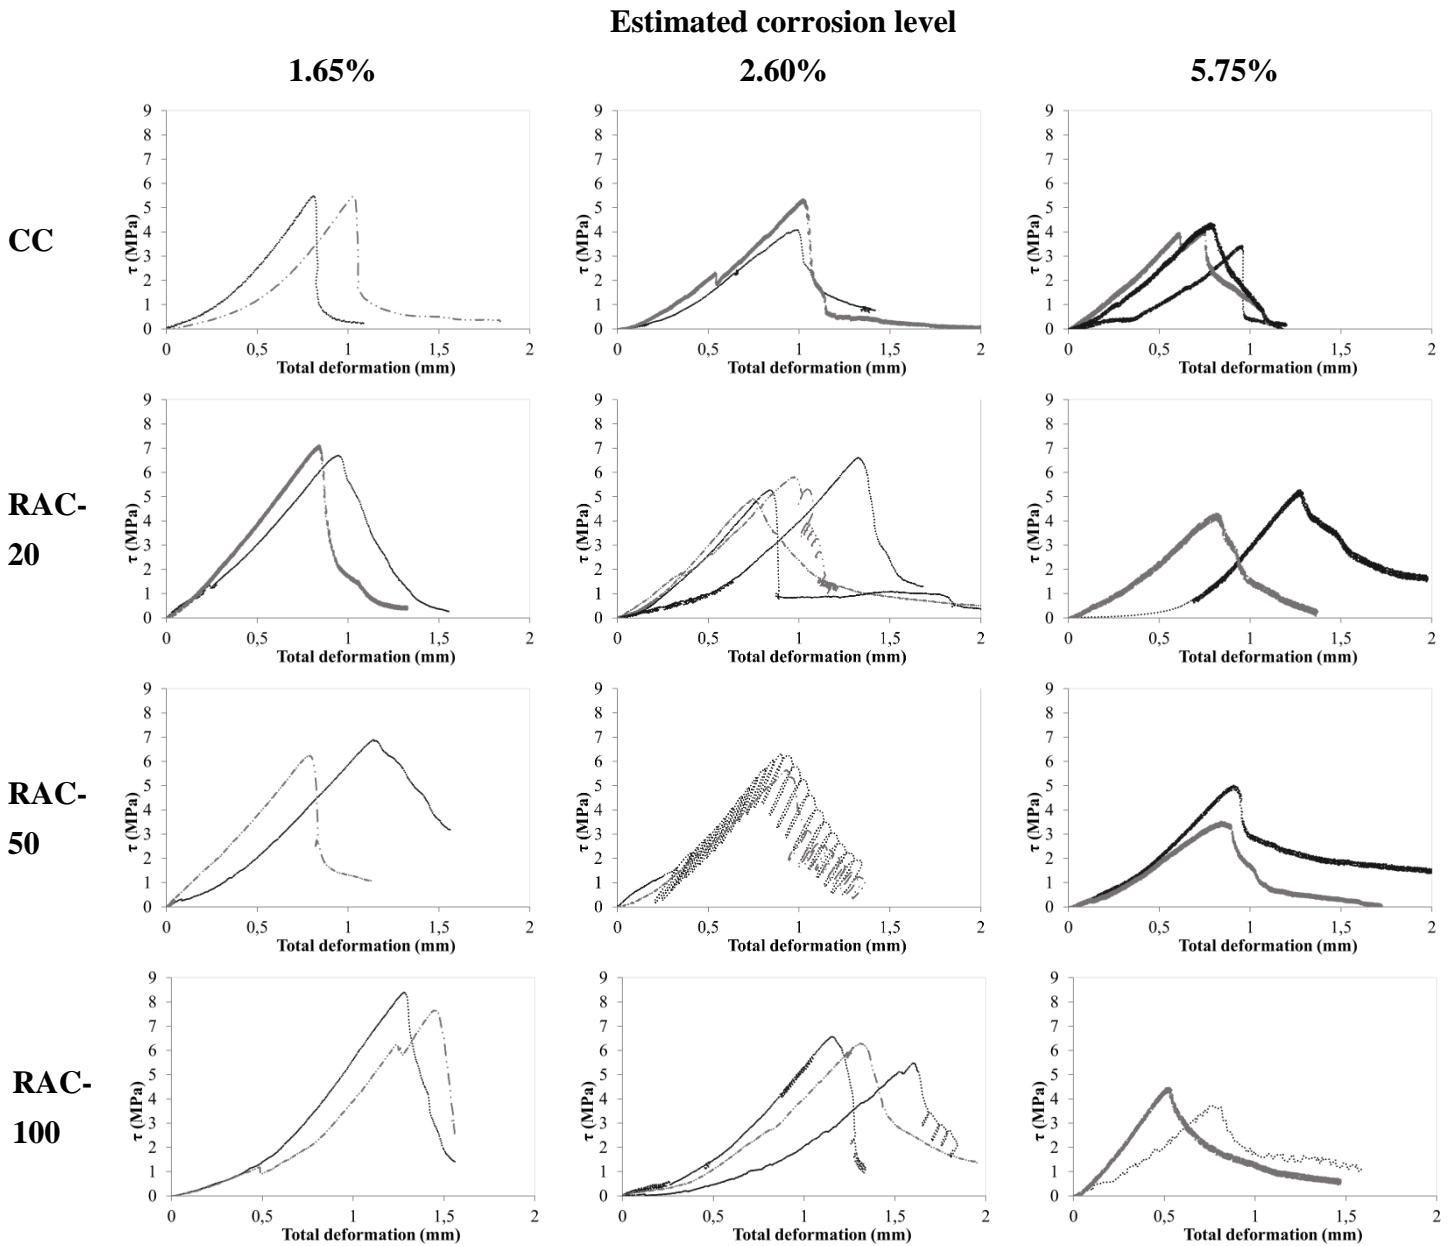
Figure IV-32. Bond (τ , MPa) –displacement (mm) behaviour of all the tested corroded specimens

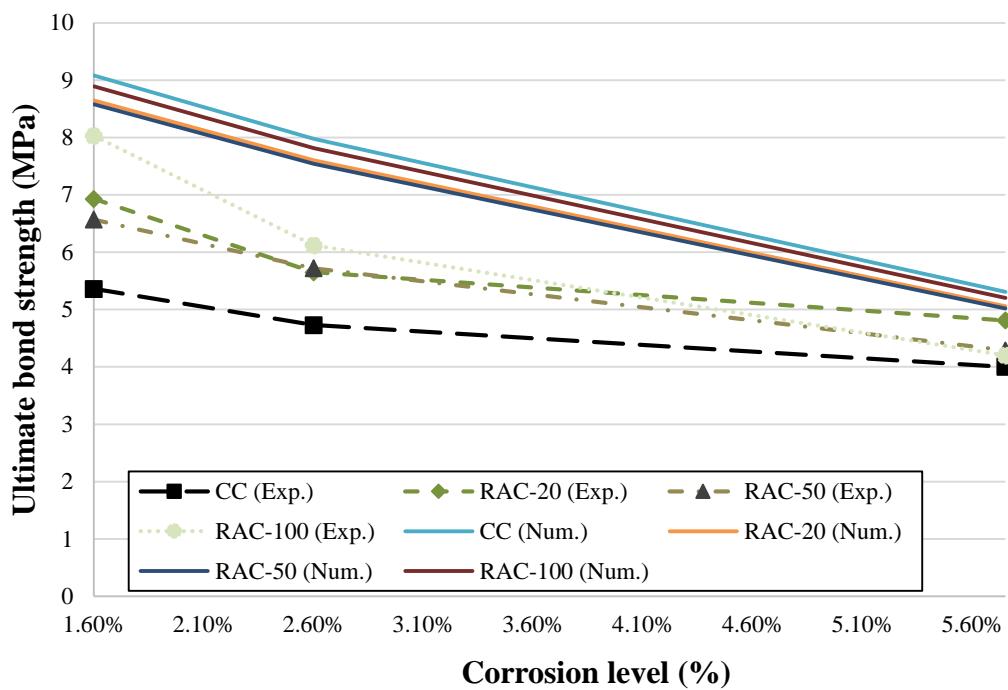
Figure IV-34. Experimental and numeral bond strength values for corroded specimens

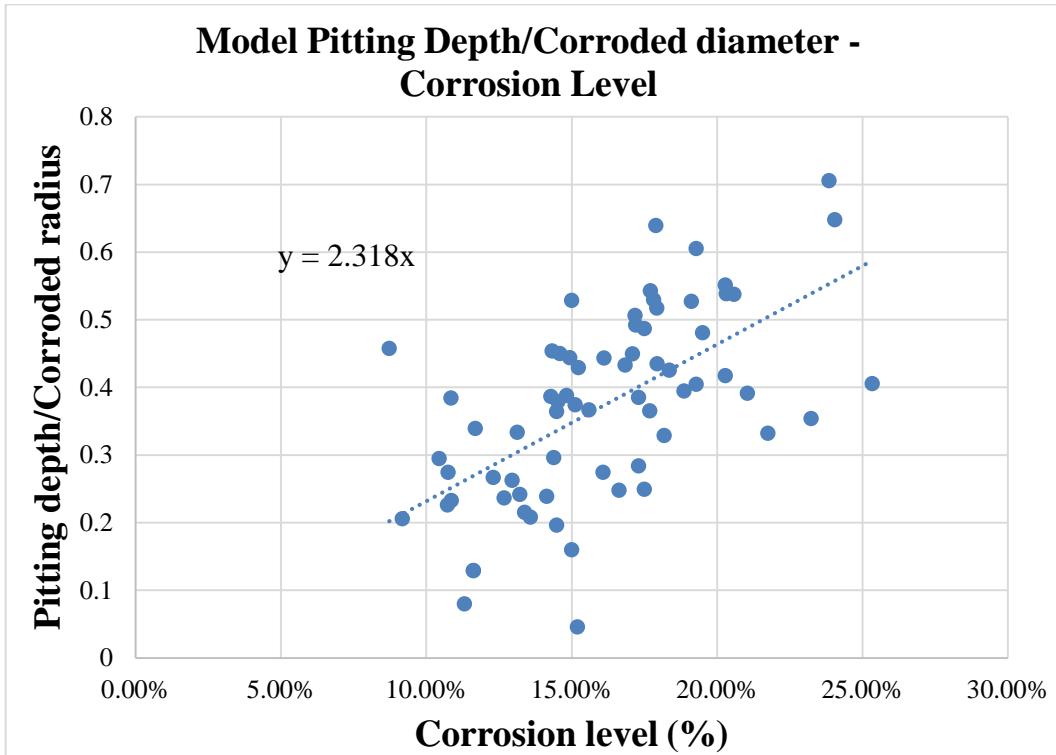
Figure V-10. Relationship between corrosion level and the quotient pitting- corroded bar diameter

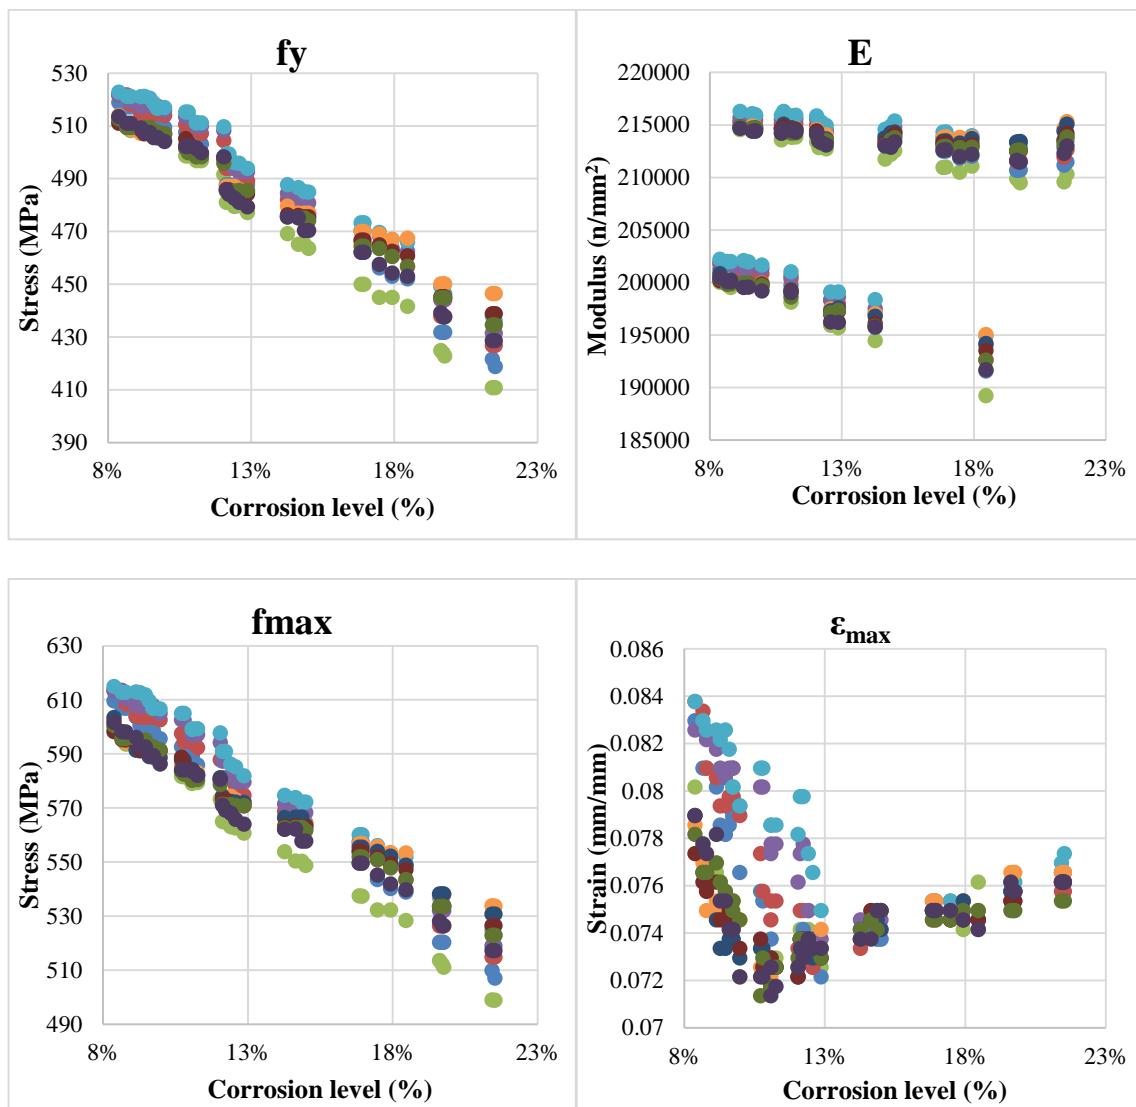
Figure V-12. Corroded steel tensile properties – Pitting angle variation

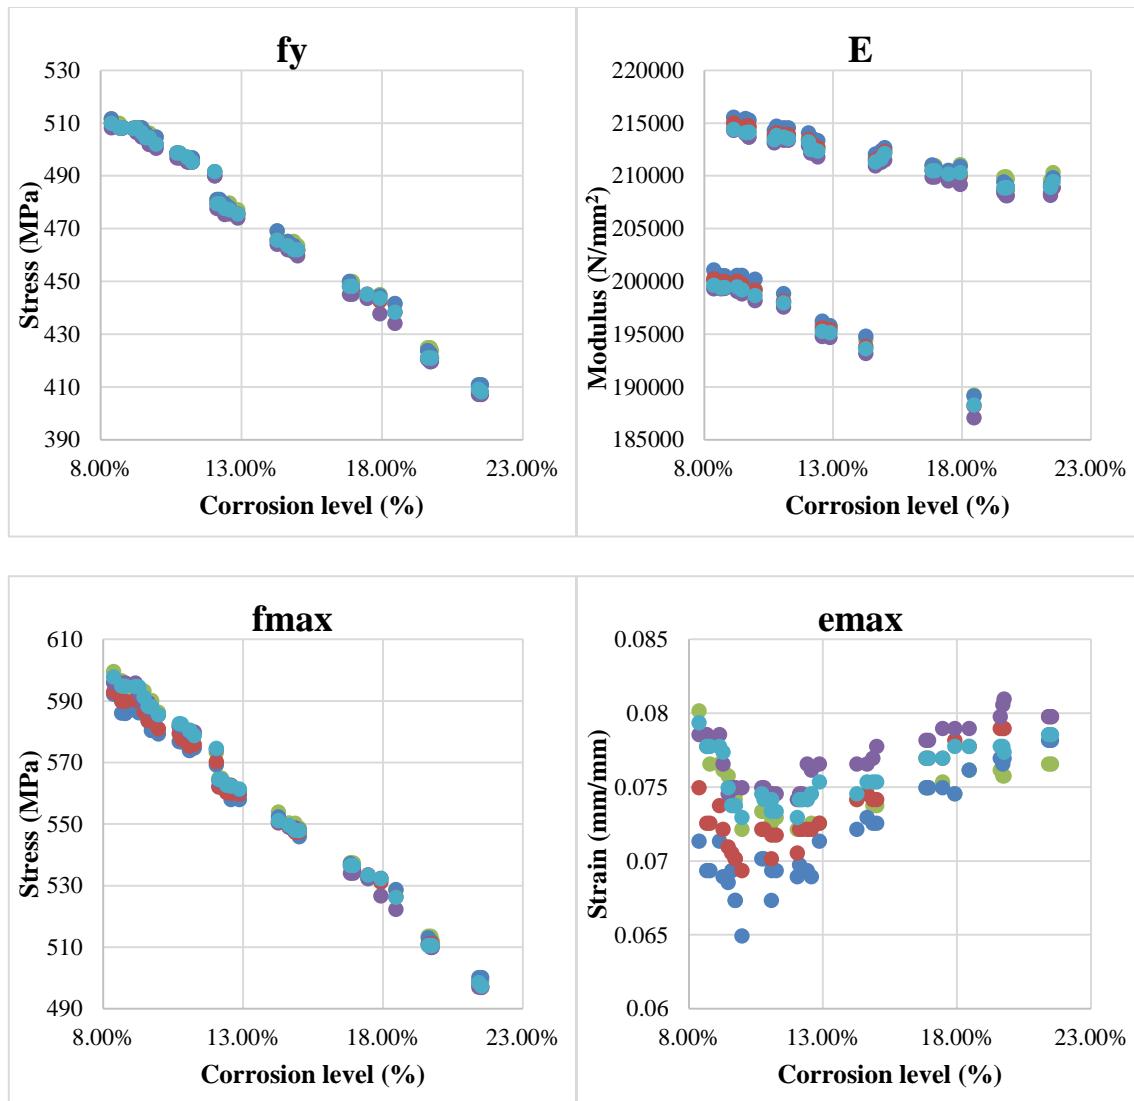
Figure V-13. Corroded steel tensile mechanical properties - Pitting length variation

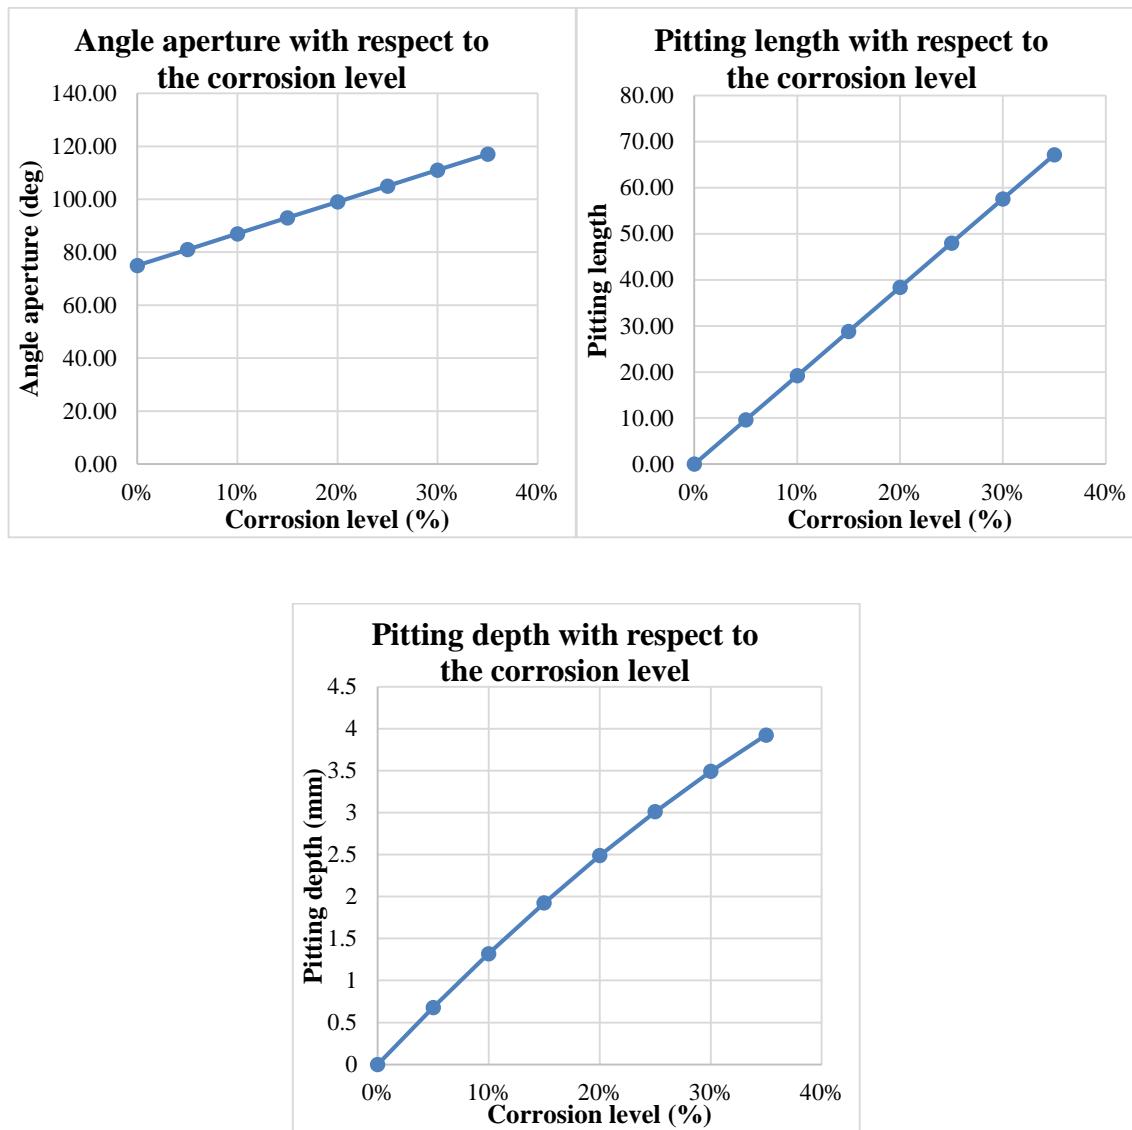
Figure V-14. Pitting geometry implementation
