Experimental and numerical study of the structural effects of steel corrosion in continuous RC beams

Doctoral Thesis
Ignasi Fernandez Perez

Universitat Politècnica de Catalunya - Barcelona Tech
Departament d'Enginyeria de la Construcció

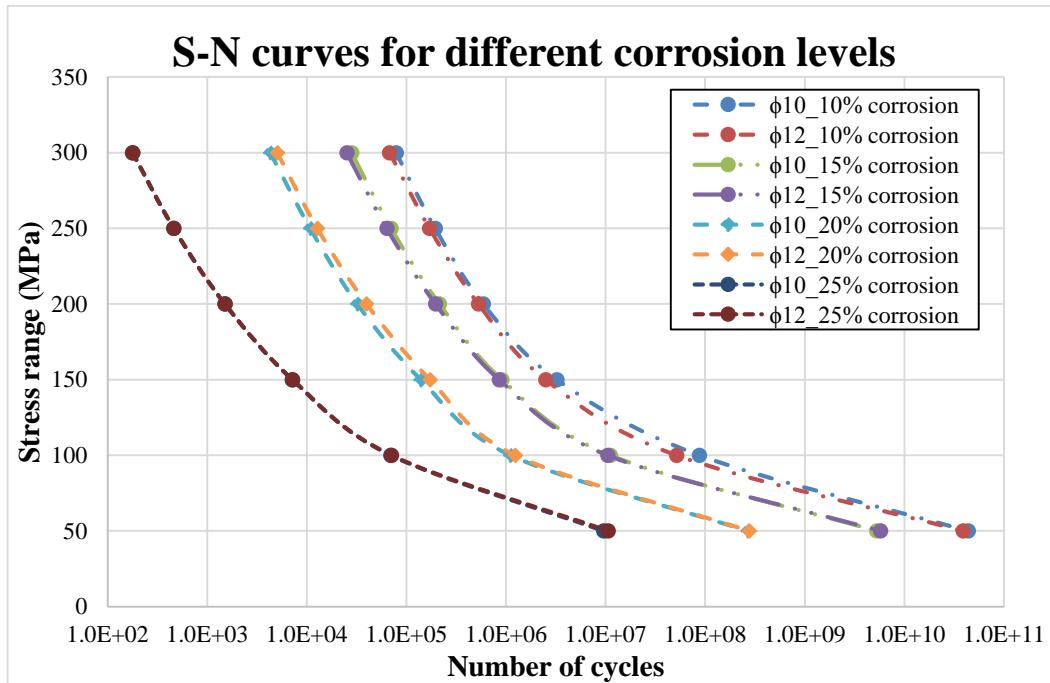
Figure V-16. Fatigue curves obtained with the presented model for different corrosion levels and two diameters according to 95% characteristic pitting – Stress range referred to nominal diameter

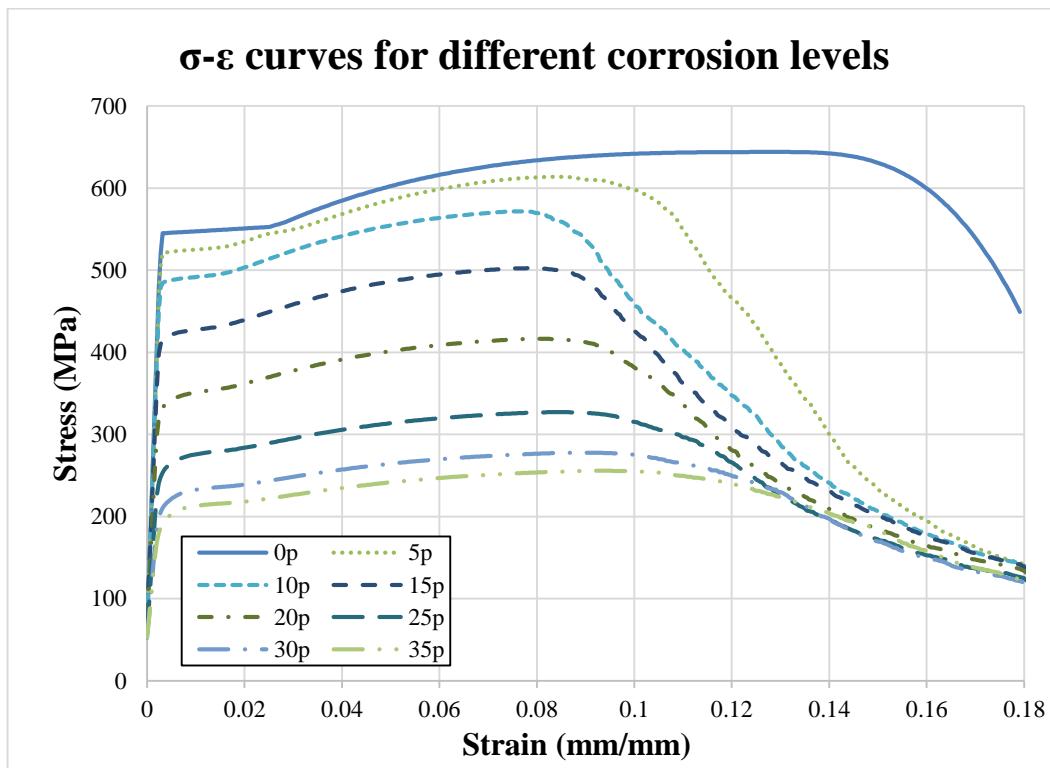
Figure V-17. σ - ϵ curves obtained with the model for different corrosion levels according to 95% characteristic pitting depth – Stresses referred to generalized corrosion level

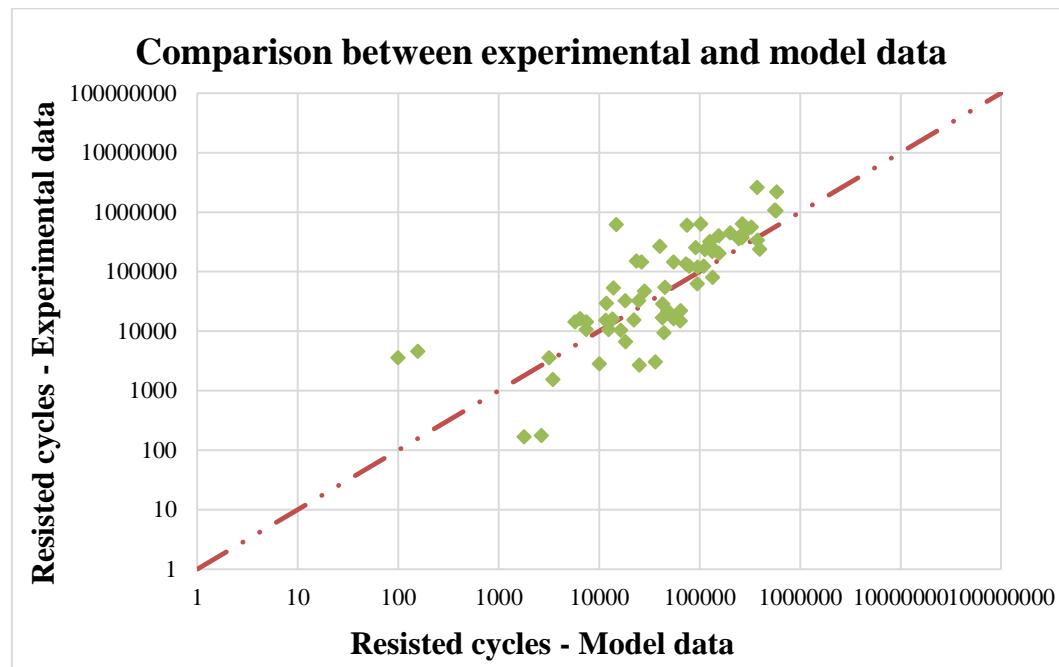
Figure V-18. Fatigue validation for corroded specimens

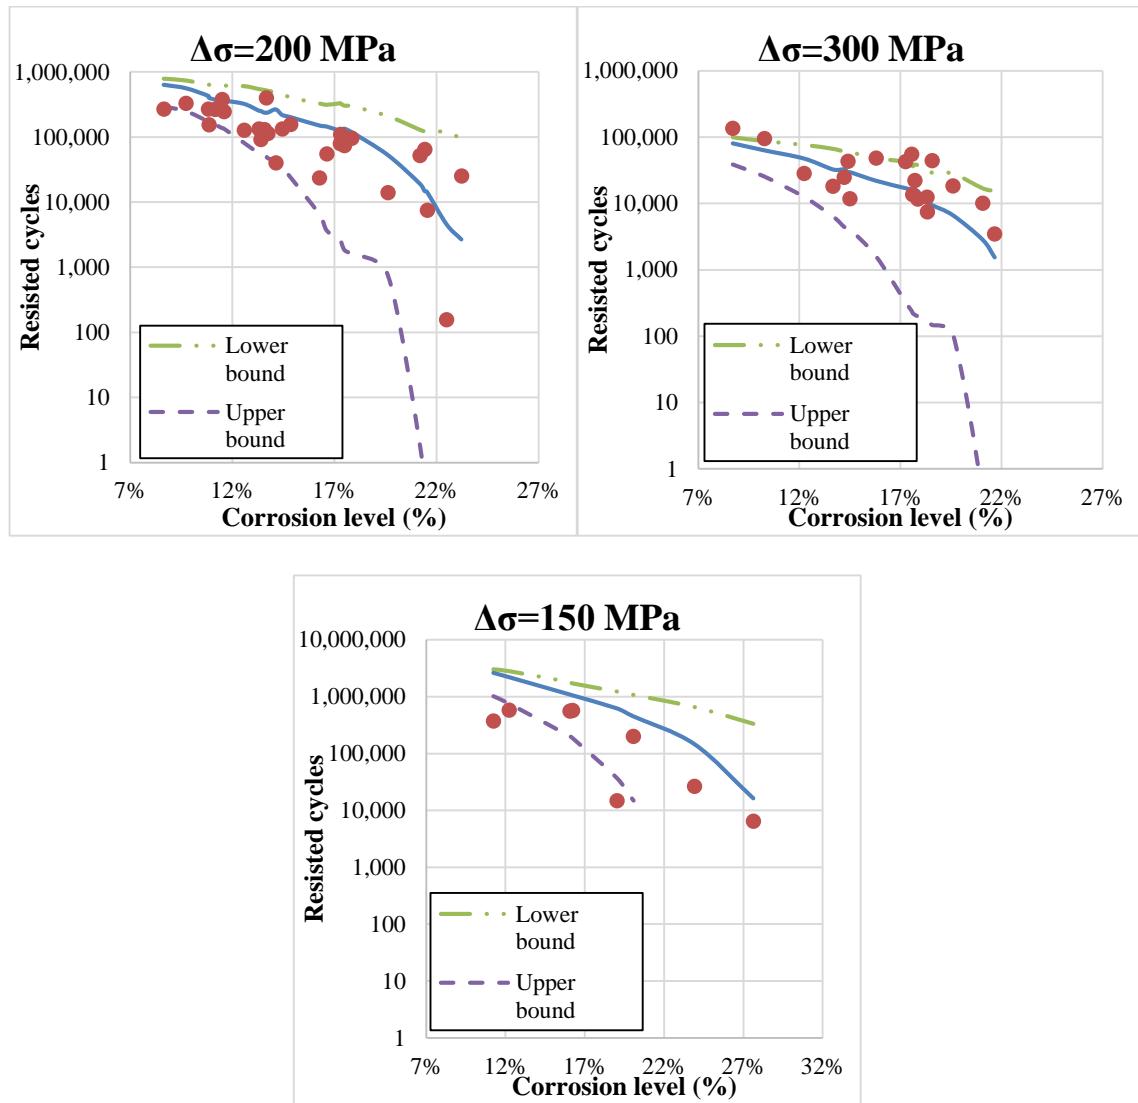
Figure V-19. Fatigue validation. Model curves and experimental for the testes stress range

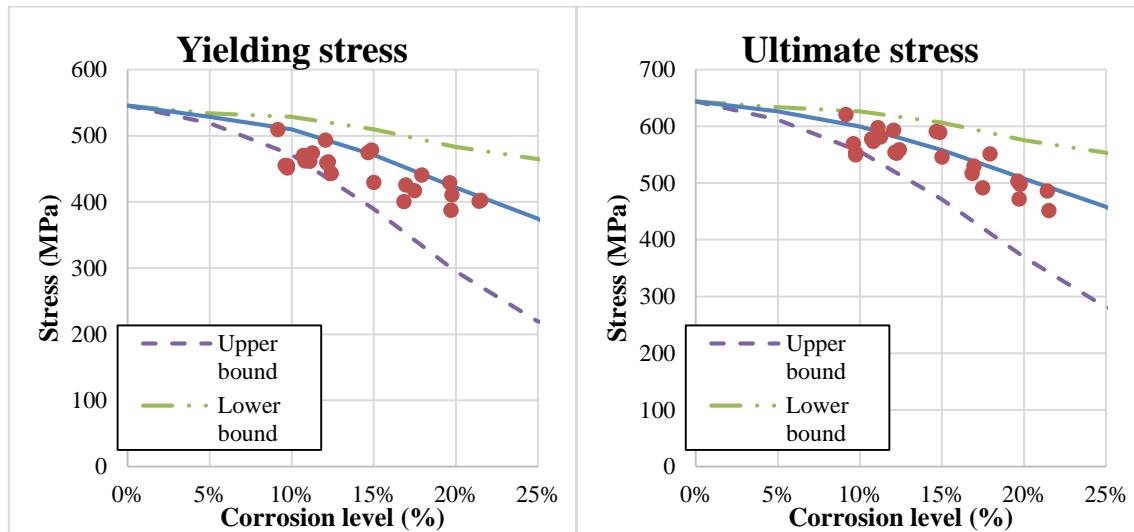
Figure V-20. Monotonic validation. Fernandez et al. test [16]

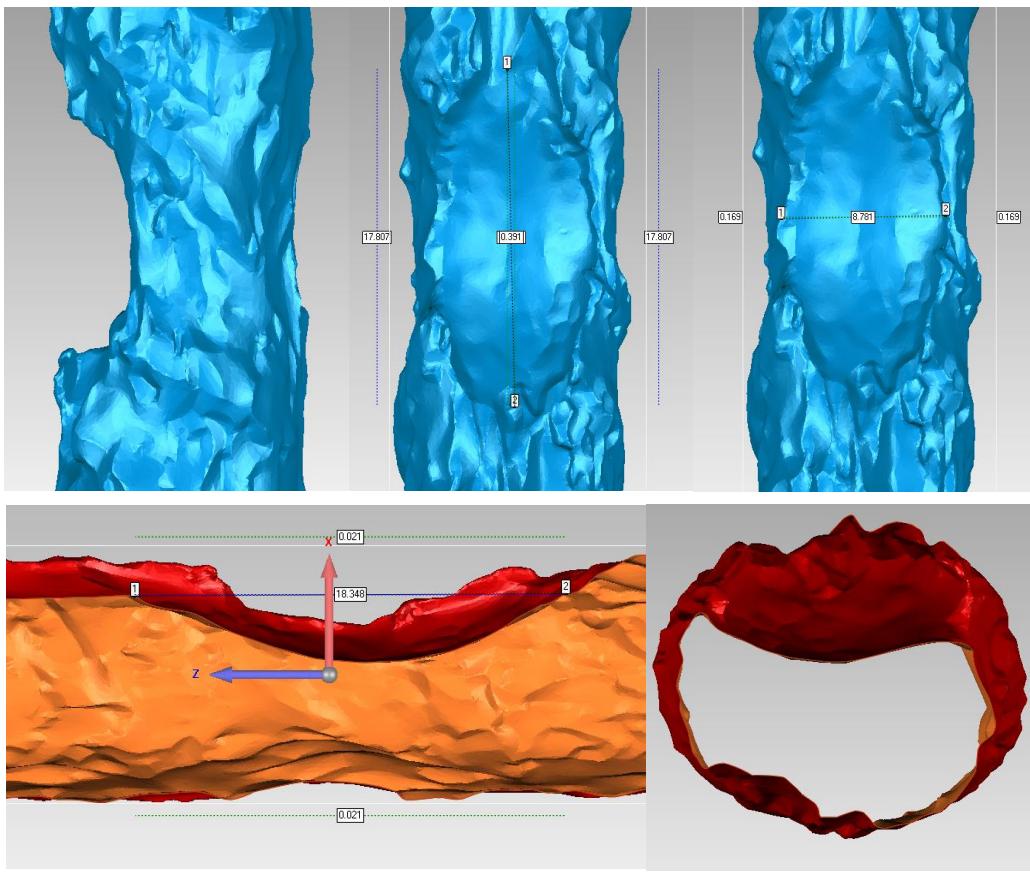
Figure V-26. Critical cross-section definition

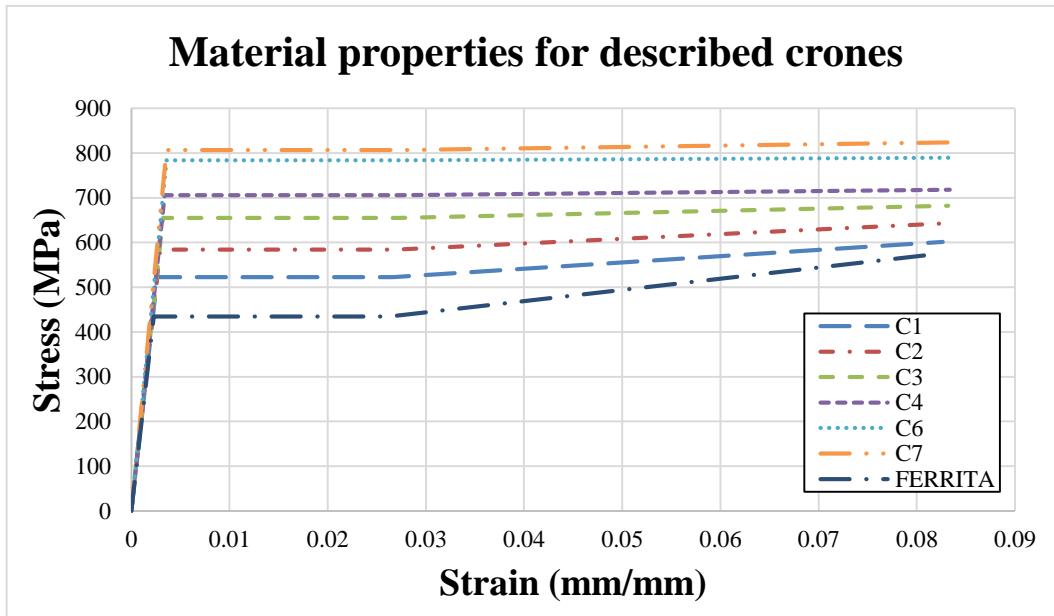
Figure V-30. Obtained stress profile from the tested bars

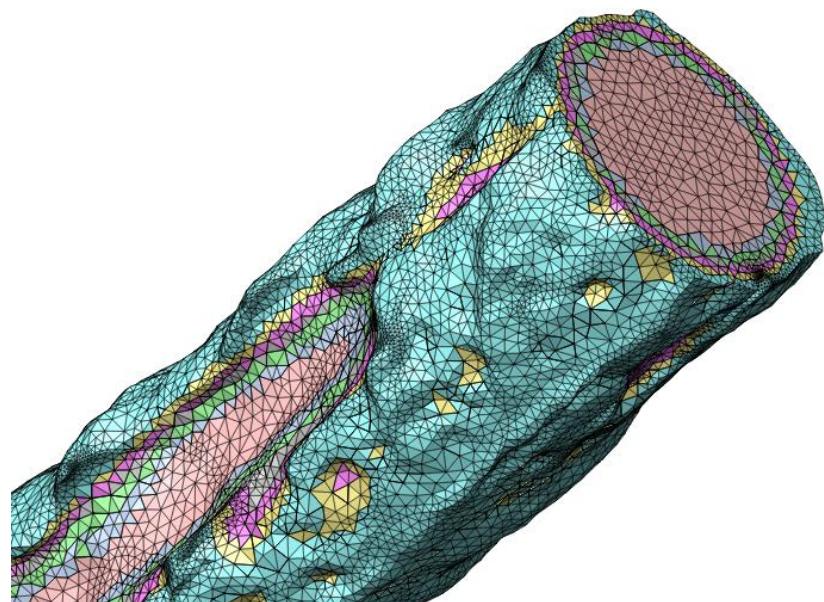
Figure V-31. Material data distribution corroded specimen

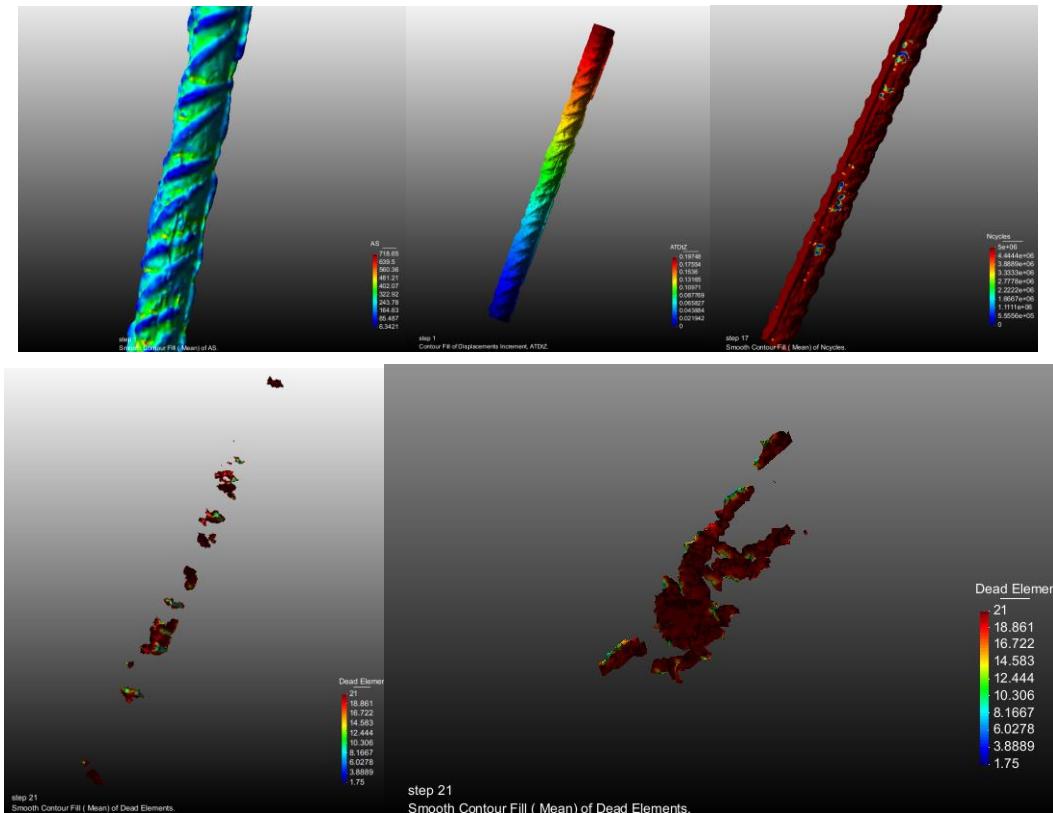
Figure V-35. Top pictures from left to right, stress distribution, total displacement, number of cycles resisted.
Bottom figures dead elements whole bar (left), dead element critical cross-section zone (right figure)

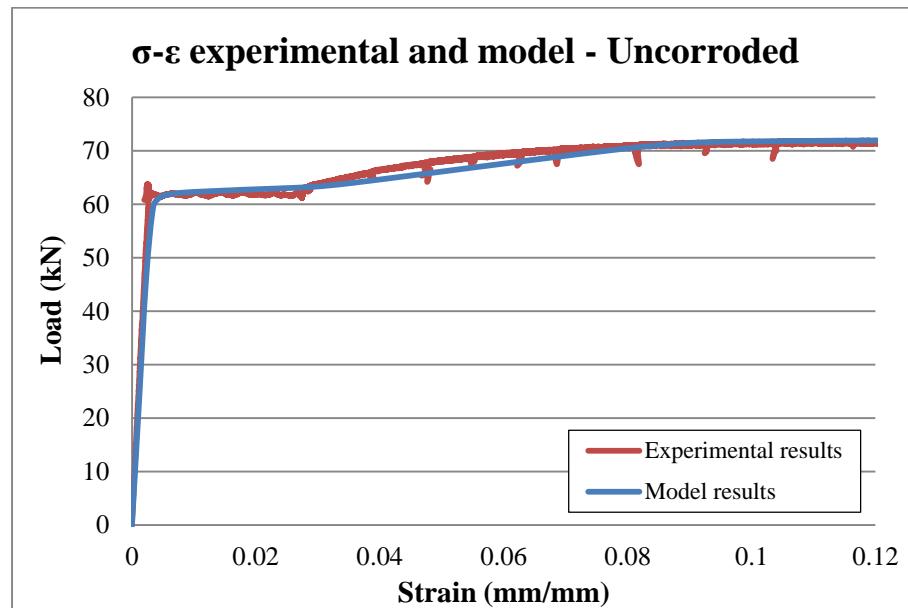
Figure V-36. $\sigma - \varepsilon$ experimental and model results. Uncorroded specimen

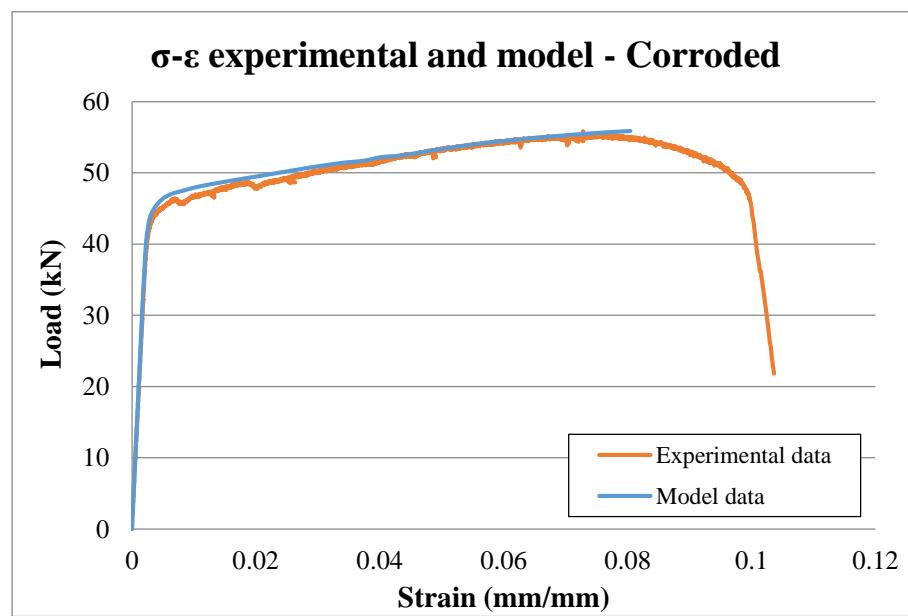
Figure V-37. $\sigma - \varepsilon$ experimental and model results. Corroded specimen

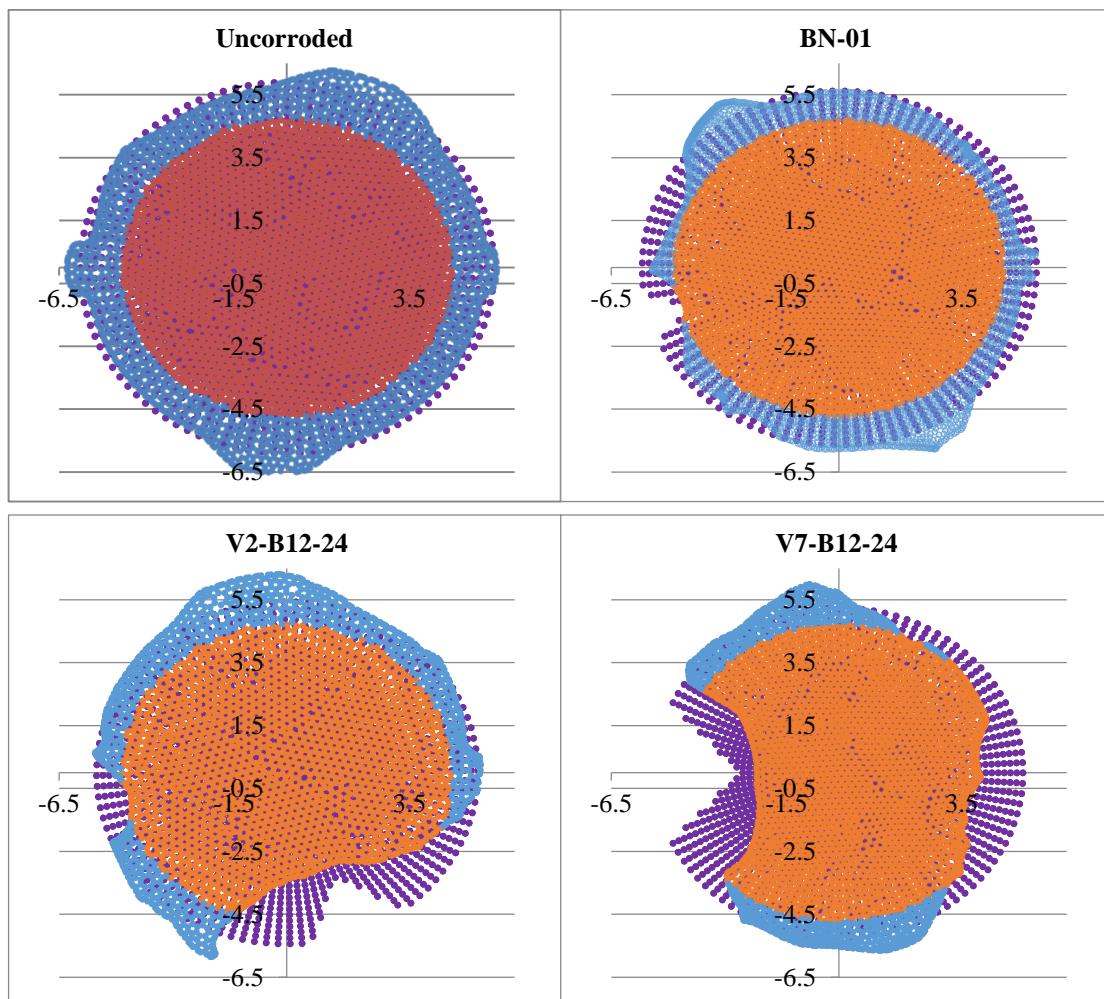
Figure V-40. Real cross-section from 3D scan and cross-section defined by model [24]

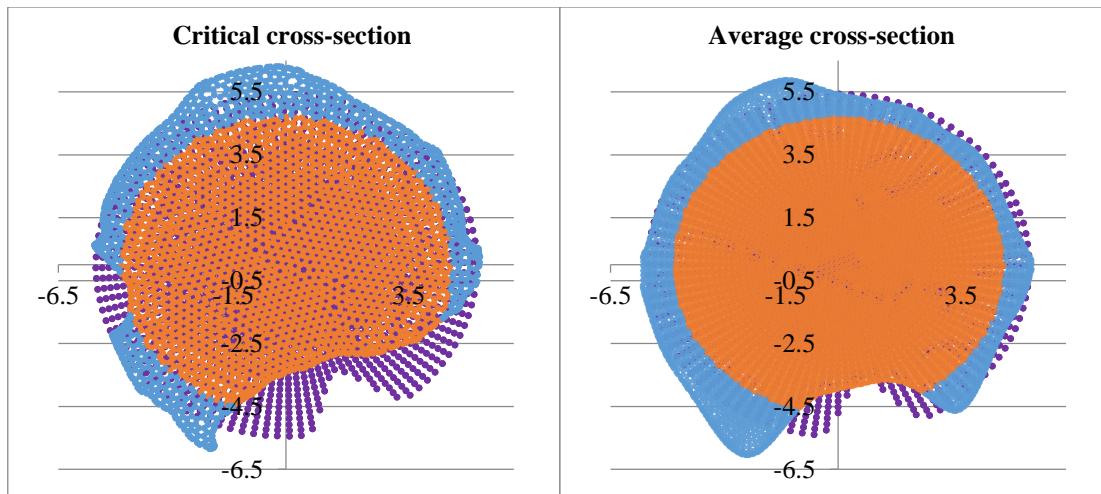
Figure V-44. Real critical cross-section compared to idealized pitted cross-section - Left. Average critical cross-section compared to idealized pitted cross-section – Right

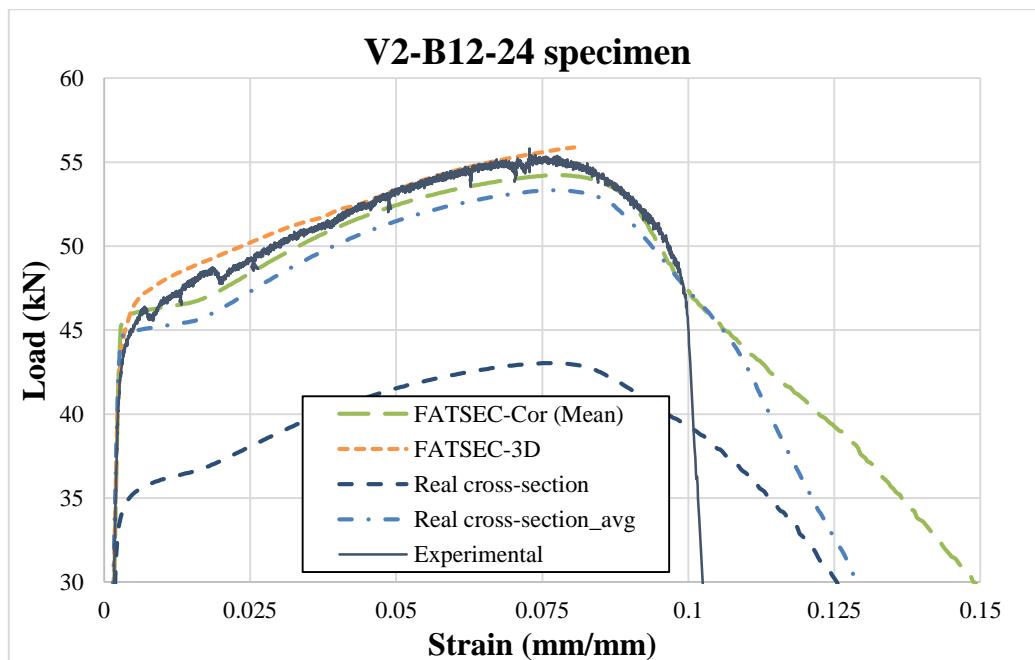
Figure V-45. Real critical cross-section, average critical cross-section and idealized pitted cross-section results comparison

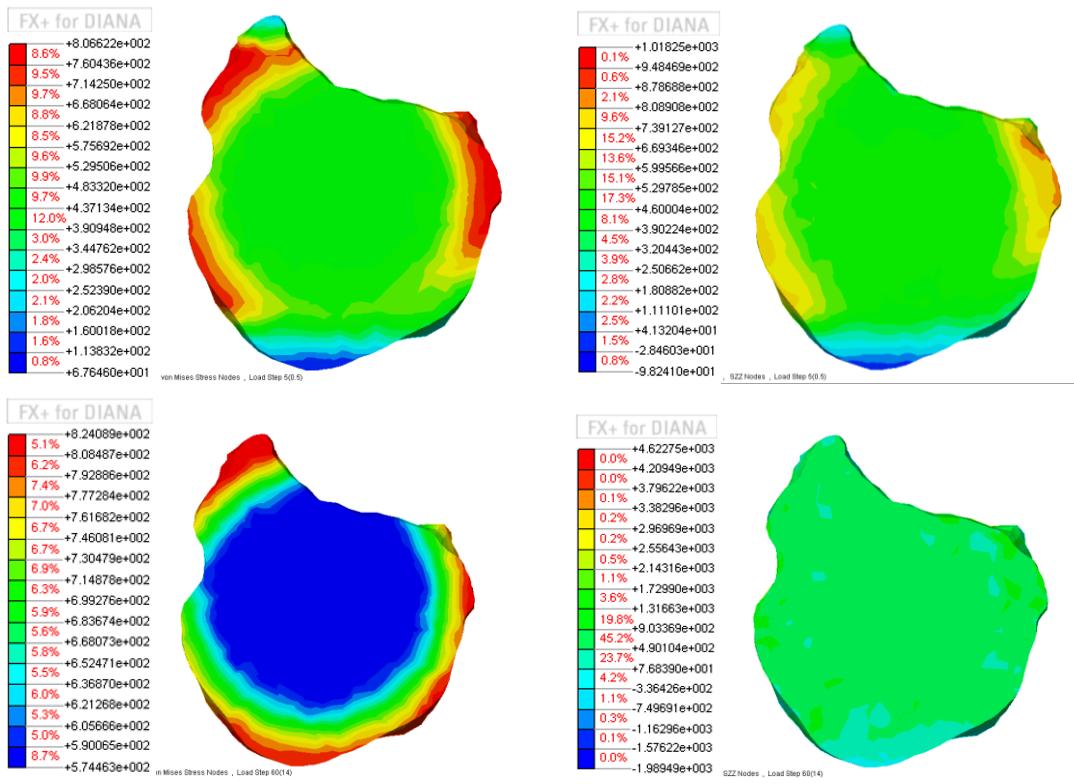
Figure V-46. Multi-axial stress behaviour of corroded specimens. Von-Misses multi-axial yielding criterion left, uniaxial stress right. Overall yielding stresses instant step with respect Von-Misses criterion top, ultimate stress step with respect to Von-Misses criterion bottom

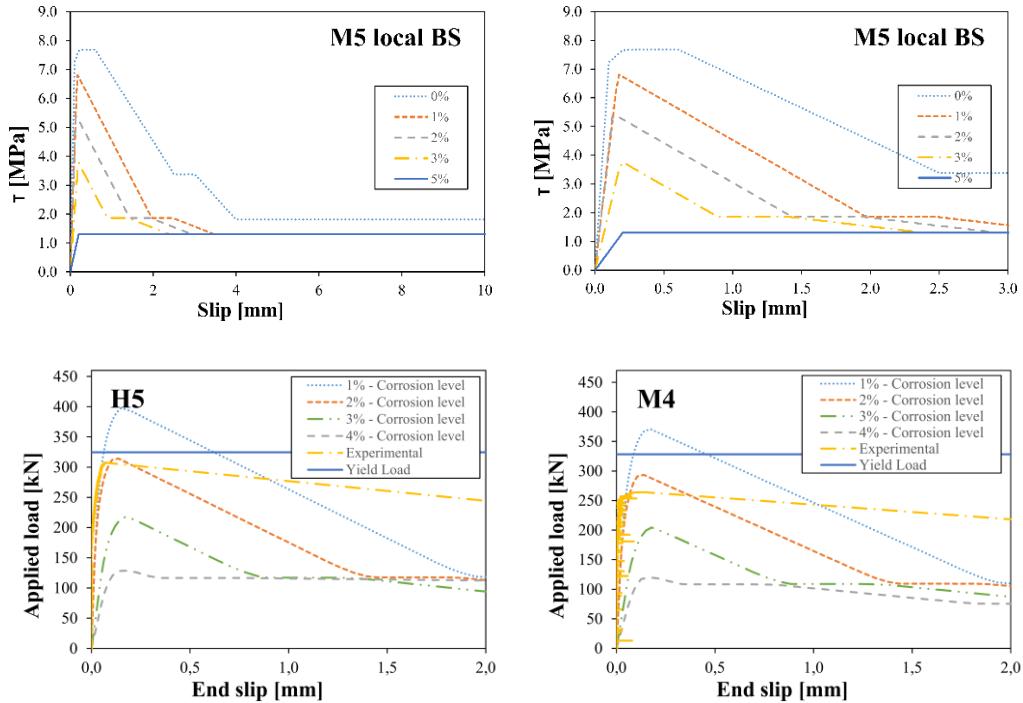
Figure V-49. Top, Bond-slip curves accounting for four different corrosion levels, obtained by means of the 1D bond-slip model for beam M5 (Right figure is enlargement of left). Bottom, Applied load end-slip curves for H5 and M4 specimens accounting for 1 to 4 % co

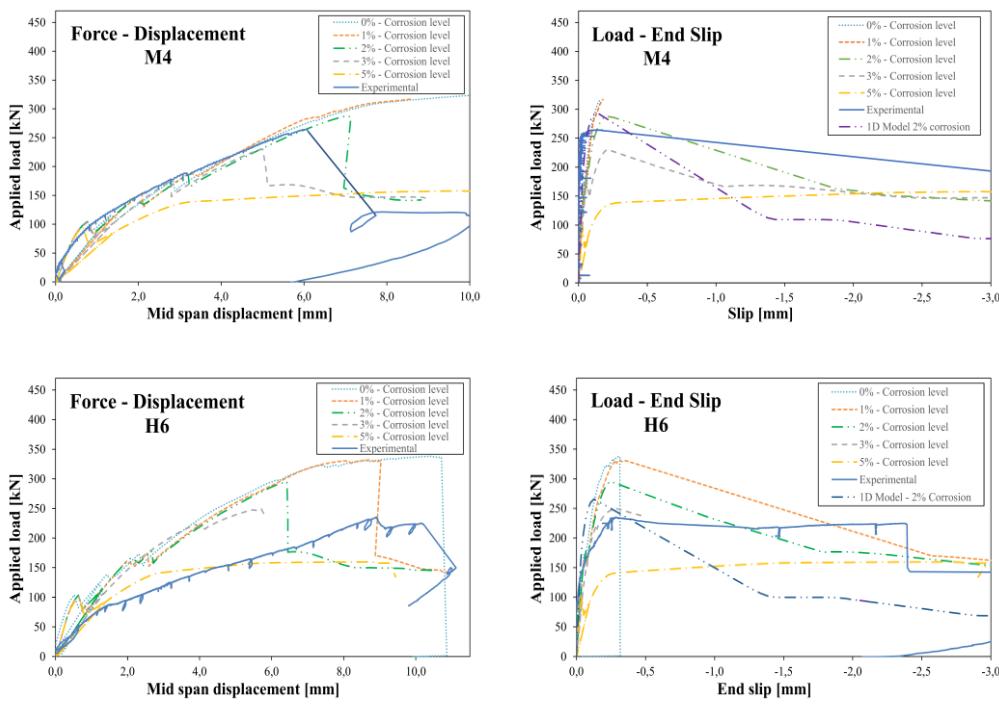
Figure V-51. Results of 3D FE analysis in comparison with experiments and 1D Bond-slip Model

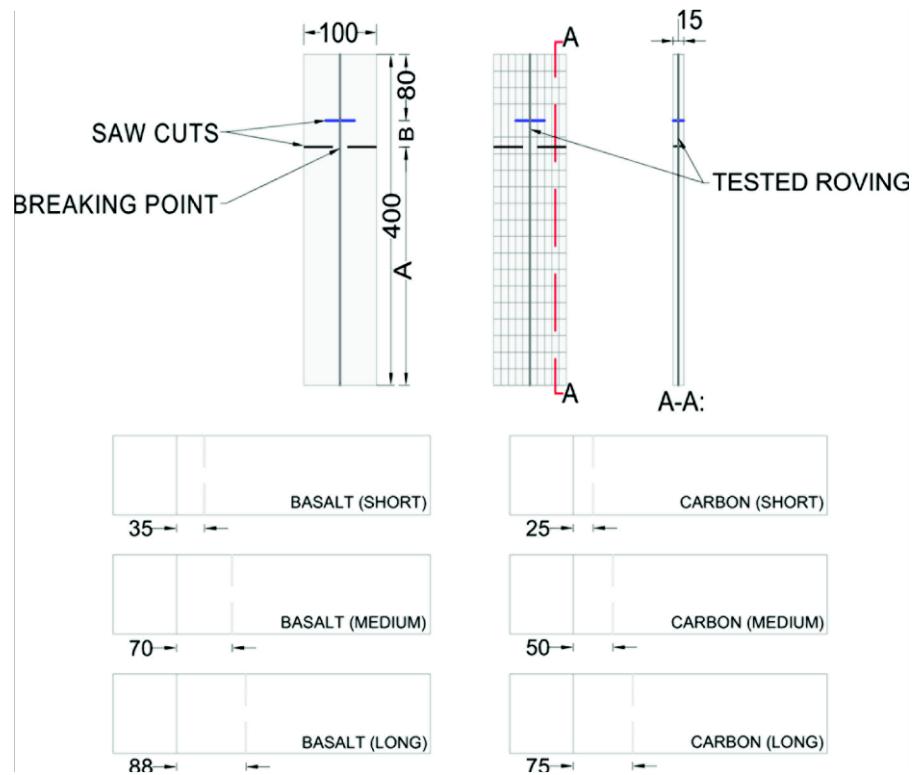
Figure V-53. Test specimen configuration and embedment length (mm)
