# Assessment of chloride corrosion in steel fibre reinforced cementitious composites

Doctoral thesis by:

Mylene de Melo Vieira

# DOCTORAL THESIS

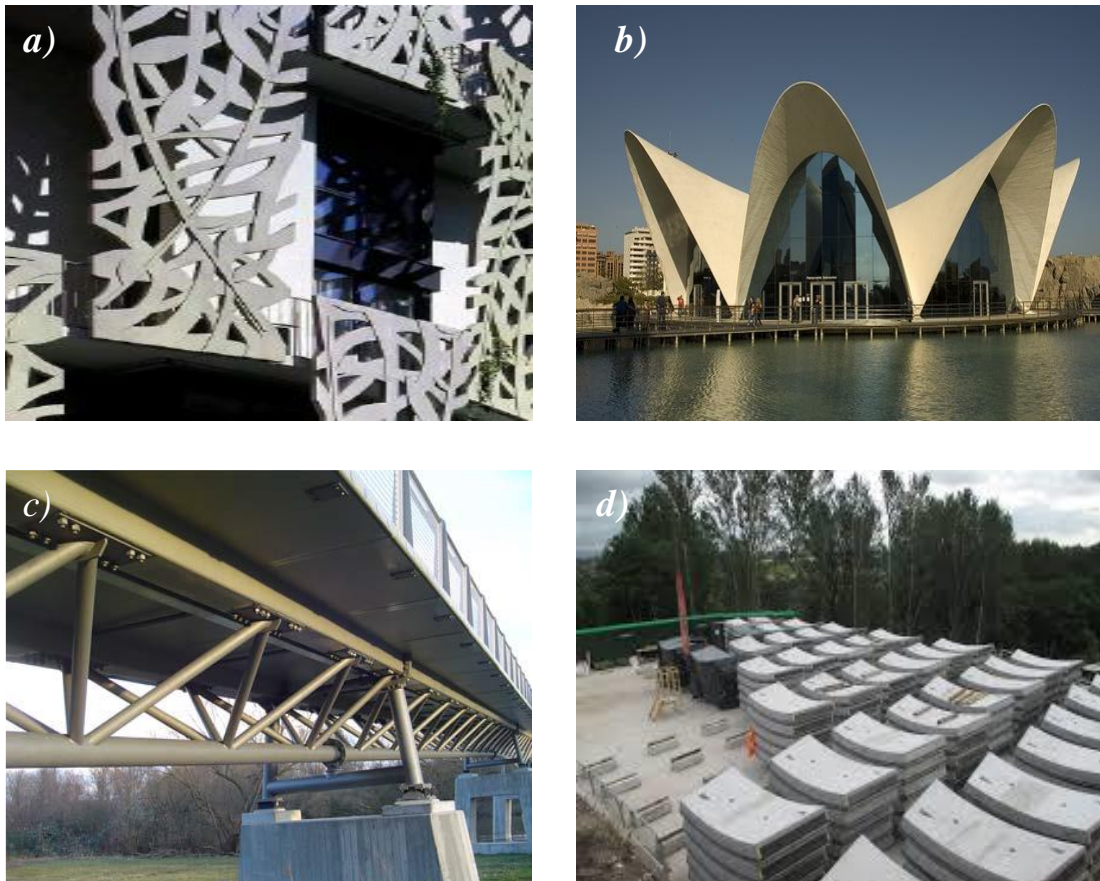
Figure 1.1 – Field applications of HPFRCCs: a) façades panels, b) shell roof, c) high performance deck glued to a 3-D steel truss and d) precast elements.

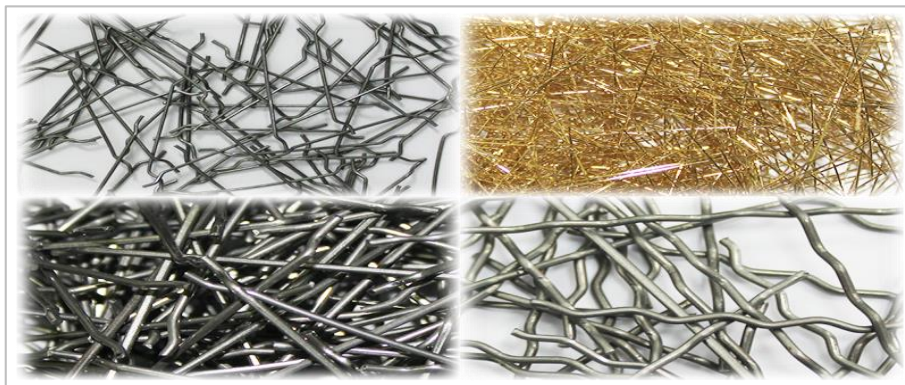
Figure 2.1 –Types of steel fibres.

The improved mechanical properties of FRCCs increased the use of such materials in structural engineering applications. Such outcome also increased the research on SFRC about four decades ago. The various types of steel fibres developed (see Figure 2.1) have different mechanical properties in terms of tensile strength, grade of mechanical anchorage and capability of stress distribution and absorption (Holschemacher *et al.* 2010). Fibres play a key role in reaching a certain load bearing capacity after the matrix fracture, depending on allocation, orientation and embedded length (Holschemacher *et al.* 2010). Regarding orientation, a clear example is the walls of the formwork, which clearly limit the possible directions that fibres might assume (Cavalaro and Aguado 2015).

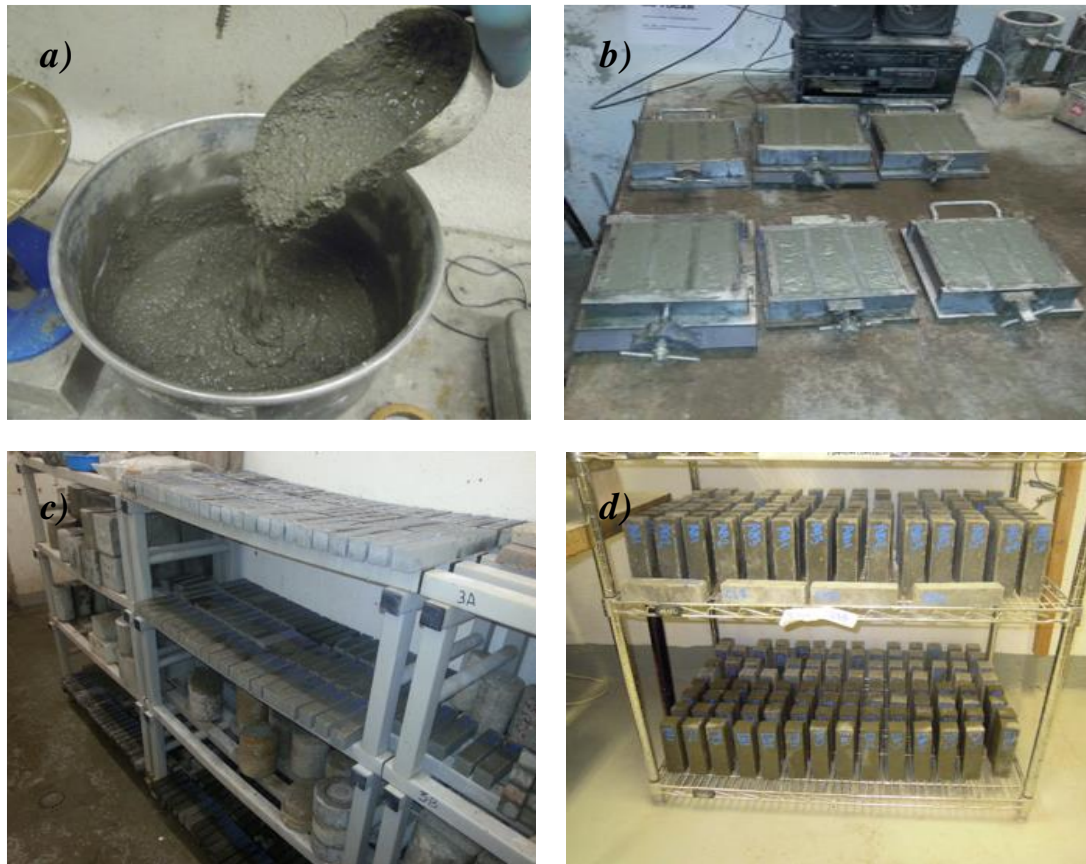
Figure 3.2 – Specimens preparation: a) mix prepared, b) mixes placed into metallic moulds, c) curing in the wet room and d) curing in the climatic room.

controlled temperature (20 °C) and between 45% to 55% of relative humidity until the date of tests and analyses (see Figure 3.2-d). The degree of humidity affects the diffusion rate of oxygen enhancing the corrosion rate. In theory, in a saturated condition, almost no oxygen is available to enable the corrosion process. On the contrary, for lower relative humidity, oxygen is available and might lead to corrosion.

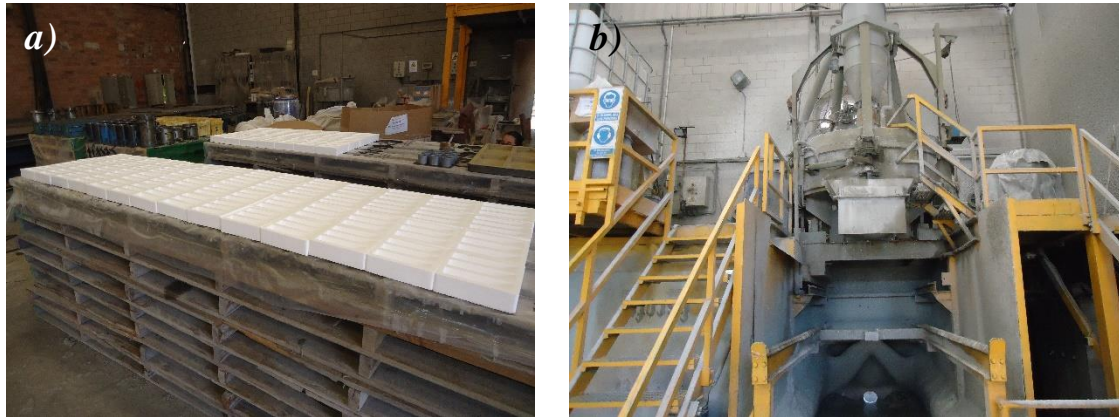
Figure 3.6 – Preparation of the specimens: a) moulds and b) vertical axis mixer.

Cylinders for control tests were cast in metallic moulds and prisms for the durability test were cast in disposable moulds due to the large number of specimens per mix. The first step of the production process was to organize the metallic moulds (Figure 3.6-a). Then, one layer of a de-moulding agent was sprayed in the metallic moulds.

A 1000 litres vertical axis mixer (see Figure 3.6-b) was used to produce 1 batching volume per composition. Initially, the dried components (cement, silica sand and calcium carbonate, in this order) were weighed and placed by means of a conveyor belt into the

mixer and mixed for one minute. Subsequently, water, nanosilica and steel fibres were added manually and mixed for approximately four minutes.

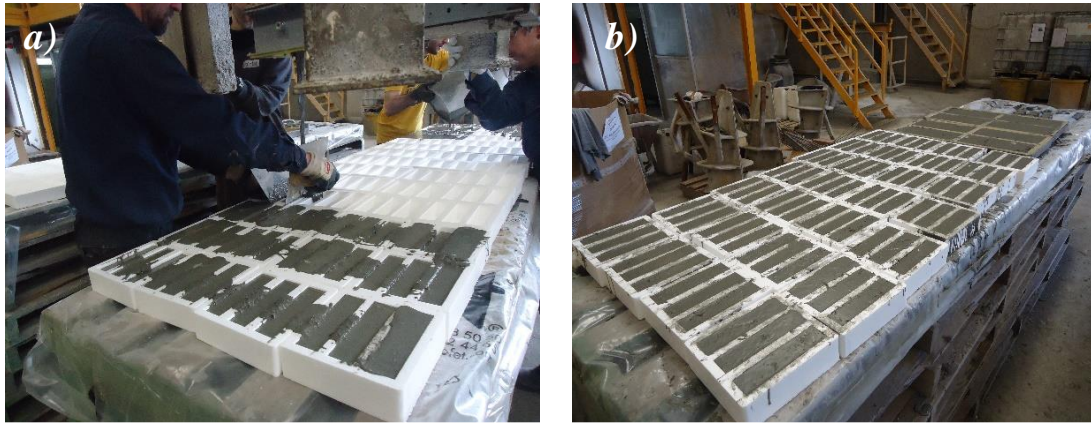
Figure 3.8 – Casting process: a) filling the moulds and b) final aspect of moulds after removing excess.

Small amounts of material was extracted from the mixer to assess the flow extent according to the procedure described in the preliminary experimental programme (see Figure 3.7). The test also allowed a qualitative evaluation of the material stability by analysing signs of fibre segregation, such as the formation of lumps and irregular distribution of fibres. Once approved, mixes were placed in a skip with straight outlet that was transported over the moulds and opened to cast the specimens (see Figure 3.8-a). The excess of materials over the moulds was removed manually (Figure 3.8-b).

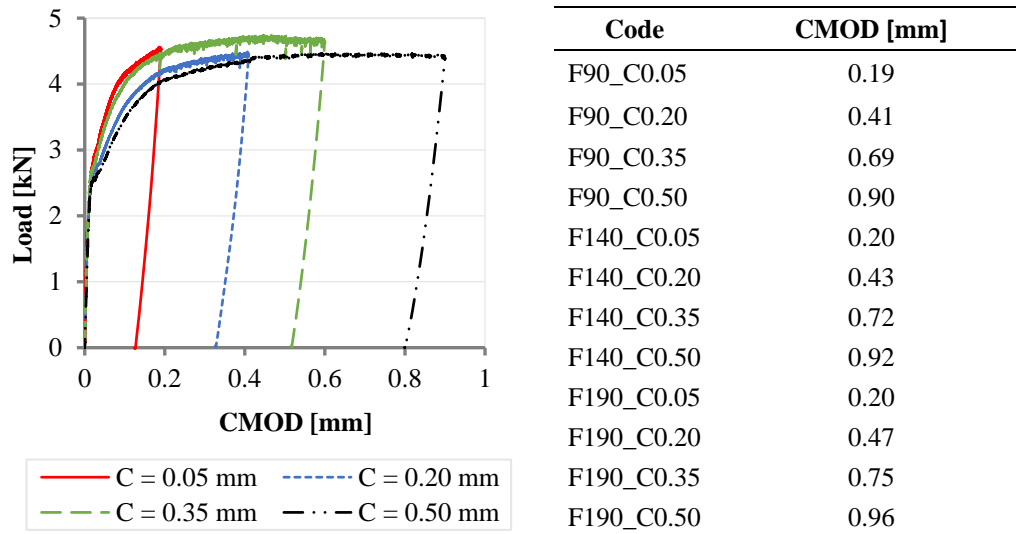
Figure 3.14 – Load-CMOD curves for pre-crack openings for 90 kg/m<sup>3</sup> of fibre and CMOD values for all pre-cracking openings and fibre contents.

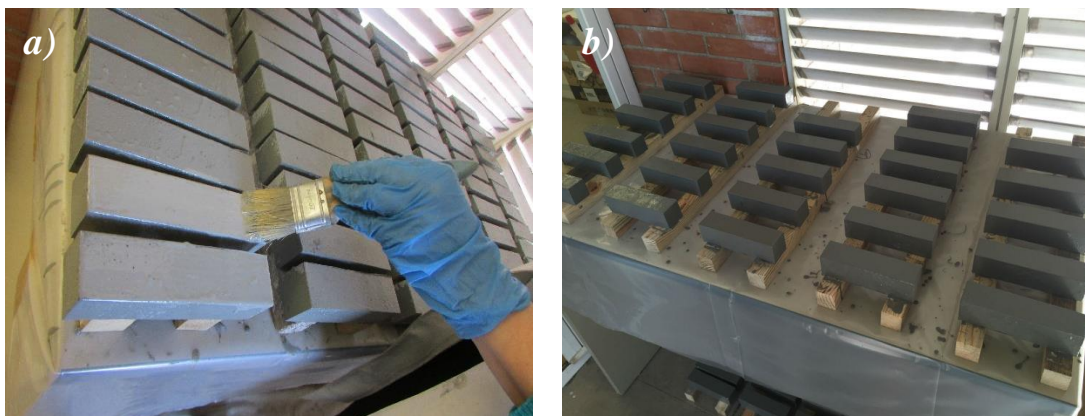
Figure 3.15 – Waterproofing the specimens: a) applying the epoxy membrane and b) curing of samples.

In order to allow the ingress of chlorides in only one direction, five faces of each specimen were waterproofed. A flexible water-based epoxy membrane resistant to high humidity and medium chemical attack (including salt water) was used. The epoxy membrane was applied with a brush to the faces of specimens in two coats (see Figure 3.15-a) with interval of 24 hours between them according to the producer's instructions. Afterwards the specimens were maintained stored for 7 days at ambient temperature for curing (Figure 3.15-b). To avoid the penetration of the product into the pre-cracks, an adhesive tape was placed over the face with the notch before the waterproofing. The adhesive tape was removed after the curing process.

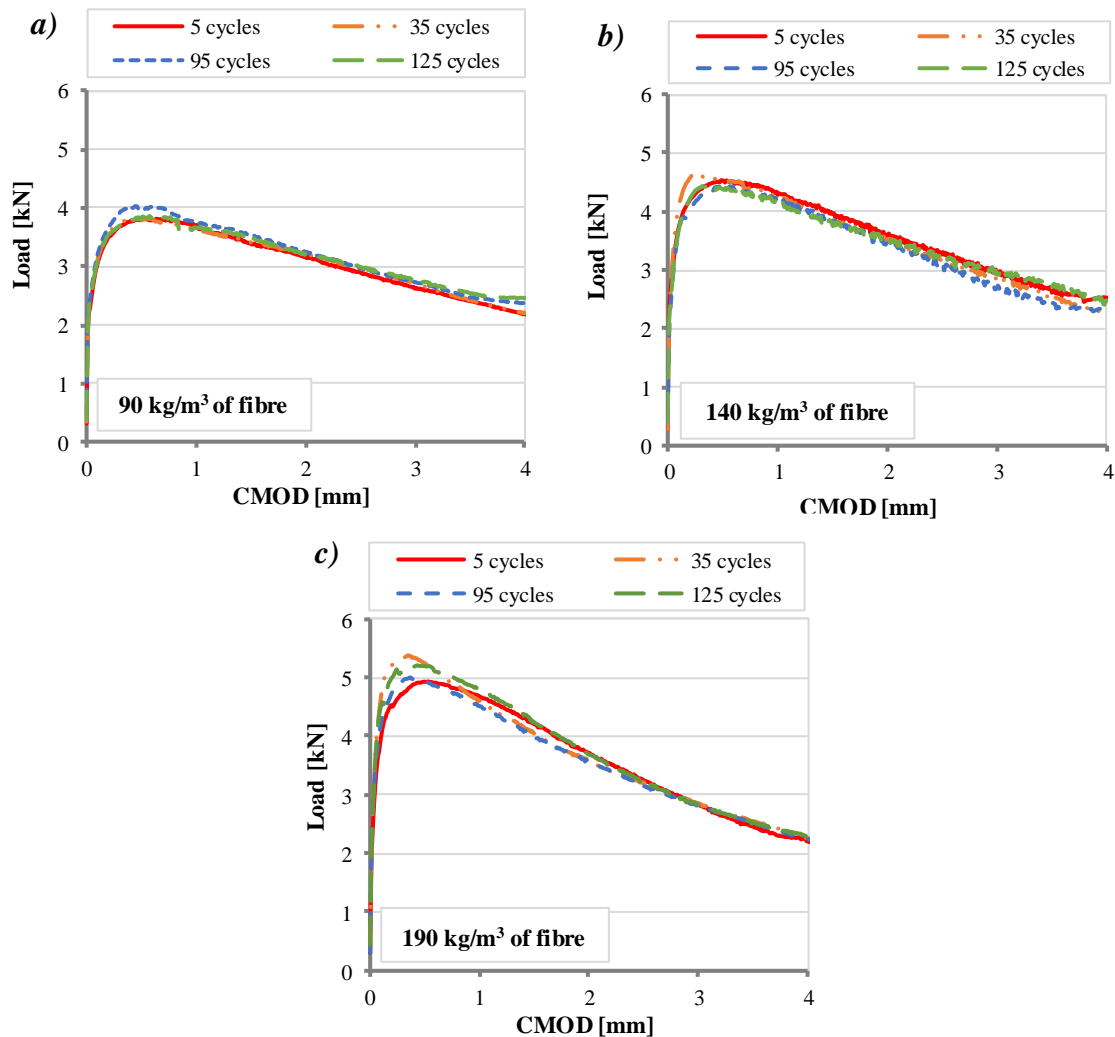
Figure 5.21 - Load-deflection curves for uncracked sections at 5, 35, 95 and 125 cycles of specimens with: a) 90 kg/m<sup>3</sup>, b) 140 kg/m<sup>3</sup> and c) 190 kg/m<sup>3</sup> of fibre.

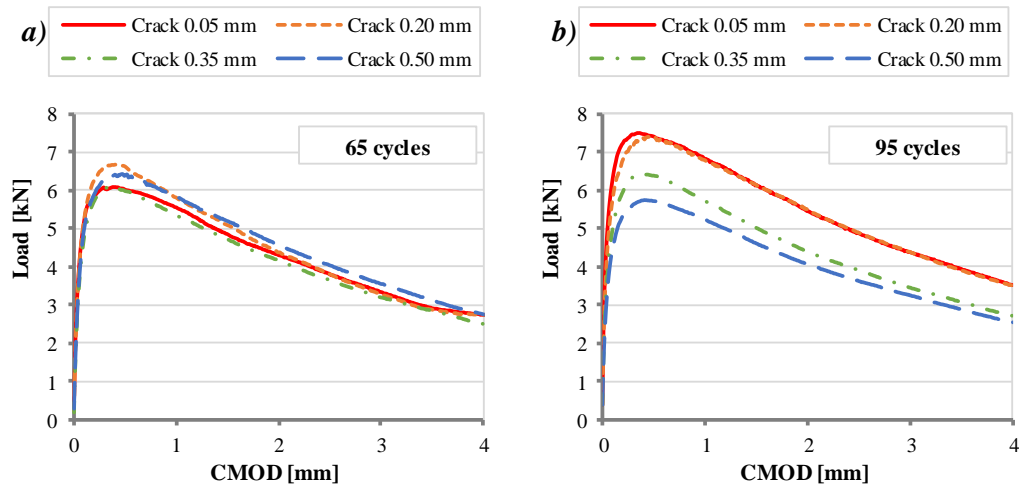
Figure A. 5 – Load-CMOD curves for specimens with 190kg/m<sup>3</sup> of fibre, w/c of 0.28, pre-crack widths of 0.05, 0.20, 0.35 and 0.50 mm at cycles : a) 65 and b) 95.
