Seismic vulnerability assessment
of traditional timber frame and
masonry wall buildings.
Application to the historical centre
of Valparaíso, Chile

Doctoral Thesis by:
Belén Jiménez Ramirez

Barcelona, November 2020

Universitat Politècnica de Catalunya, UPC BarcelonaTech
Doctorat en Enginyeria de la Construcció
Departament d'Enginyeria Civil i Ambiental

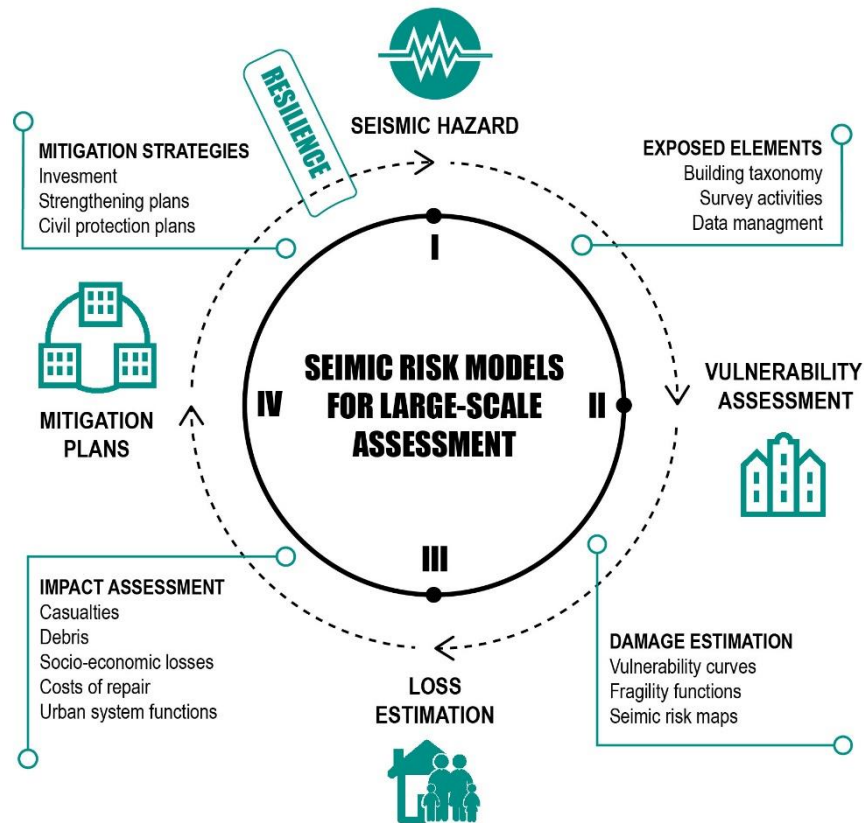
Figure 2-1. Main work stages and activities involved in models for large-scale assessment of the seismic risk.

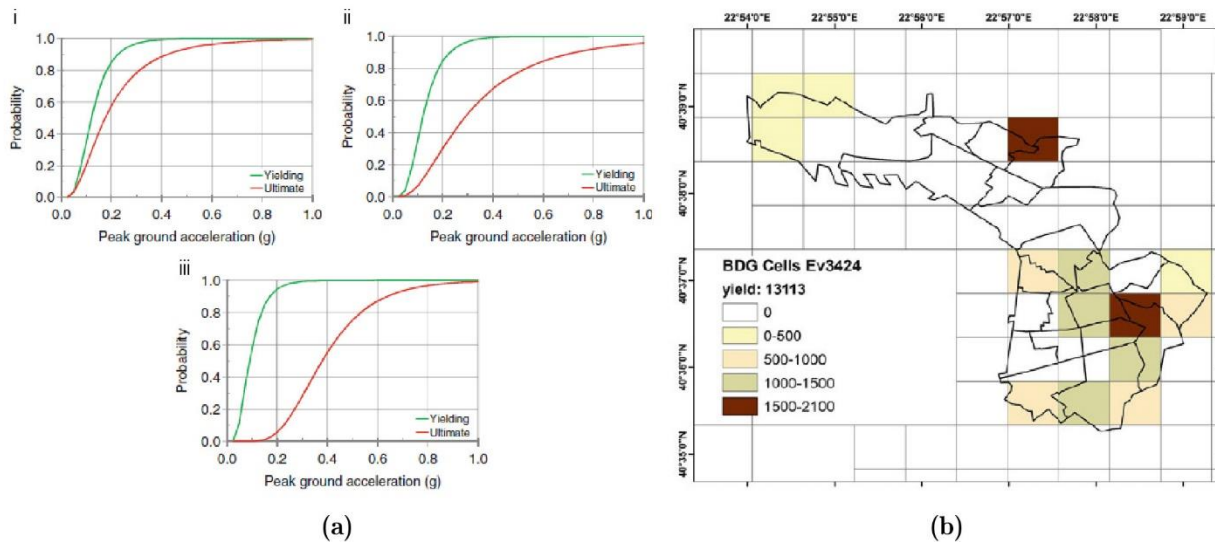
Figure 2-3. SYNER-G implementation in the city of Thessaloniki (Greece): (a) fragility curves for i) low-level, ii) medium-level and iii) high-level seismic code, and (b) distribution of estimated building damages into cells of the study area for a seismic event of $M=6.5$ (Pitilakis et al. 2014)

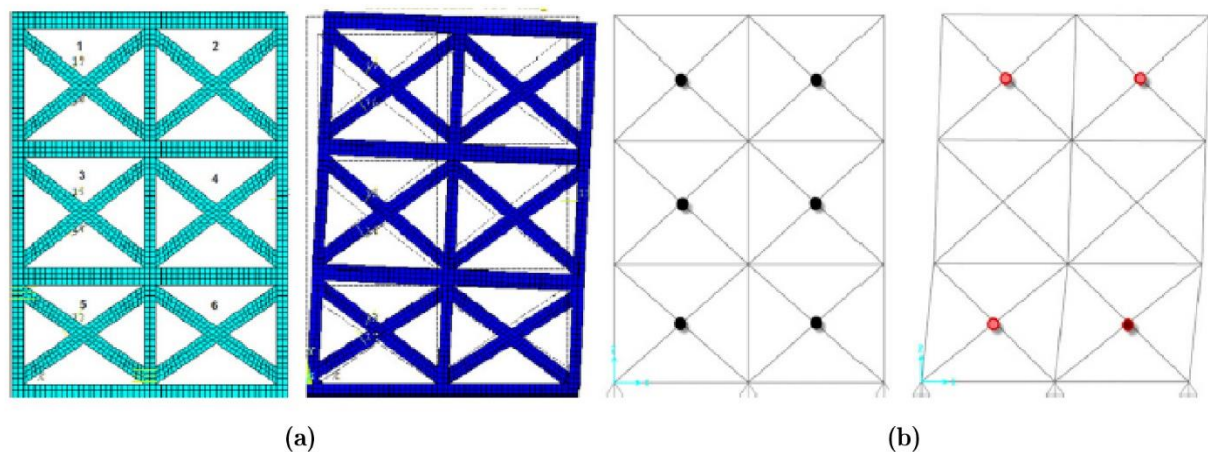
Figure 2-14. Modelling of a Pombalino wall using (a) Micro-modelling and (b) Lumped Plasticity Model (Kouris and Kappos 2012)

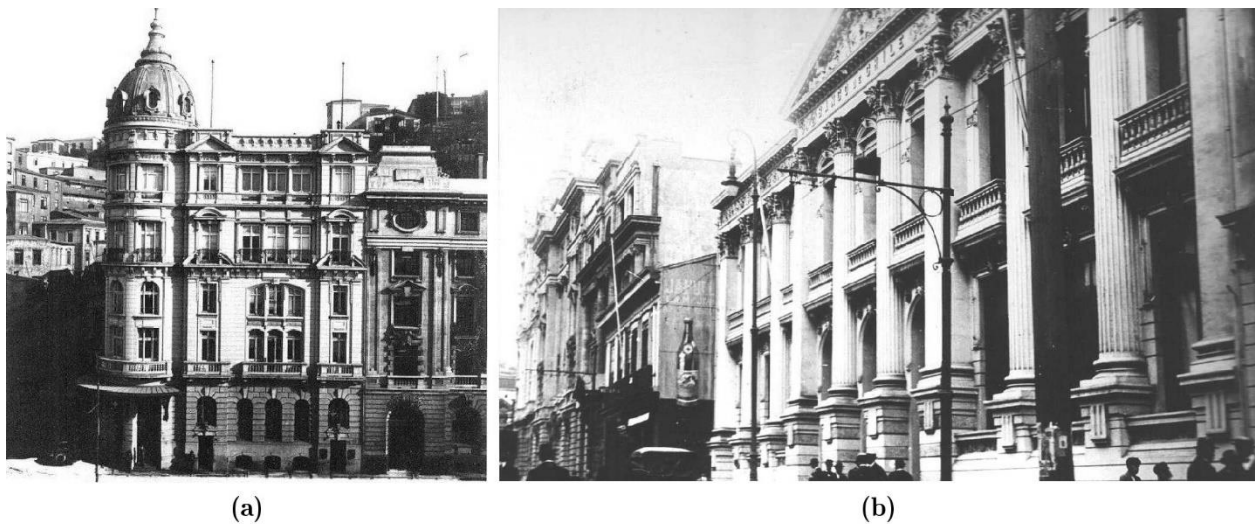
Figure 3-3. Buildings belonged to the Neoclassical style in the commercial downtown area of Valparaíso: (a) Valparaíso's Stock Exchange building and (b) Chile Bank (unknown author).

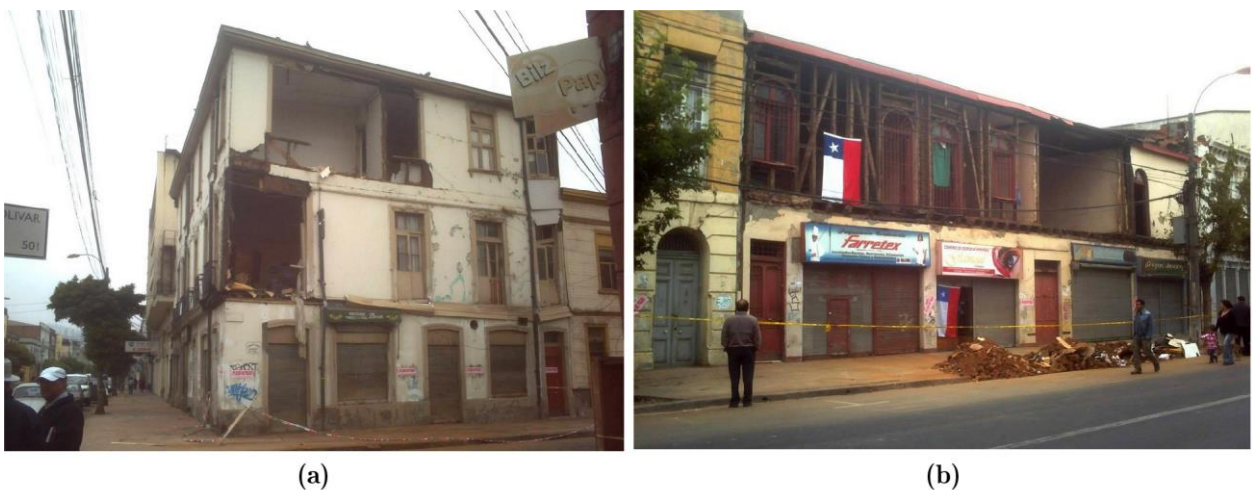
Figure 3-9. Timber frame buildings damaged after the 2010 earthquake in the down town area of Valparaíso: (a-b) partial overturning of the façades. (Photos by Lautaro Triviño)

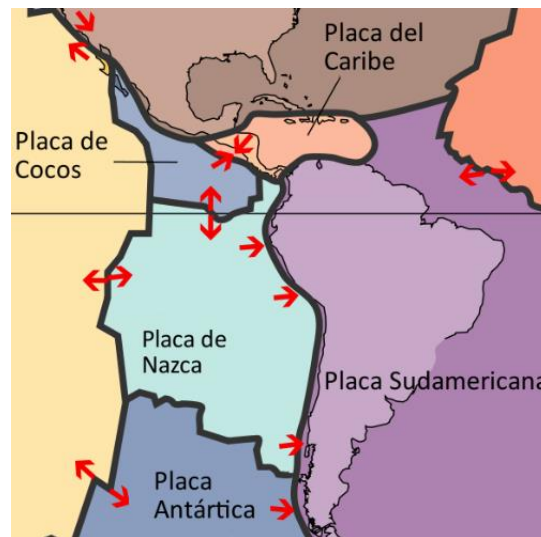
Figure 3-10. Chilean subduction zone: Nazca and South American plates.

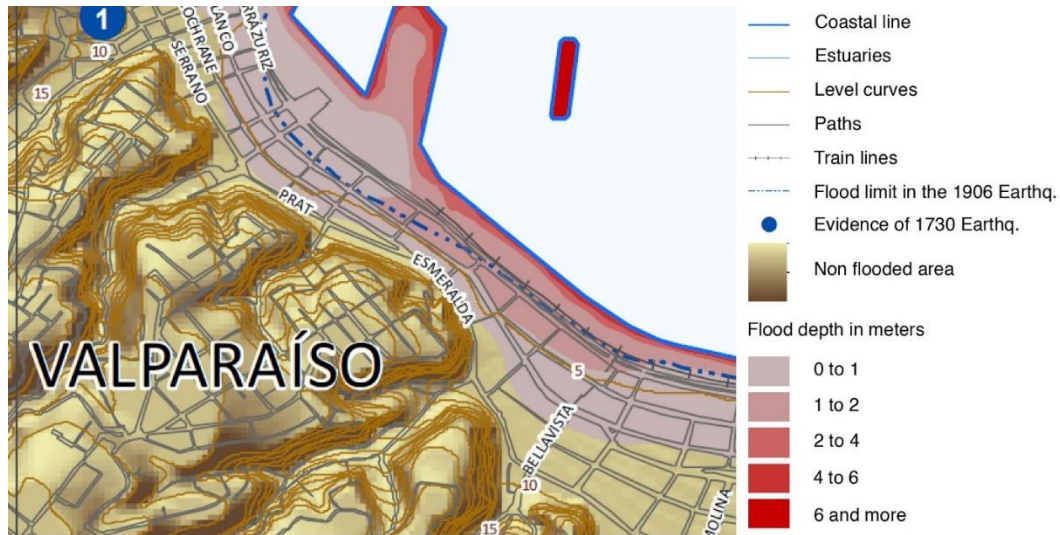
Figure 3-16. Tsunami Inundation Map of the city of Valparaíso developed by the Hydrographic and Oceanographic Service of the Chilean Navy (SHOA 2012).

Tsunami Inundation Maps are also used in Valparaíso to determine the potential impact of a flood in the city. These maps are developed based on recorded data of historical tsunamis combined with numerical simulation tools taking into account topographic, bathymetric and seismic data of the territory. Figure 3-16 depicts a Tsunami Inundation Map of the city of Valparaíso developed by the Hydrographic and Oceanographic Service of the Chilean Navy (SHOA 2012). The areas that could potentially flood in case of a major tsunami are delimited based on two sources of data: (i) the historical records of the 1730 earthquake, which provoked a subsequent tsunami, and (ii) a numerical simulation model. The numerical model was fed with topographic and bathymetric information, as well as with the urban plan of the city. The evidence of the flooded areas in the past tsunami was highlighted in the map to reference hazardous zones. The inundation map has a direct application in the civil protection plans executed by the local authorities, concerning the mitigation and prevention of tsunami impacts. Comparing both the Tsunami evacuation and the Tsunami inundation maps it is possible to recognize a good agreement between the unsafe zones and the potentially flood-prone areas.

The *Cerro Alegre* and *Cerro Concepción* neighborhoods are within the safe zones located at levels higher than 30 meters far away from areas of possible flooding, as shown in Figure 3-15 and Figure 3-16. Two evacuation routes connect the risky zones in the centre of the city with the safe zones in these neighborhoods, named the *Urriola* (Figure 3-17) and *Almirante Montt* streets. In the following section, the civil protection plan of the city of Valparaíso is used to delimit the area for the seismic risk assessment of this doctoral thesis. The study of this delimited zone of the city constitutes a first pilot case that may be extended in the future to other vital networks and elements of the city.

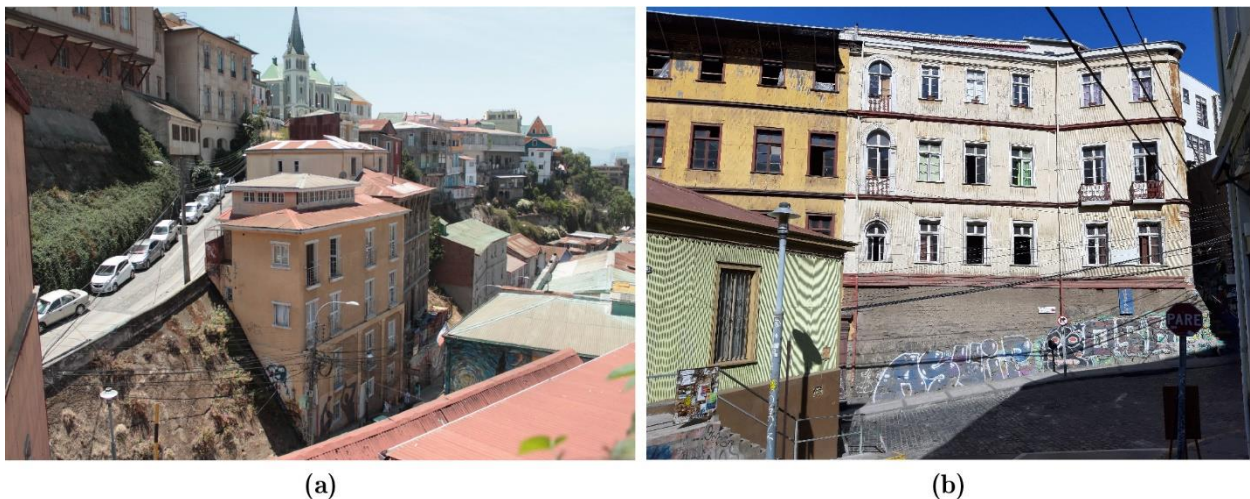
Figure 3-20 (a) Buildings adapted to the stepped hillside in the Almirante Montt street, and (b) a mixed stone and masonry basement in the Urriola street.

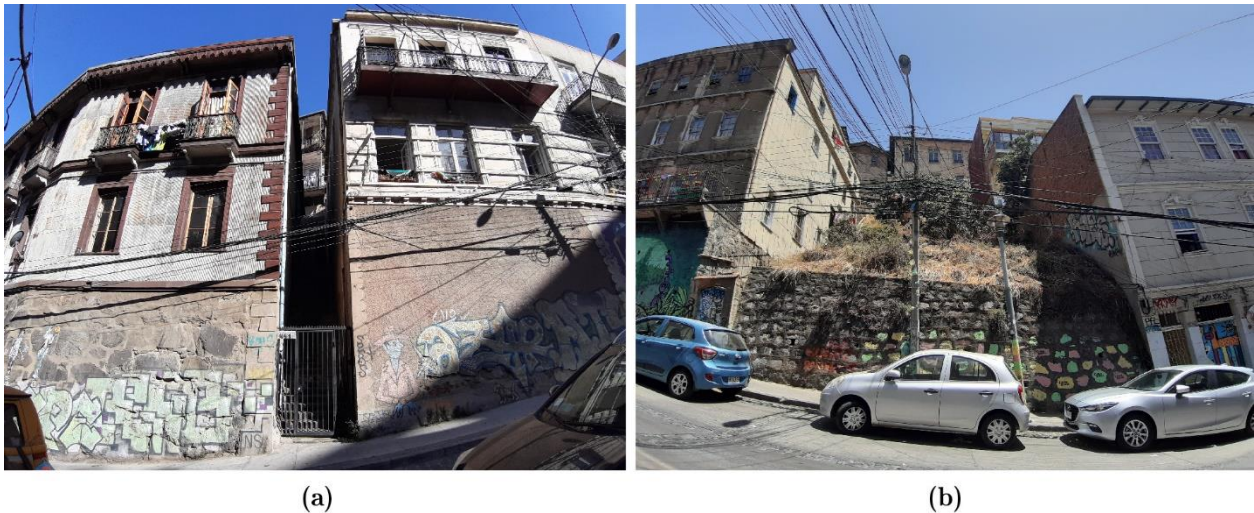
Figure 3-21. (a) Narrow passage between two buildings in Urriola street, and (b) buildings next to a wasteland in Almirante Montt street.

The buildings located on the hills are characterized by a fearless adaptation the staggered hillsides, some of them with more than 40 degrees' slope (Figure 3-20a). A common adaptation strategy involved the use of stone or brick masonry basements (Figure 3-20b), as well as retaining walls to counteract the trusting effect of the soil. In the steepest hillsides, the buildings usually have staggered configurations in elevation, and combine the use of basement and retaining walls structures to create terraces and stabilize the terrain. Most of the buildings of the stock are enclosed in structural aggregates arranged in-row. This condition is sometimes interrupted by narrow passages existing between two buildings with public or private walkways or stairways (Figure 3-21a). Some wastelands are also present between buildings (Figure 3-21b).

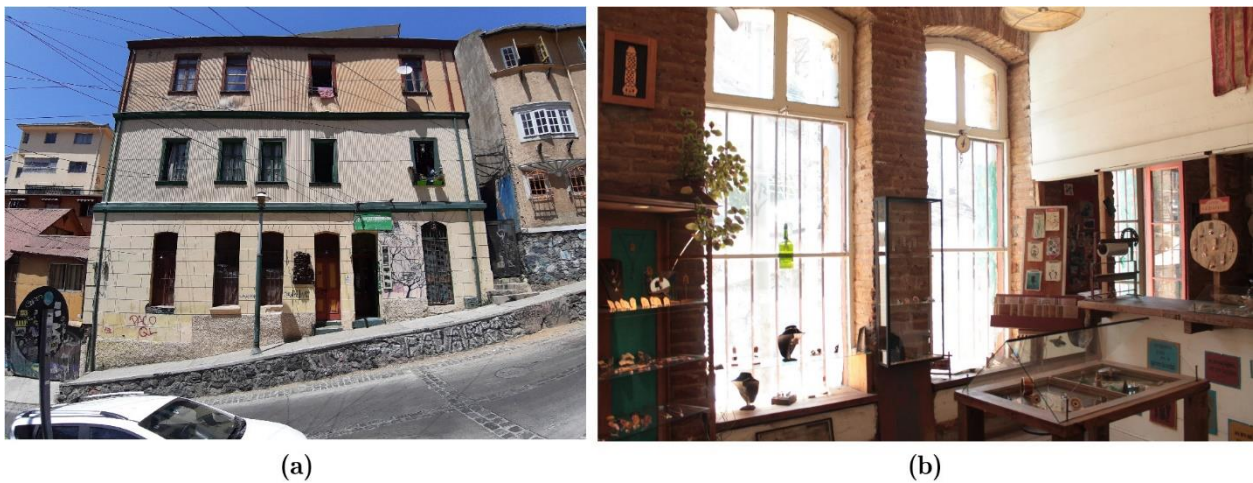
Figure 3-22. Hybrid timber-masonry building with masonry walls at the ground floor and timber frames at upper levels: (a) façade, and (b) internal view of the brick masonry wall.

The timber frame buildings can be easily recognized by the typical use of corrugated iron planks covering the façade. Many of these buildings combine timber and masonry load-bearing systems, the last less notorious from exterior inspections. Masonry sidewalls are commonly present in structural aggregates, having both structural and firewall roles. In other cases, load-bearing masonry walls arrange the façades along the total or partial height of the building, with timber frame structures only for the internal partitions and stories. Masonry is commonly covered by lime plaster and painted, as shown in Figure 3-22a. Low-rise buildings (up to two stories) have usually timber frame for the main load-bearing structure, and masonry only for sidewalls. The high-rise buildings (up to five stories) usually combine timber and masonry load-bearing systems even in the façades, as shown in Figure 3-22. Most of the timber frame systems present regular façades, with bow windows or balconies, and few ornamentations. The in-plan layout of these

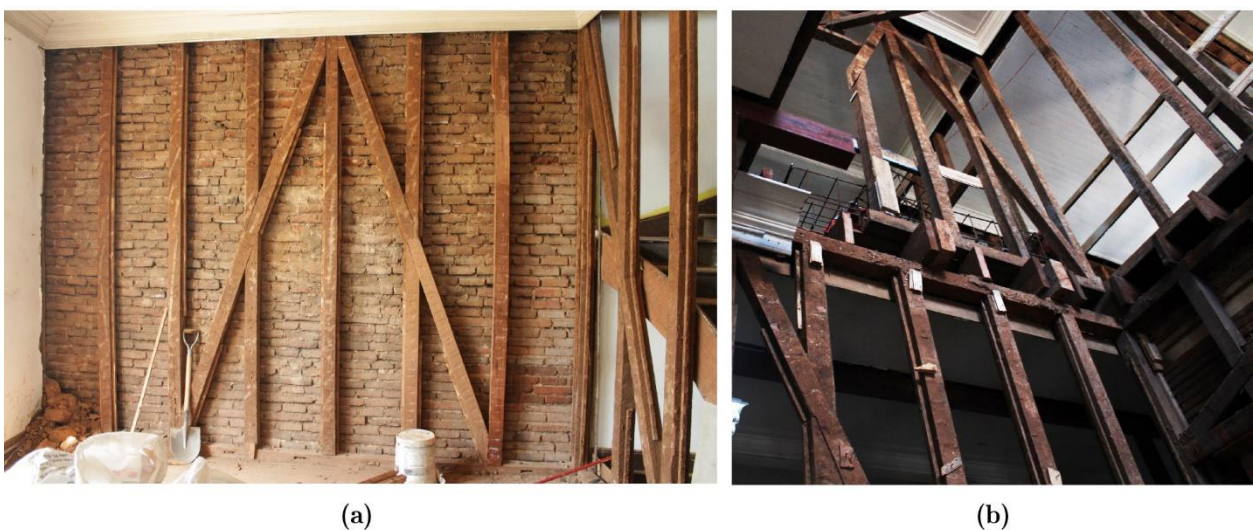
Figure 3-23. Timber frame load bearing systems: (a) bare frame wall built next to a masonry sidewall, and (b) platform frame configuration (Jiménez 2015).

According to Jiménez (2015), the timber structures usually follow the platform frame configuration where each story works as a platform to support the structures above. The walls are mainly configured by vertical posts, named studs, spaced $0.4 \div 0.6$ m each, and located between the top and bottom horizontal plates. The walls are braced by diagonal members usually crossing three studs, grouped according to “V” bracing systems. These diagonals are usually placed next to the openings, as shown in Figure 3-23a. The timber elements of the walls are connected using traditional carpentry joints, being the mortise-and-tenon and the notched the most frequent ones, as shown in Figure 3-24. These connections are usually reinforced using nails to fasten the pieces.

Adobe blocks constitute the common filling of the timber frames along the perimeter of the buildings, while the lath-and-plaster technique is used to cover the internal partitions, as shown in Figure 3-25. The cross-section of the elements of the façades vary from $0.15 \times 0.15 \text{ m}^2$ and $0.15 \times 0.10 \text{ m}^2$, while the internal elements have a smaller cross-section of $0.10 \times 0.10 \text{ m}^2$. The stories are composed of timber joists of $0.12 \times 0.05 \text{ m}^2$ cross-section and 0.4 m separation, as shown in Figure 3-23b. The roofs have usually pitched shape made of rudimentary timber trusses.

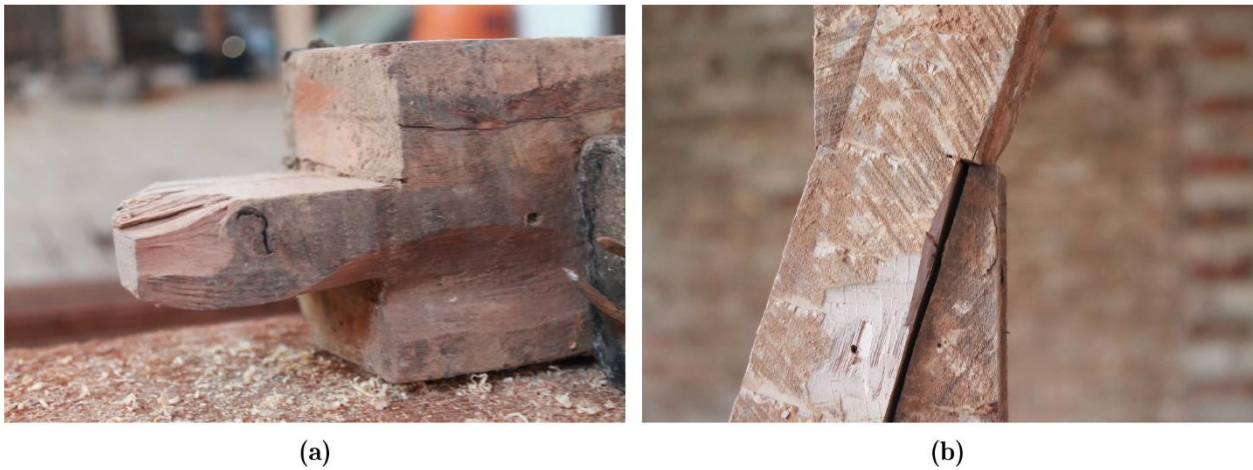
Figure 3-24. Carpentry joints in timber frames: (a) tenon at the end of a stud, configuring the mortise-and-tenon joints, and (b) stud and diagonal connected by a notched joint (Jiménez 2015).

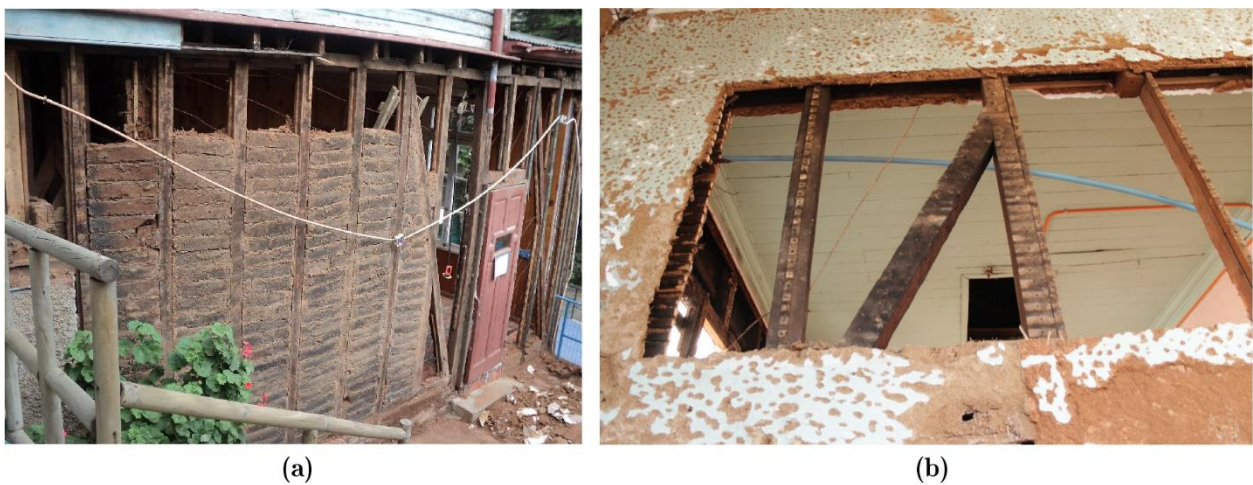
Figure 3-25. External wall filled with adobe blocks and (b) internal wall covered using the lath-and-plaster technique.

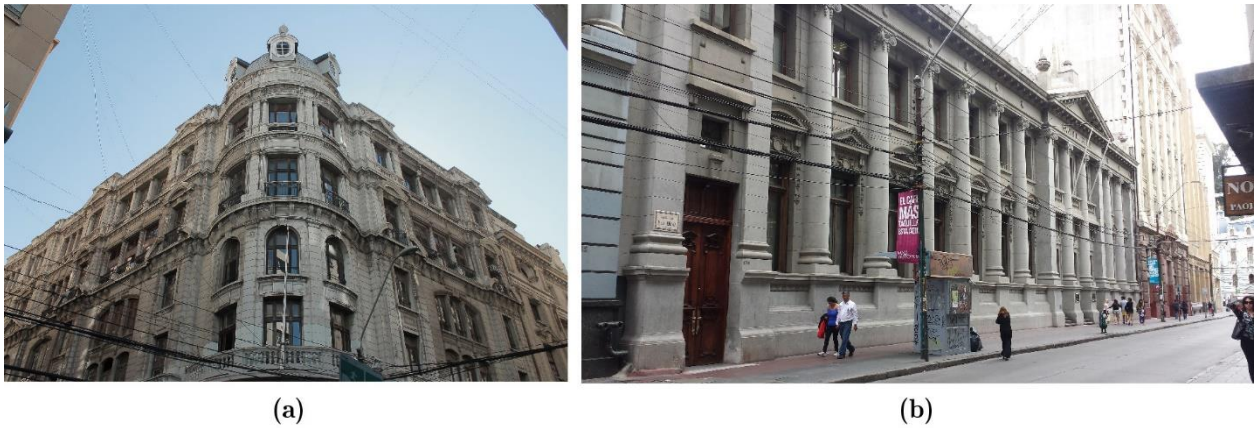
Figure 3-26. Hybrid wrought iron-RC buildings: (a) Ex Bolsa de Valores de Valparaíso and (b) Banco de Chile in Urriola street

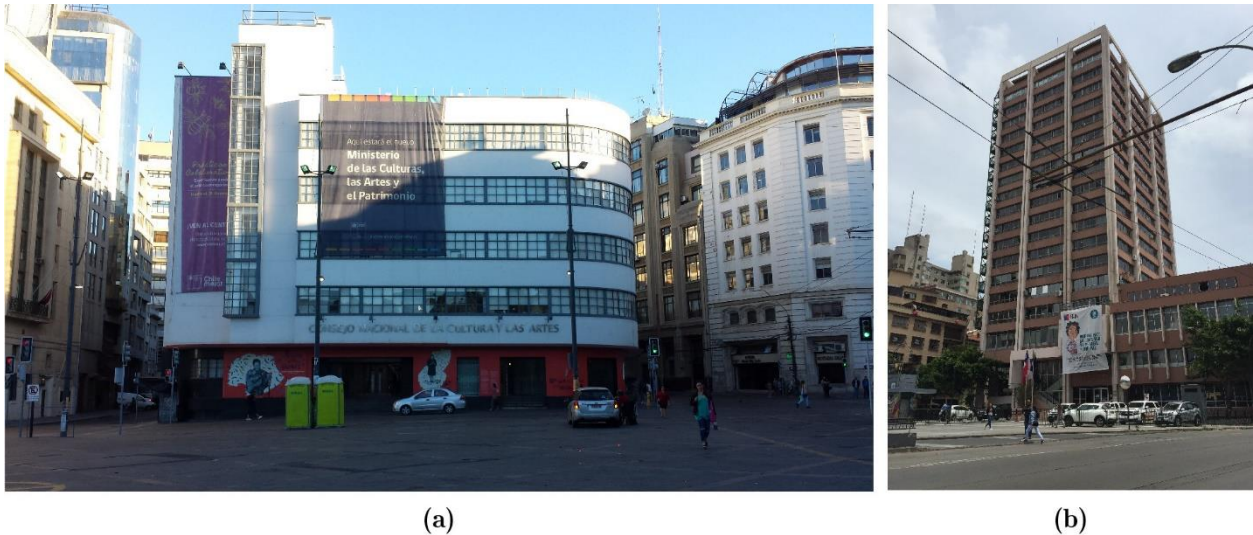
Figure 3-27. Recent RC buildings built in the Port downtown: (a) Edificio del Consejo Nacional de la Cultura y las Artes in Sotomayor Square built in 1936-1942, and (b) Intendencia Regional de Valparaíso in Anibal Pinto square built in 1980.

Based on the existing building documentation, the external load-bearing systems of the buildings are entirely made of RC in line with the seismic code, while internal partitions can be made of brick masonry or light wrought iron profiles with thicknesses varying from 0.10 to 0.25 m. Brick masonry walls are composed of clay-fired bricks bonded with cement mortar. The roof structures, as well as the stories, are made of RC slabs supporting light steel trusses to achieve the minimum slope requirements. The foundations are commonly made of RC isolated or strip footings. Most of the RC buildings present very good conditions of conservation, given their newest character. However, subsequent addition of upper stories is a recurrent intervention within this type of building stock. In all these cases, the quality of the later intervention should be carefully evaluated in order to determine the influence of possible overloads on the global seismic response of the building.

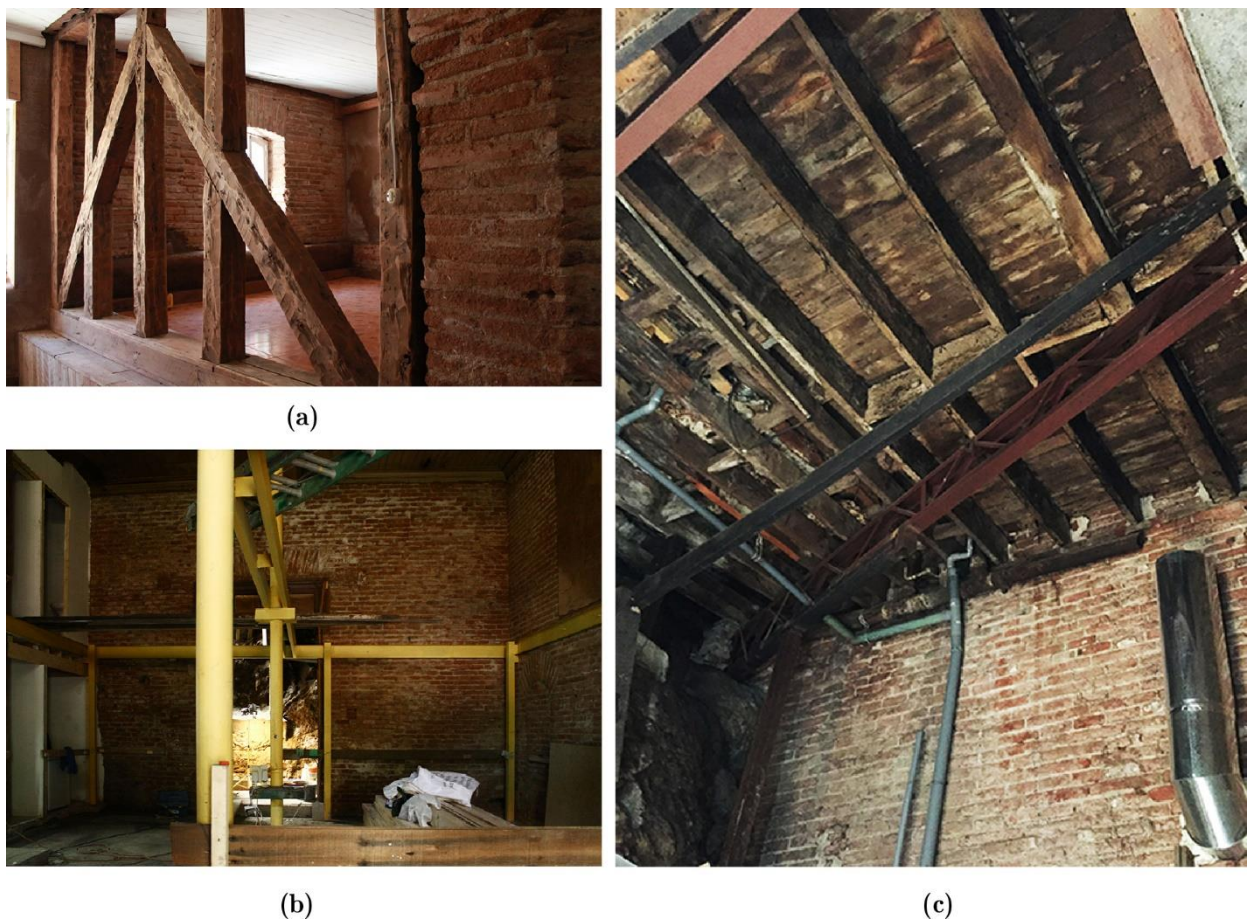
Figure 4-15. Typical features of masonry buildings in Valparaíso: (a) timber frame internal partition in Urriola street, (b) steel reinforcing structure, (c) timber story with reinforcing steel truss in Almirante Montt street.

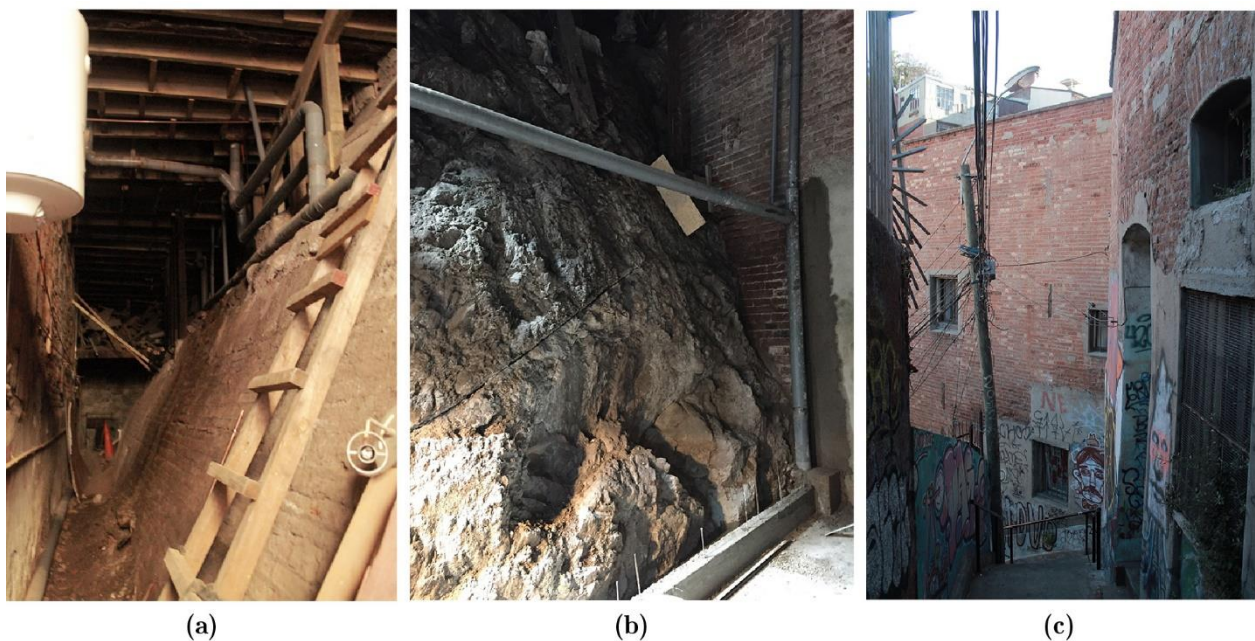
Figure 4-16. Typical features of masonry buildings in Valparaíso: (d) gravity wall, (e) rock hillside visible from the interior of a building, and (f) side wall.

A large number of masonry buildings are located on Almirante Montt street, where the terrain is very steep (20 ÷ 40% slope). In these cases, the use of gravity retaining walls is recurrent to contain the surrounding thrusting soil. The thickness of a retaining wall is normally variable, and commonly vary between 2.0 m at the foundation to 0.5 m at the top. In some specific cases, these walls receive loads from the upper walls and story structures, as shown in Figure 4-16d. It should be noted that gravity walls are not present in hard rock soil zones, such as in the Almirante Montt and Urriola streets, as shown in Figure 4-16e. Gravity walls presented many difficulties of inspection due to their hidden condition. However, the representative ones investigated in the hills prove to be made of materials of suitable quality and derived from a good seismic design, given their satisfactory seismic performance during past-earthquakes. The typical foundation system is the brick or stone masonry strip footing. Raised buildings, commonly placed in significantly steep lots, make use of a platform made of quarry stone. These buildings sometimes present habitable basements built with stone or brick masonry gravity walls. Staggered buildings in steep terrains present commonly difference of levels in the foundations (1 ÷ 2 m average), a condition that negatively influences the seismic response of a structure according to GNDT (2007).

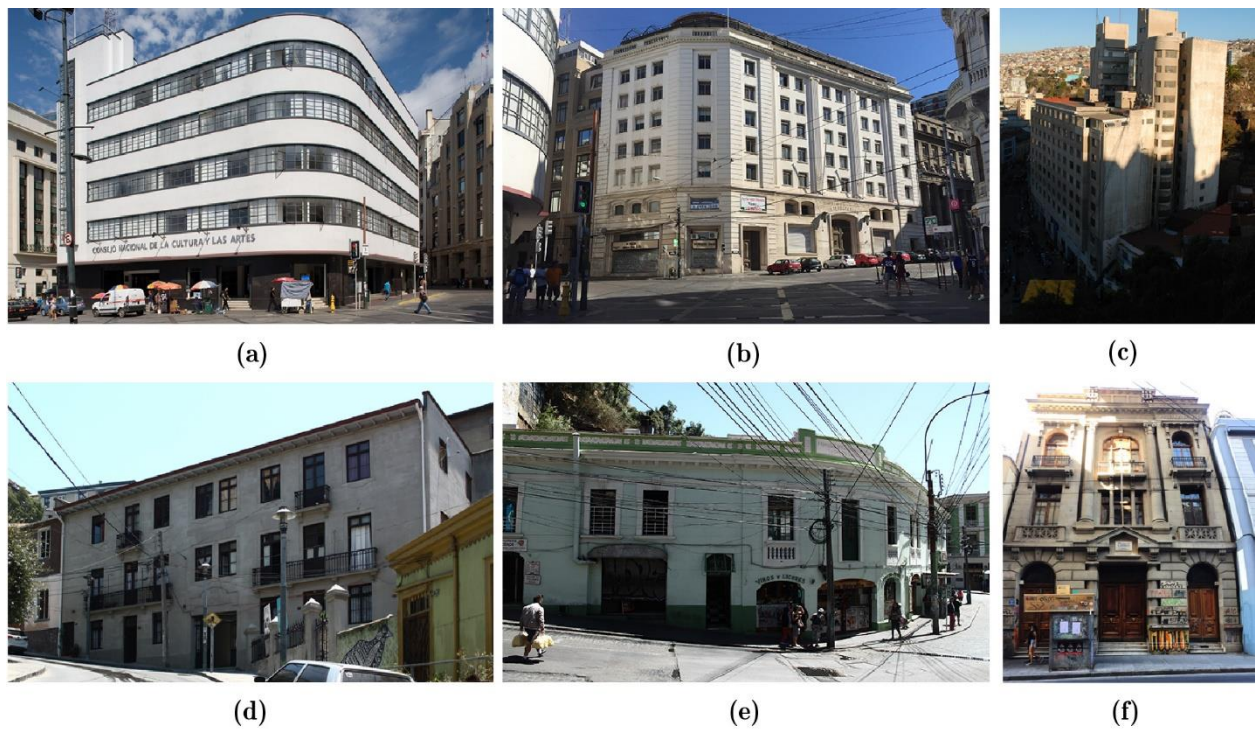
Figure 4-17. Reinforced concrete buildings in Valparaíso: (a) Consejo de la Cultura y las Artes building (1918), (b) Compañía Chilena de Navegación Intraoceánica building (1955), (c) the Cooperativa Vitalicia building (1947), (d) the Bavestrello compound in Alvaro Besa street (1927), (e) corner building in Anibal Pinto square (1929) and (d) historical façade in Arturo Pratt Street.

Most of the reinforced concrete (RC) buildings of the study area were built in compliance with the seismic design standards NCh 433.Of 96 (Instituto Nacional de Normalización 2009) after their first release in 1960. Chilean regulations for RC structures are very demanding due to the high seismicity of the territory. Minimum standards for material resistances and structural design are required in projects of RC structures and therefore they are generally reliable buildings if designed in compliance with construction standards. RC buildings are the largest ones of the surveyed stock in terms of area and height (see Figure 4-17). These characteristics are associated to their predominant commercial and governmental use, such as the banks and administrative buildings in Sotomayor and Anibal Pinto squares, as well as in Arturo Prat street. Most of these buildings house more than 100 occupants, reflecting their high exposure within the stock. According to FEMA (2015) vulnerability assessment, high-rise RC buildings should be penalized in order to increase the assessment of the potential hazard of these buildings, and thus to

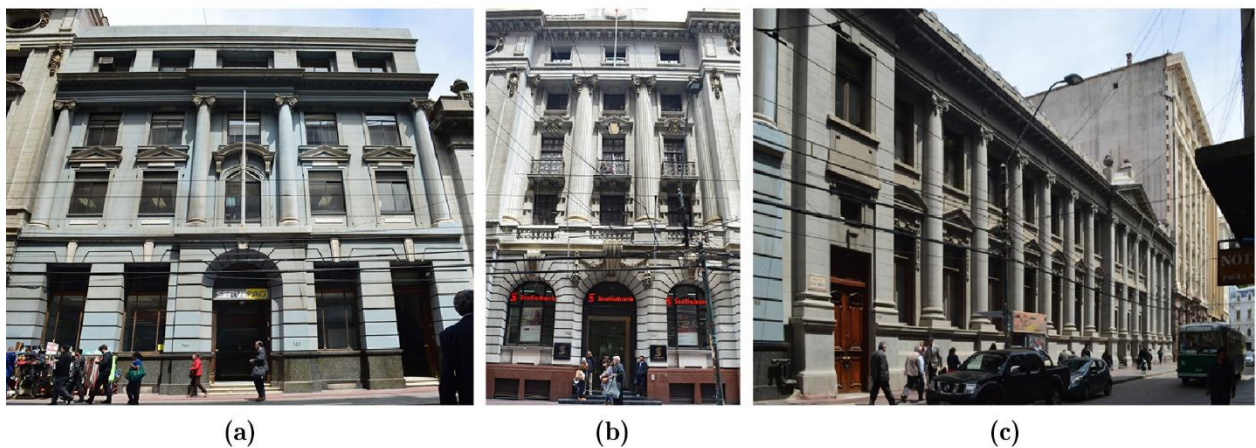
Figure 4-20. Typical mixed iron-RC buildings in Valparaíso: (a) Ex Banco de Chile dating back to 1919, (b) Ex Banco de Londres y Río de la Plata dating back to 1914, (c) Banco de Chile dating back to 1893.

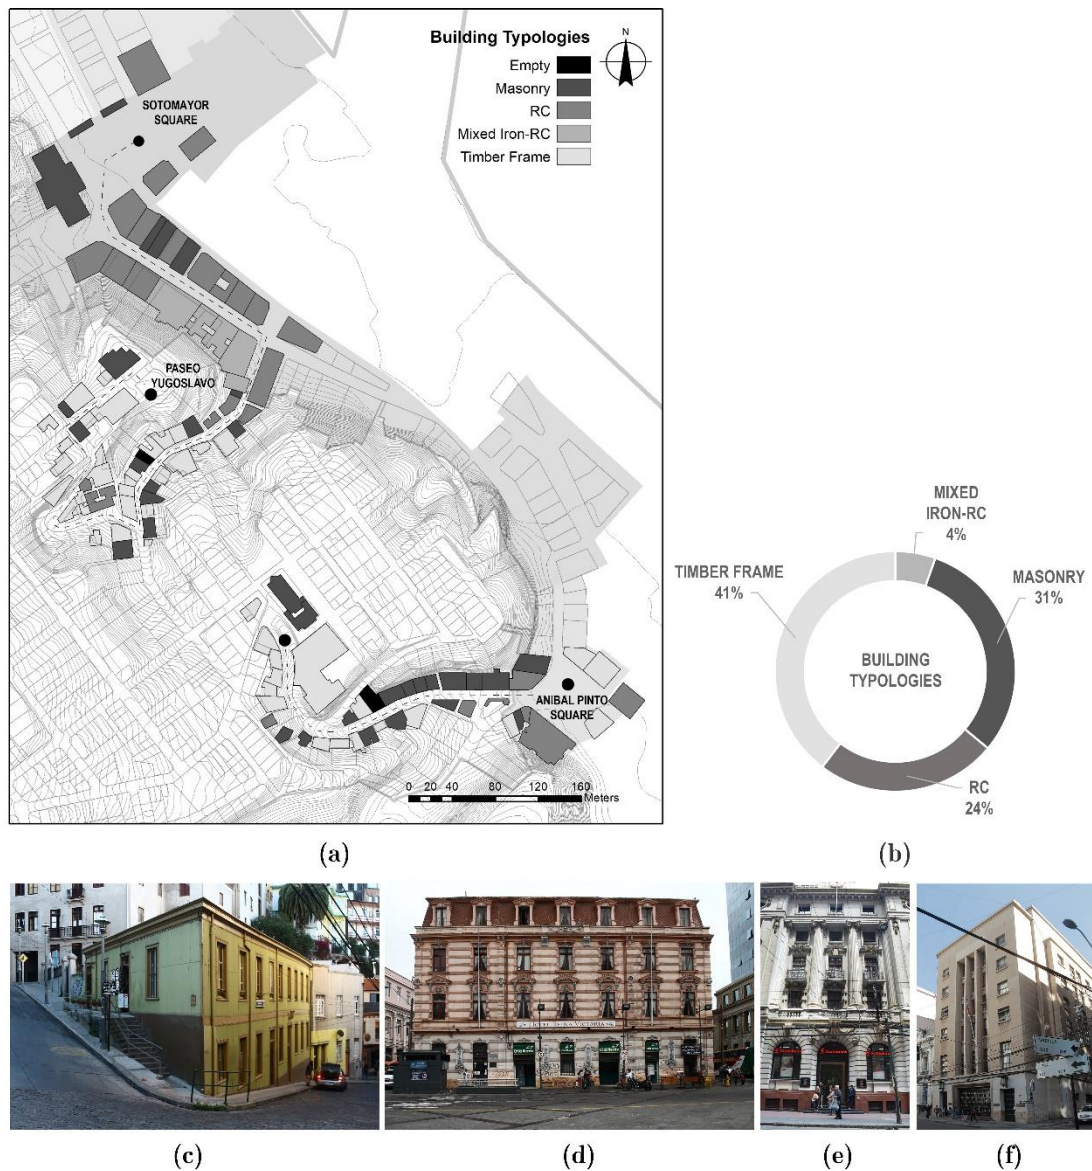
Figure 4-24. GIS mapping of the structural typologies (a) and their statistical distribution (b). Representative timber frame dwelling (c), masonry building (d), mixed iron-RC building (e) and RC building (f).

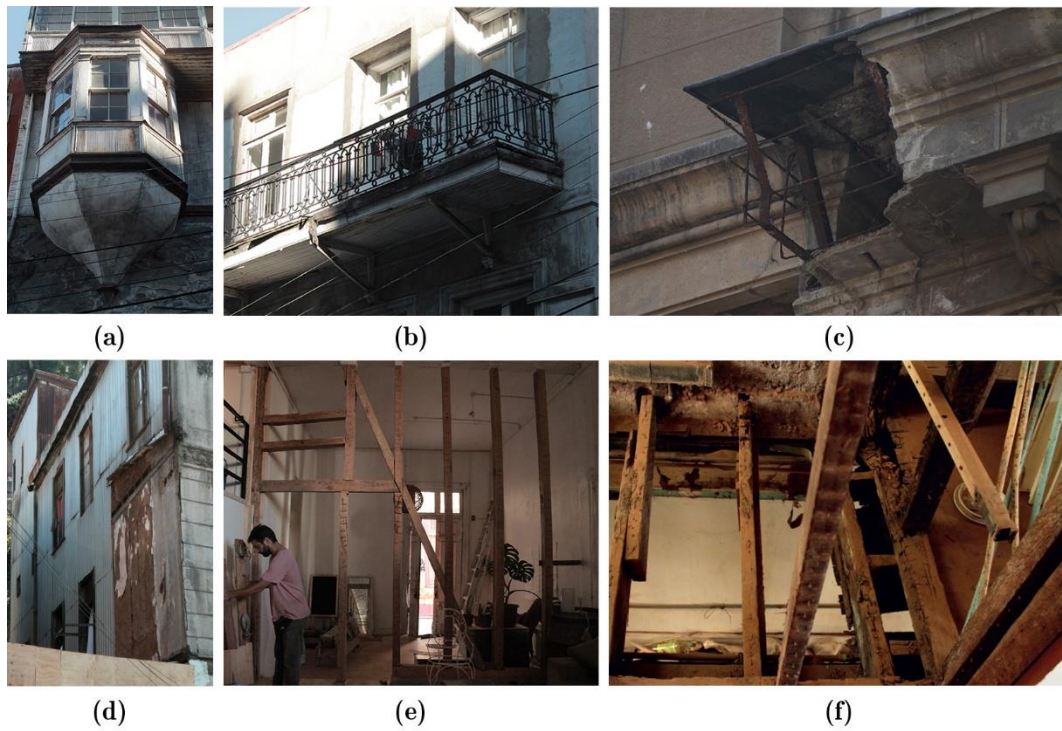
Figure 4-28. Representative non-structural elements and damage conditions: (a) large dimension bow-window, (b) poorly connected balcony, (c) severe damage of RC cornice, (d) sheathing detachment, (e) empty timber frame wall and (f) timber joists attacked by termites.

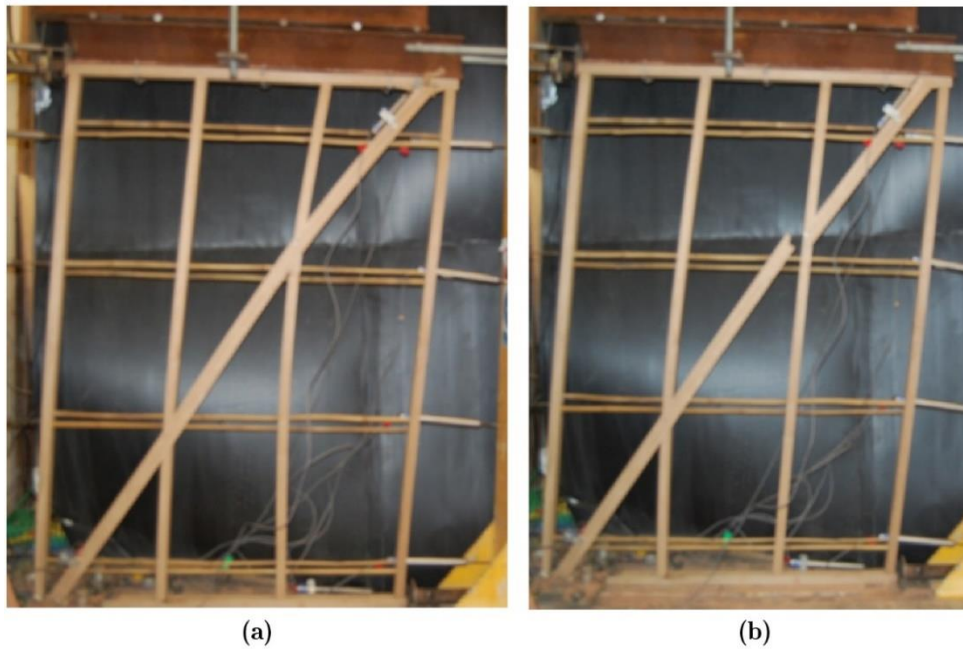
Figure 5-6. Deformation of the bare half-scale *quincha* specimen: (a) deflecting shape before and (b) after failure (Quinn 2015).

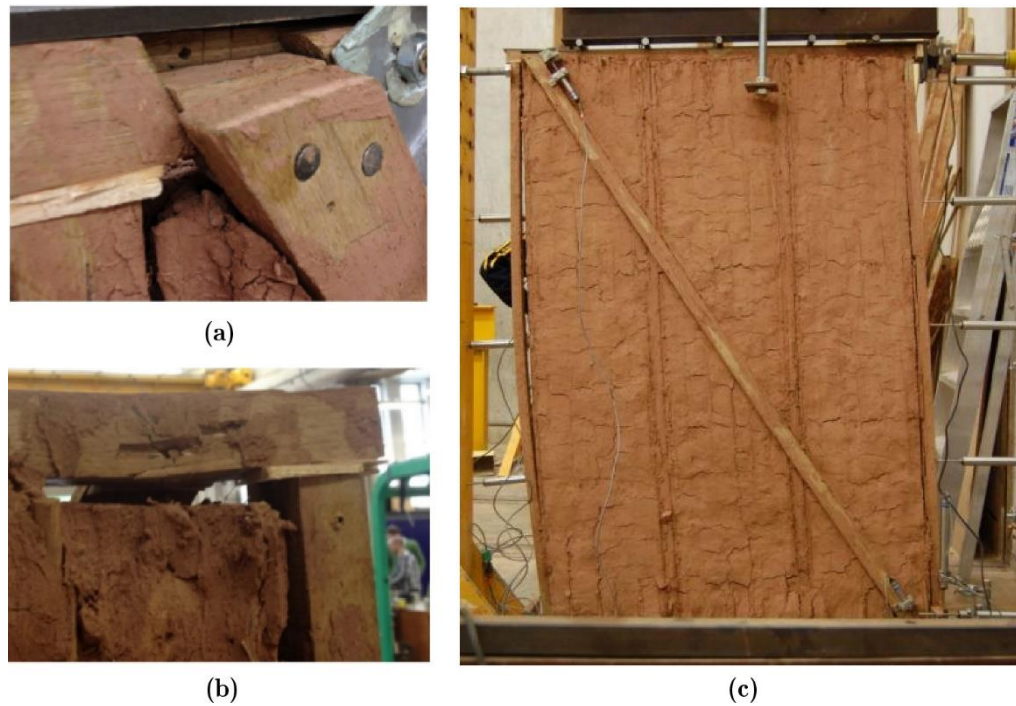
Figure 5-8. Deformation of the infilled half-scale *quincha* specimen: (a) movement of the diagonal, (b) bending of the top plate of the frame, and (c) deformation before failure (Quinn 2015).

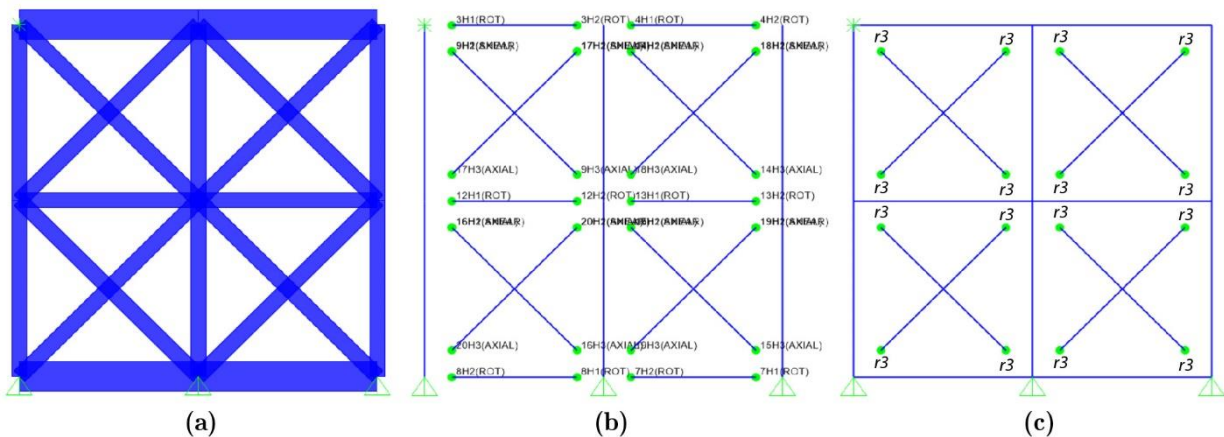
Figure 5-14. LPM of the Pombalino frame: (a) sections, (b) hinge/spring nonlinear elements and (c) moment releases.

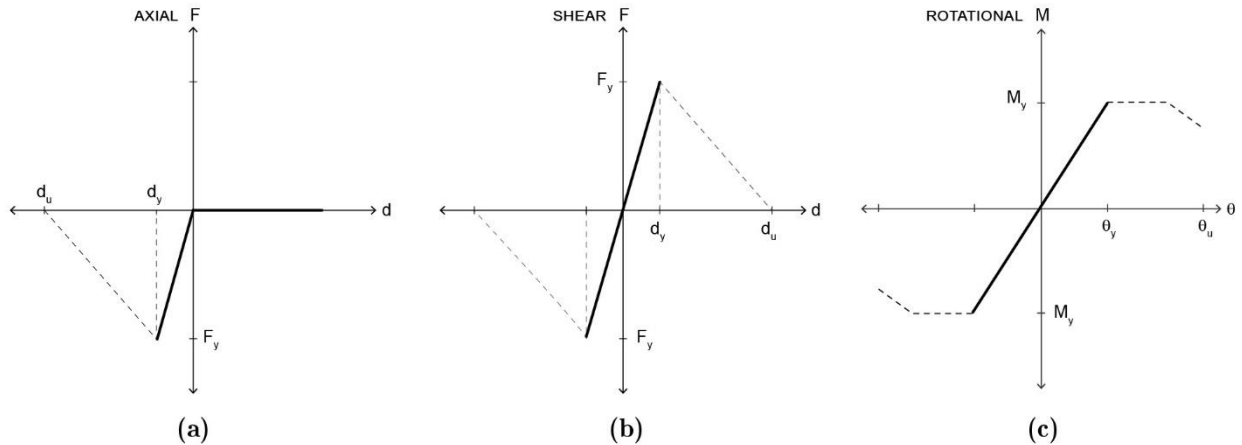
Figure 5-16. Nonlinear laws of the Pombalino model connections: (a) by contact axial behaviour, (b) by contact shear behaviour and (c) half-lap rotational behaviour.

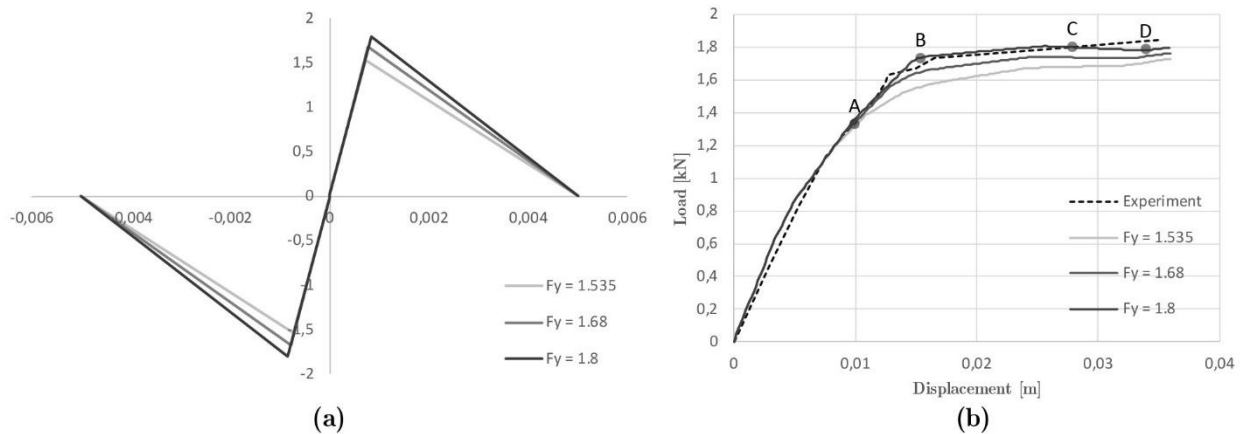
Figure 5-22. Sensitivity analysis for the *quincha* frame: (a) nonlinear load-deformation relationship for the nailed connection, and (b) obtained capacity curves of the bare frame model.

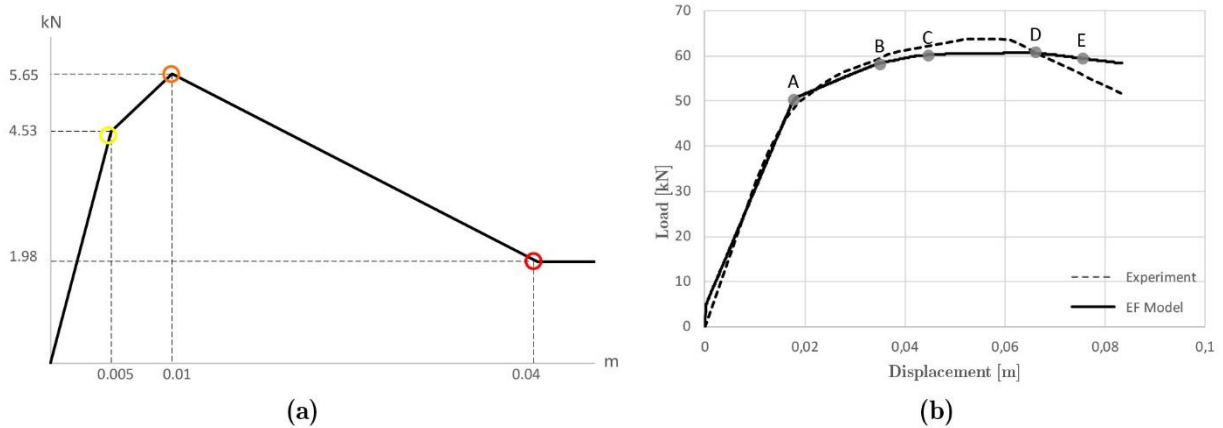
Figure 5-29. Model based on ESM of the Pombalino infilled frame: (a) nonlinear load-displacement relationship of the equivalent strut, and (b) numerical vs experimental capacity curves.

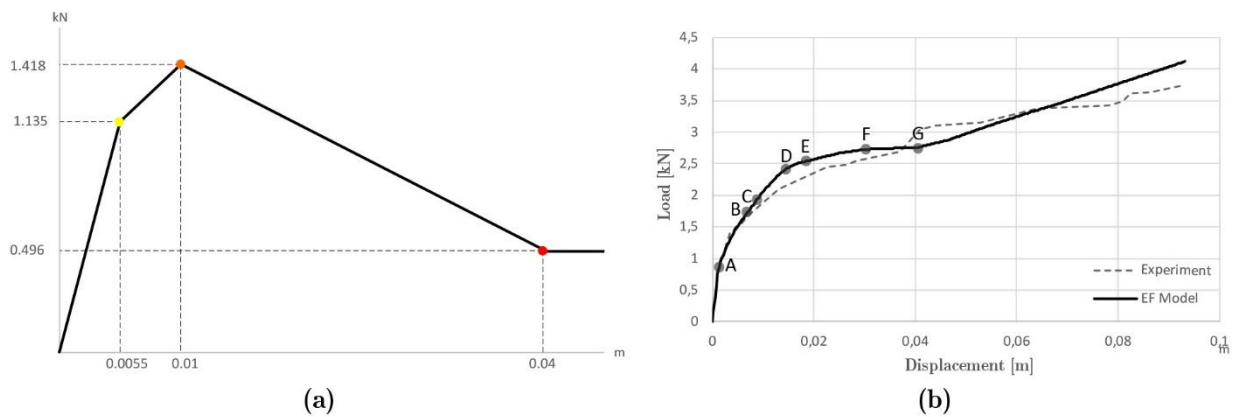
Figure 5-31. Model based on ESM of the half-scale infilled *quincha* frame: (a) nonlinear load-displacement relationship of the equivalent strut and (b) the numerical vs experimental capacity curves.

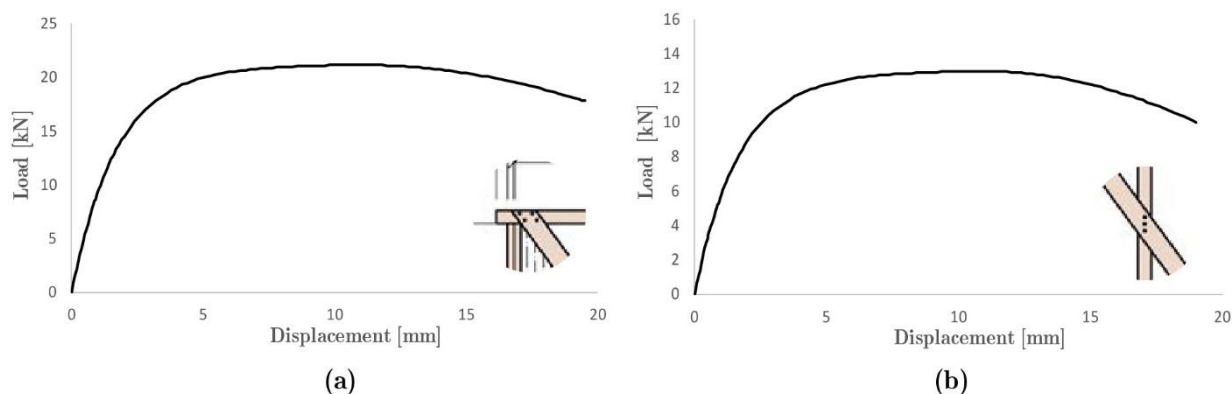
Figure 5-36. Load-embedment relationship of: (a) four nails diagonal-plate and (b) three nails diagonal-post connections of the full-scale *quincha* model.
