Seismic vulnerability assessment
of traditional timber frame and
masonry wall buildings.
Application to the historical centre
of Valparaíso, Chile

Doctoral Thesis by:
Belén Jiménez Ramirez

Barcelona, November 2020

Universitat Politècnica de Catalunya, UPC BarcelonaTech
Doctorat en Enginyeria de la Construcció
Departament d'Enginyeria Civil i Ambiental

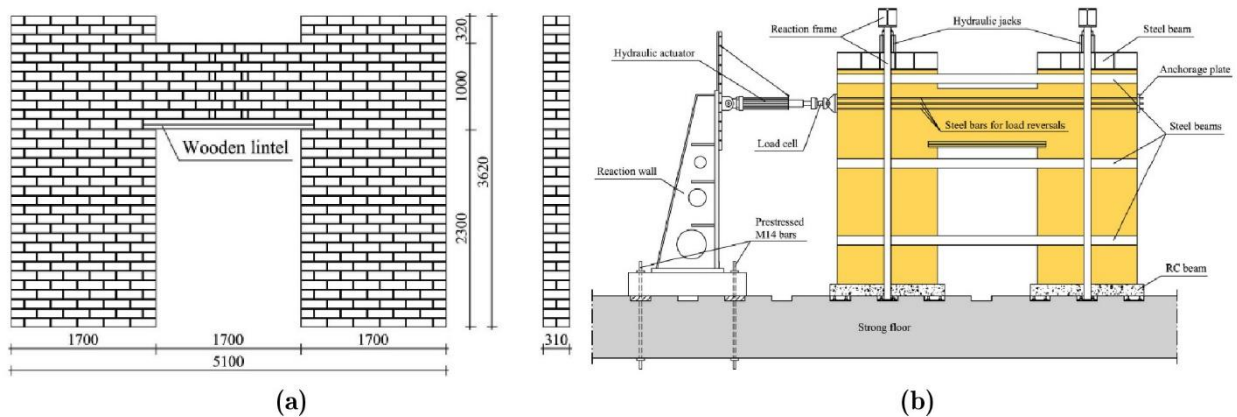
Figure 5-40 In-plane loaded URM specimen: (a) geometry and (b) test setup (in mm) (Augenti et al. 2011).

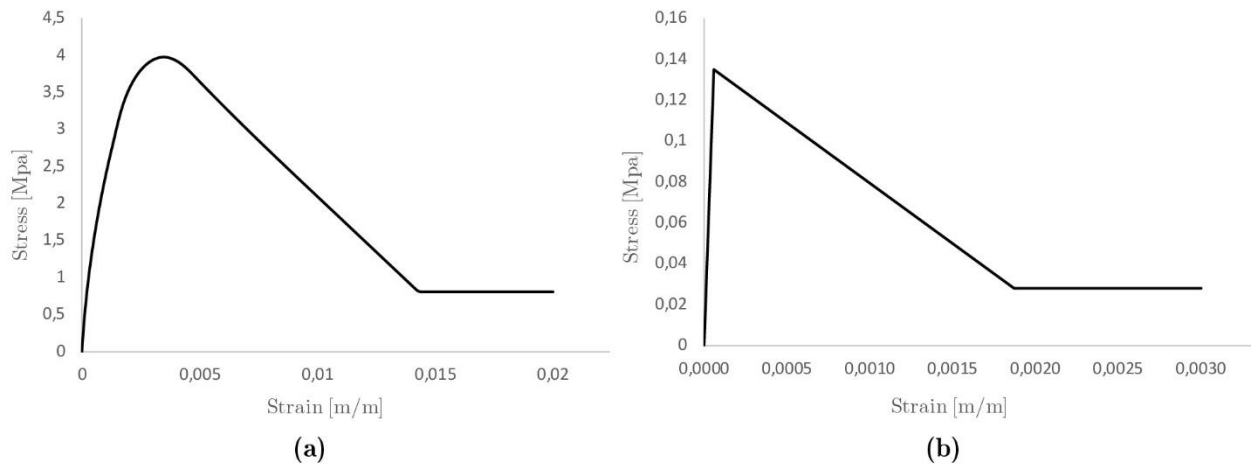
Figure 5-49. Stress-strain uniaxial relationships for masonry: (a) compressive and (b) tensile behaviours.

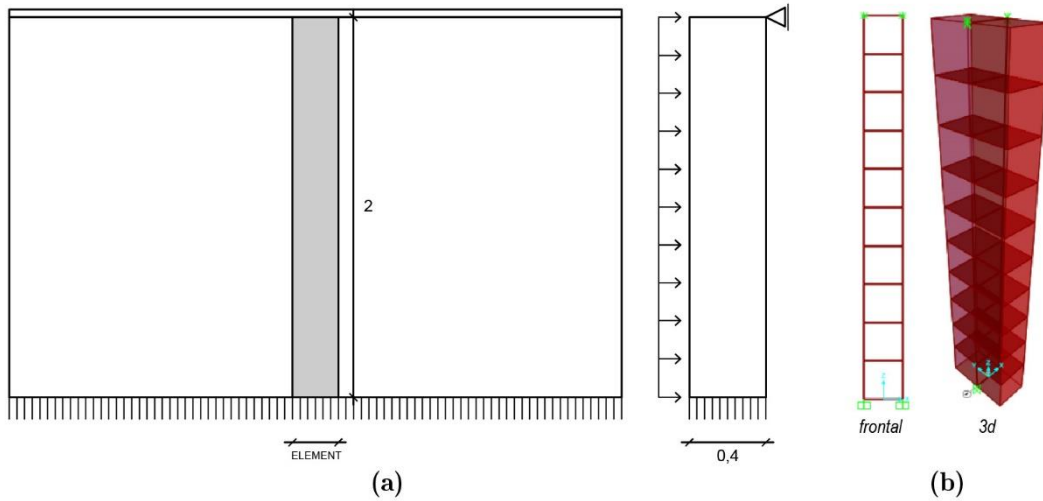
Figure 5-55. Out-of-plane loaded masonry wall: (a) geometry (modelled part in grey) and (b) shell FE model configuration.

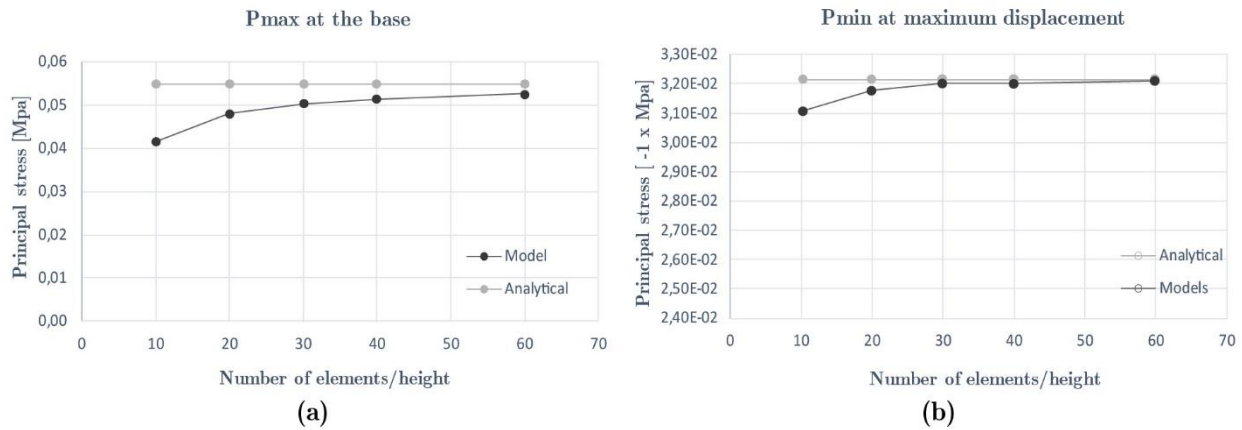
Figure 5-57. FE results of the out-of-plane loaded wall: convergence of the principal stress of the models measured at (a) the base of the model and (b) the maximum displacement point.

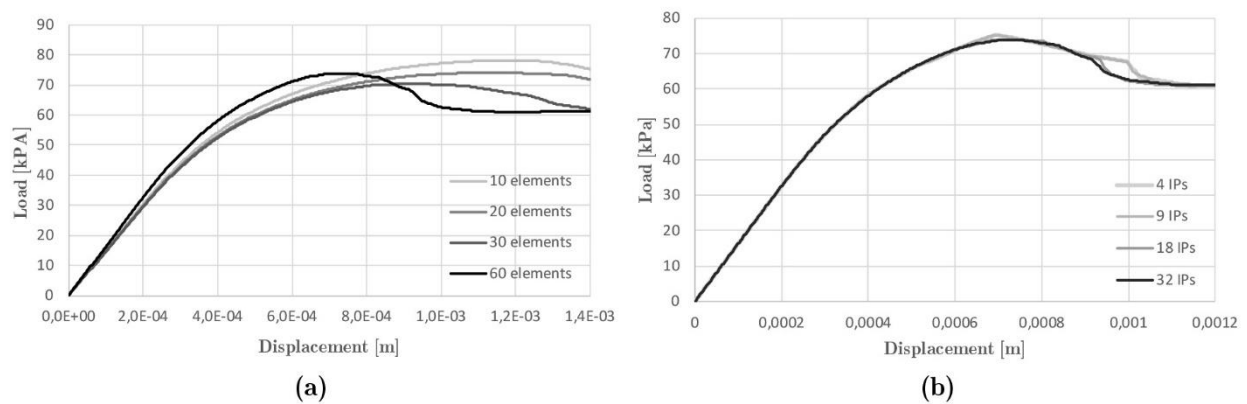
Figure 5-58. FE results of the out-of-plane loaded wall: (a) with 32 IPs and different number of elements and (b) 60 elements and different number of IPs.

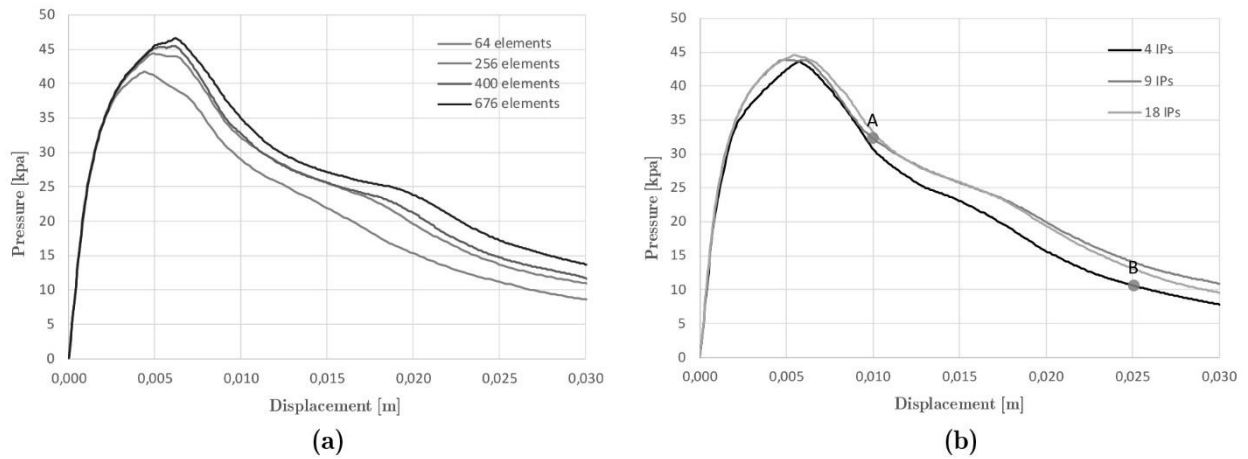
Figure 5-61. Results of the sensitivity analyses of Wall 2 FEM model considering: (a) a mesh refinement in the model with 9 IPs and (b) different IPs in the model of 676 elements.

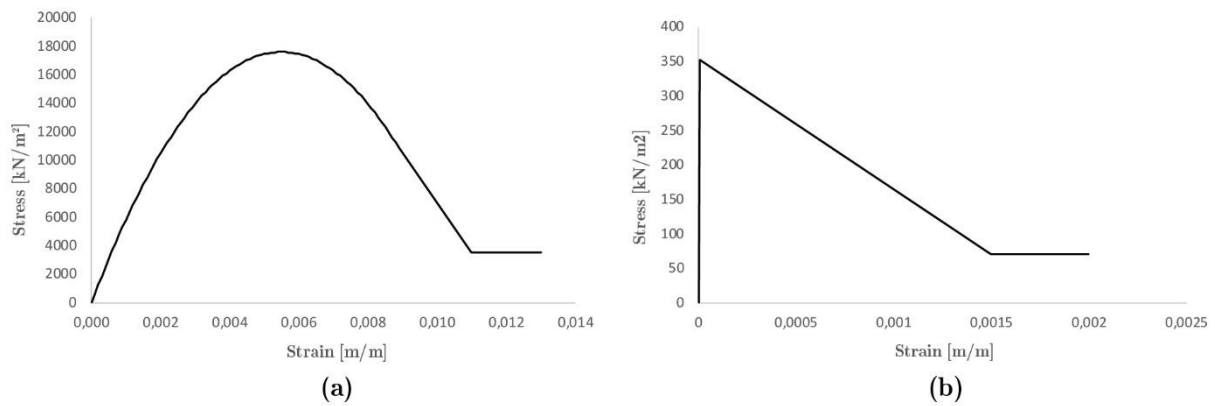
Figure 5-64. (a) Compressive and (b) tensile stress-strain relationship of masonry material for the out-of-plane loaded wall tested by Griffith and Vaculik (2007).

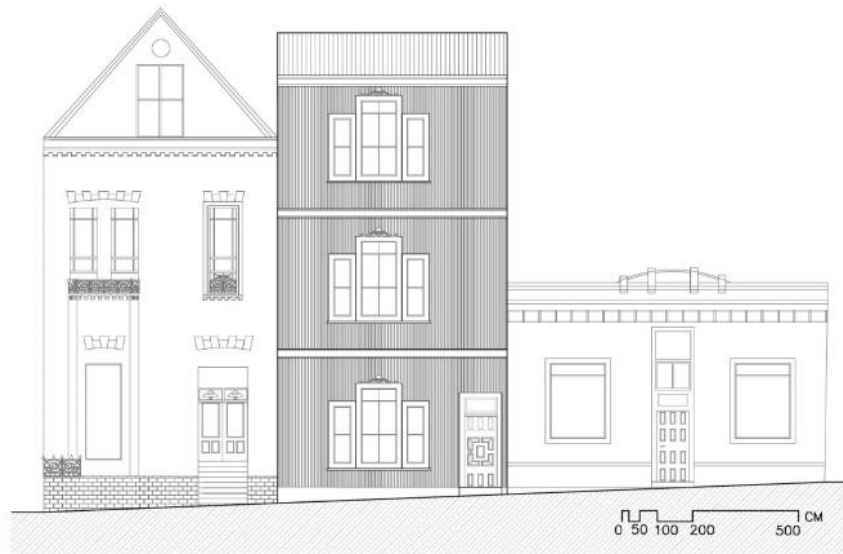
Figure 6-2. Building 1: north elevation (Jiménez 2015).

Building 1 corresponds to a three-storey building dating back to 1909. It was designed by the architect *Juan Blezard*, as revealed in the original drawings shown in Figure 6-1. The building is located in the number 558 of the *Lautaro Rosas* street, with a central position in a building aggregate, as shown in Figure 6-2 and Figure 6-6a. The first and second levels of the building are 87.39 m², while the third level has the half of the built area and an exterior terrace (Figure 6-3). The structural system is composed of two main bays along the longest direction of the building, which are divided by perpendicular internal partitions distributing the rooms.

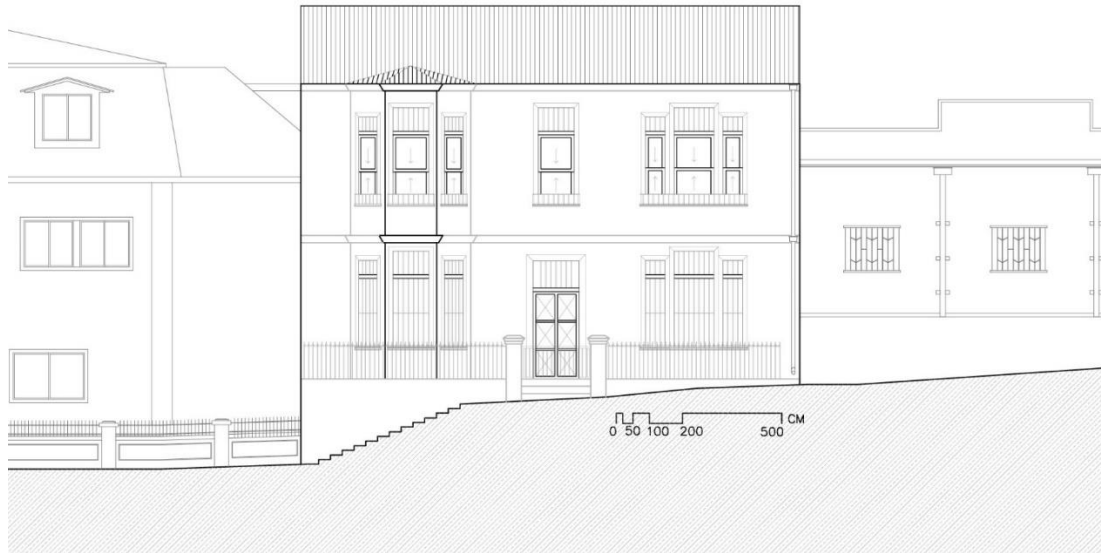
Figure 6-4. Building 2: north elevation.

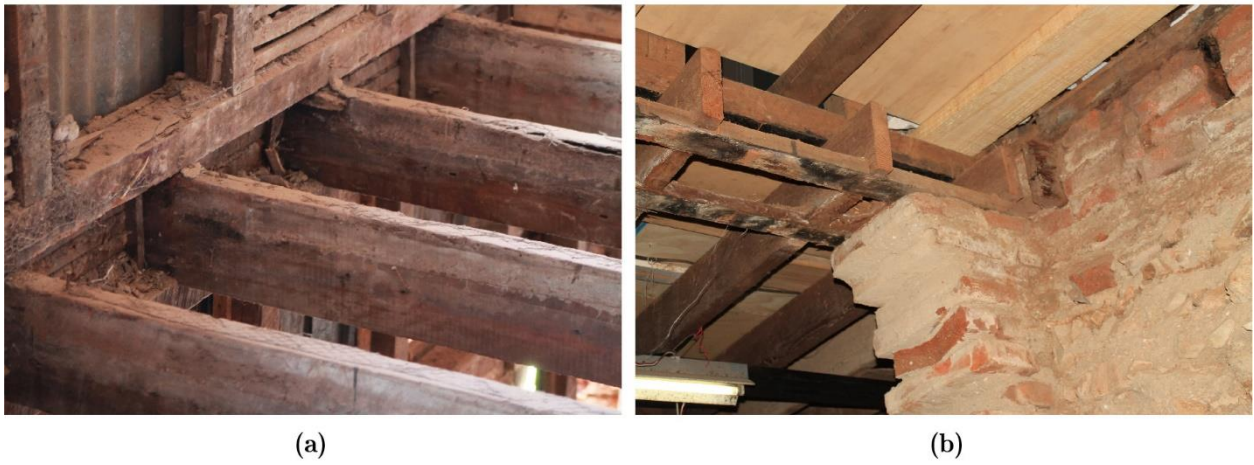
Figure 6-10. Storey system configurations: (a) joists between top and bottom sills of the walls and, (b) joists embedded into the masonry strip footings.

As reported by Jiménez (2015), most of the timber elements are made of Oakwood and Oregon Pine wood. However, different timber species might configure some other parts of the frame system. In both the selected structures, URM load-bearing sidewalls are connected to the timber frames at the storey levels. The walls are made of fired clay bricks of $0.38 \times 0.195 \times 0.06$ m³ and lime mortar, arranged in English bond. The sidewalls have variable thickness along the height, varying at each storey, as shown in Figure 6-11 and Figure 6-12. Building 1 has back and side walls with a thickness varying from 0.6 m to 0.2 m from the bottom to the top levels. Building 2 has walls with thickness varying from 0.6 m to 0.4 m along the elevation. The storeys are supported by joists commonly embedded or simply supported over the bricks, as shown in Figure 6-10b. The sidewalls are not shared with the load bearing system of the adjacent buildings, and they are placed only next to each other with the function of firewalls. The foundations under the load-bearing walls and timber frames are strip footings made of brick masonry, built on rocky soil, with 0.6 m thickness and 0.80 m height.

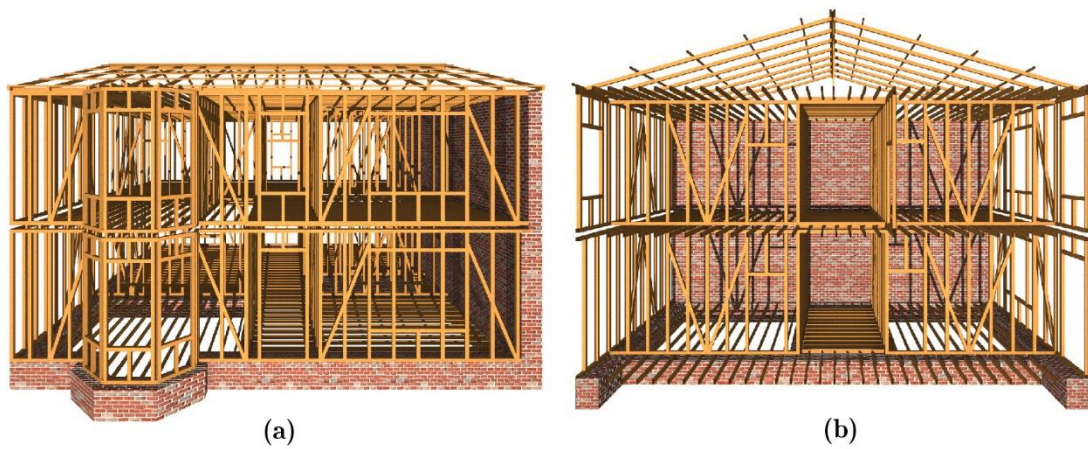
Figure 6-12. Structural configuration of Building 2: (a) frontal and (b) transversal section views.

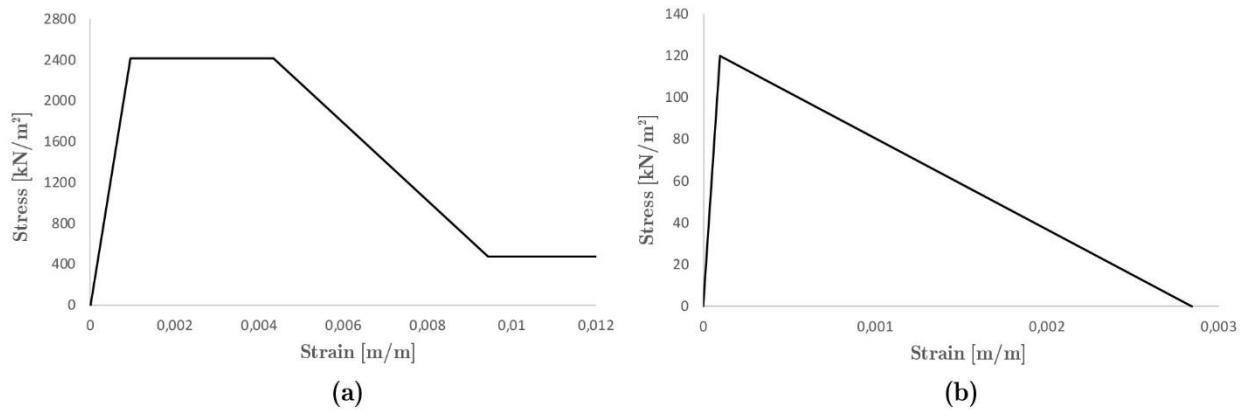
Figure 6-16. Uniaxial constitutive laws defining the behaviour of the masonry material for the Buildings 1 and 2: (a) compression and (b) tension stress-strain relationships.

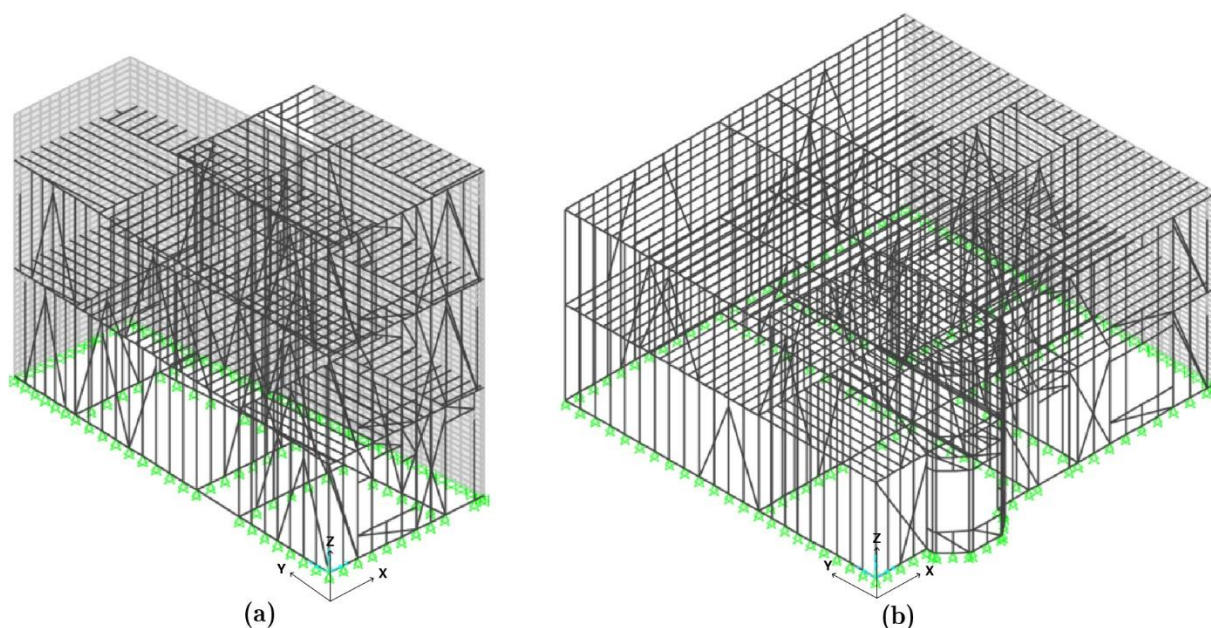
Figure 6-17. Numerical models of (a) Building 1 and (b) Building 2.

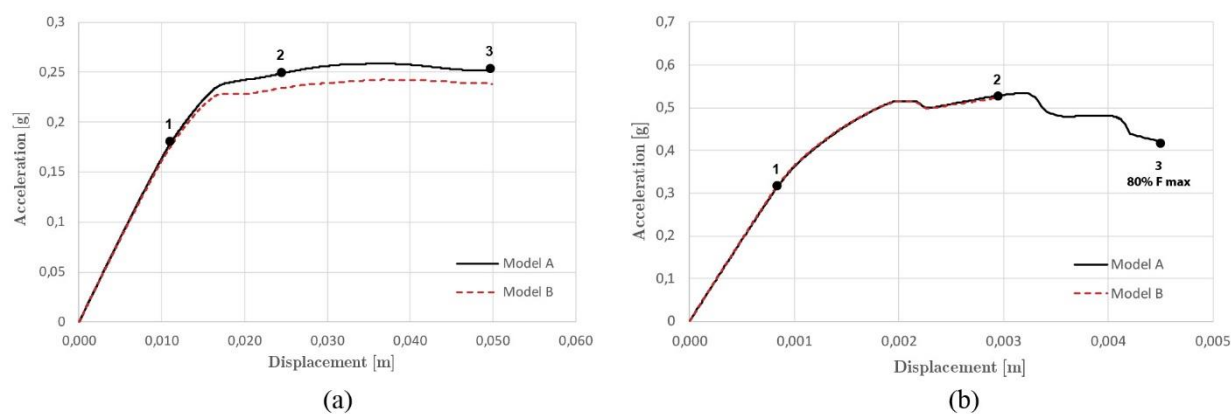
Figure 6-18. Capacity curves obtained for Building 1 in the (a) X and (b) Y analysis directions.

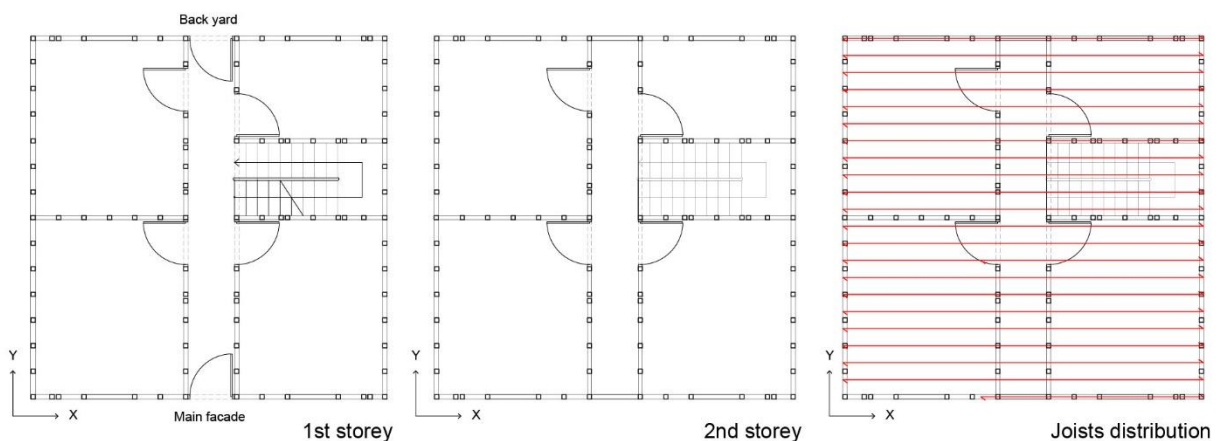
Figure 7-1. Typical structural unit of Valparaíso: plan layouts at different storeys.

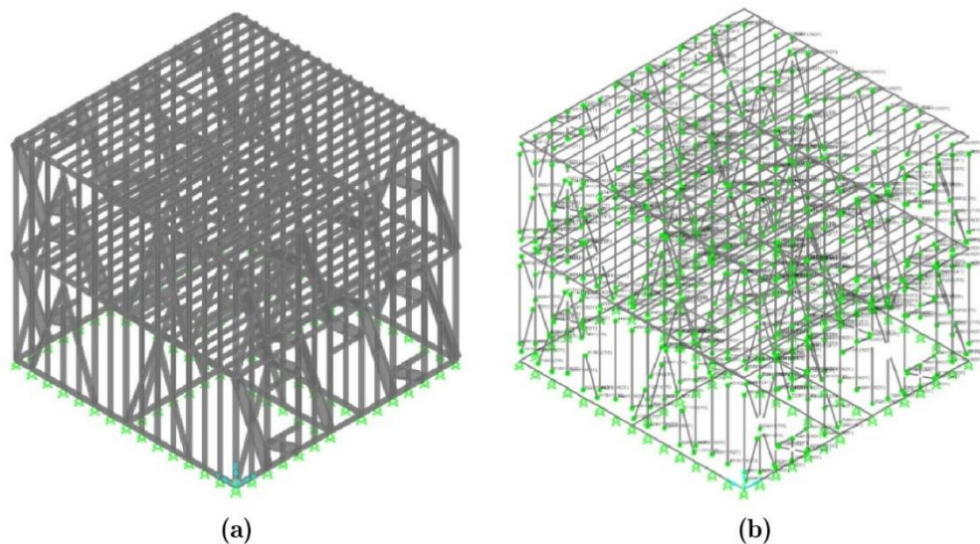
Figure 7-2. Typical structural unit of Valparaíso composed of timber frames: FE model based on Lumped Plasticity Method.

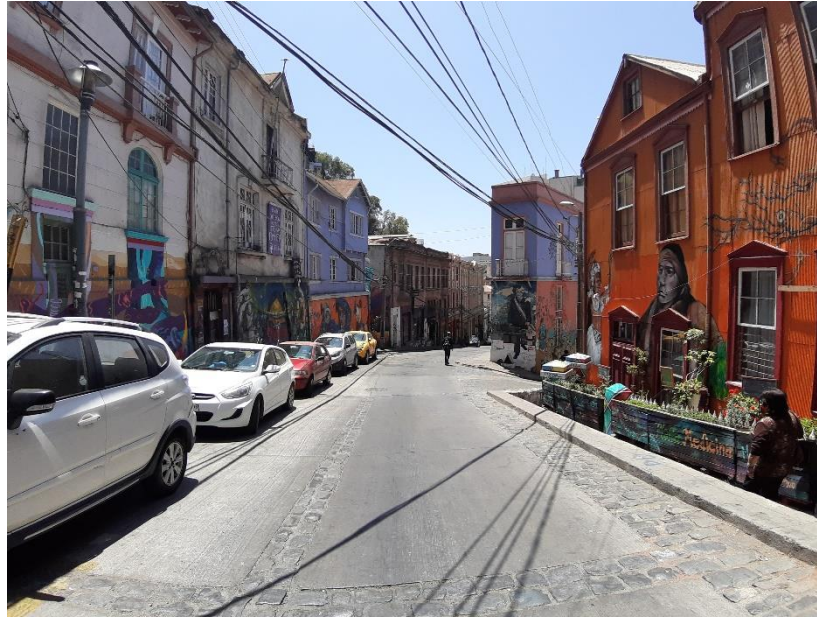
Figure 7-3. In-row aggregate conditions of the buildings of the Almirante Montt street belonging to the ELC System of Valparaíso.

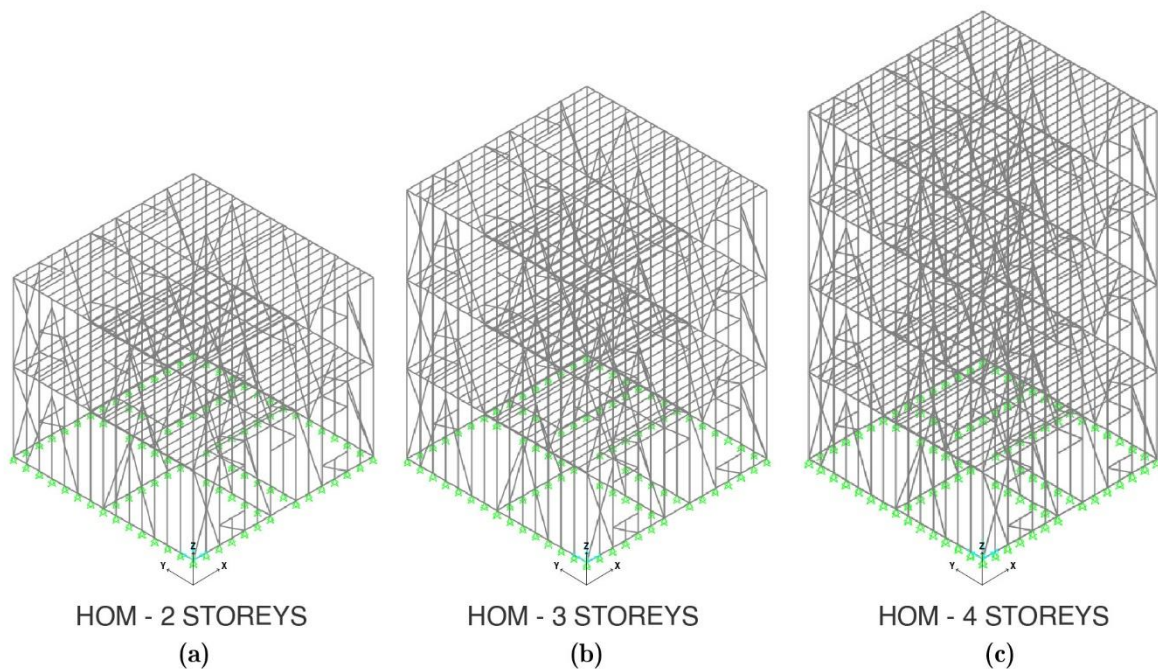
Figure 7-4. Parameter 3 “Distribution of the resisting elements”: numerical models for the analysis of the influence of the variation of the number of storeys on seismic vulnerability.

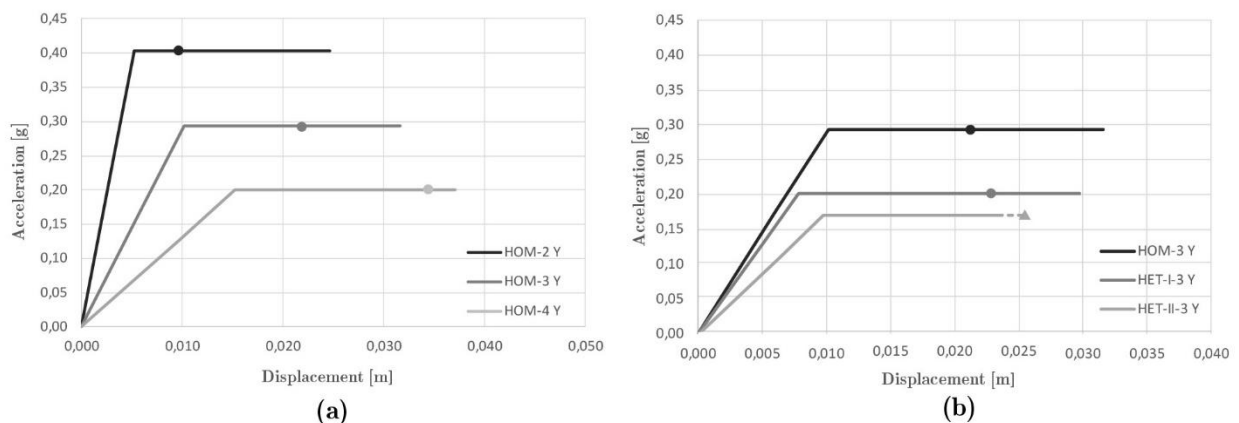
Figure 7-6 Parameter 3 “Distribution of resisting elements”. Capacity curves and target displacements from the models in the Y analysis direction: (a) variation of number of storeys in the homogeneous cases (HOM 2 to 4), and (b) influence of the hybrid timber-masonry resisting system (HOM-3, HET-I-3 and HET-II-3).

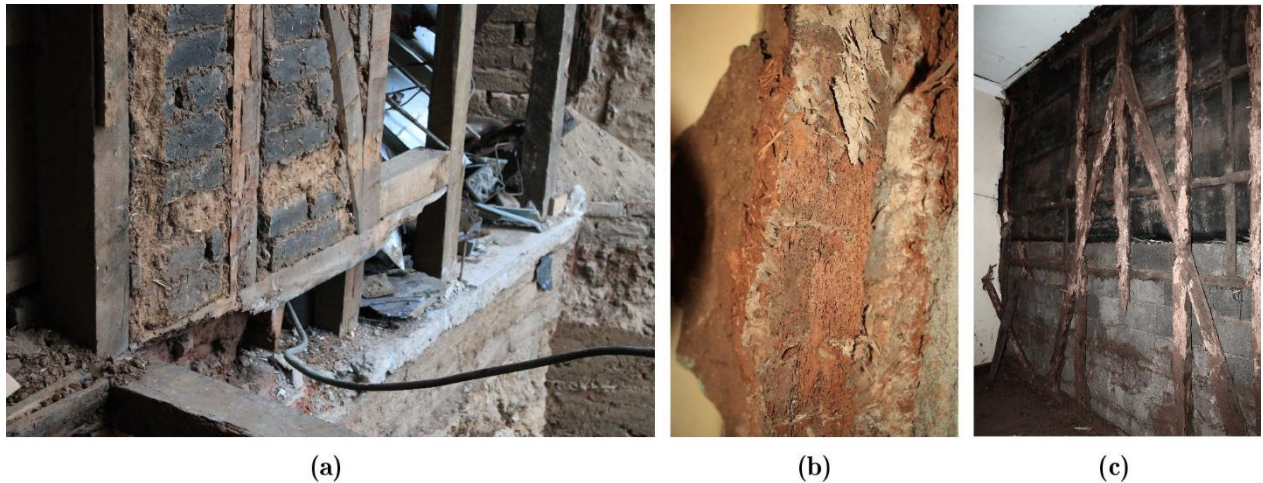
Figure 7-17. Deterioration of timber elements of different buildings in Valparaíso due to: (a) exposure to moisture, (b) termites' infestation, and (c) faulty ventilation and moisture.

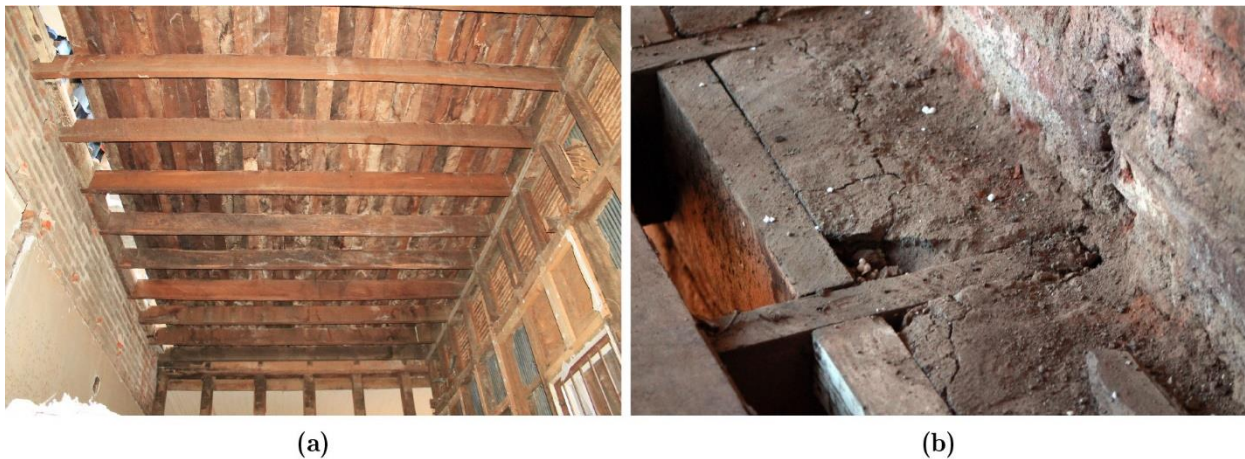
Figure 7-22. Timber-masonry buildings: (a) masonry and timber frame interaction and (b) joist-masonry wall connection.

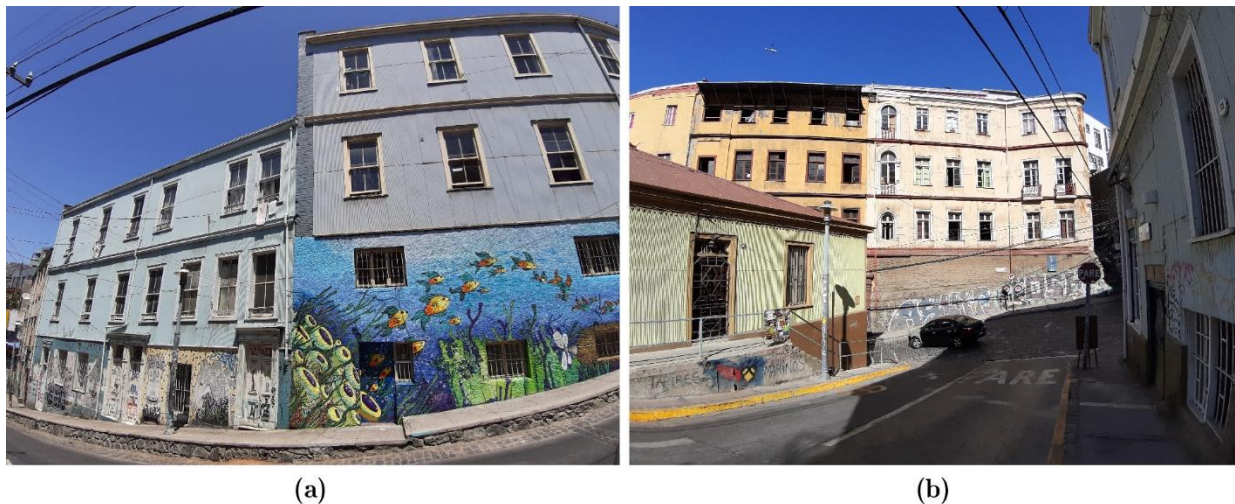
Figure 7-23. Timber-masonry buildings: located in (a) Almirante Montt street (labelled with 92 and 93 in Figure 7-21, respectively) and (b) Urriola street (21 and 22 in Figure 7-21).

vulnerability is associated with different factors. As remarked in the vulnerability map (Figure 7-21), six buildings of the Urriola St. (labelled as 15,16,17, 20, 21 and 22) show vulnerable conditions. These cases are the tallest of the street (4 storeys), made of hybrid timber and URM walls, therefore categorized as D in the Parameter 3. Besides, all they are historical buildings with very poor state of conservation (P10). The same occurred with some buildings of the Urriola St. (68 and 85 in the map). On the other hand, eight buildings of this vulnerability group present header positions in the structural aggregates (15, 16, 17, 93, 85, 68, 41 and 94), which certainly increase their vulnerability with respect to the enclosed ones (Figure 7-23b, building 93).

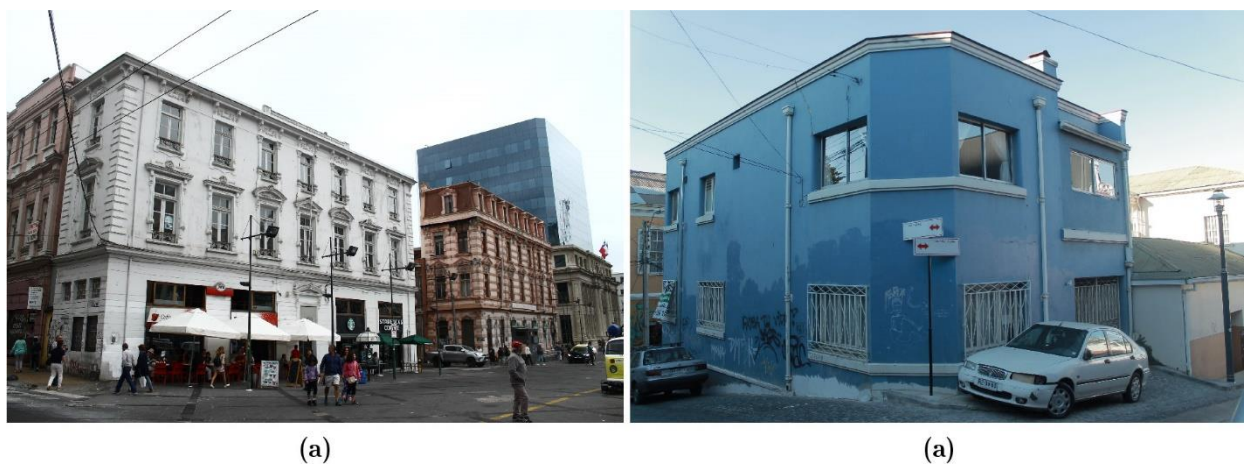
Figure 7-24. Masonry buildings (a) Historical constructions in Sotomayor square (label 99 and 100 in Figure 7-21), and (b) reinforced masonry building with visible damage in masonry (label 40).

Parameters 1 and 2, respectively). These buildings are commonly well-connected to the story systems, with the use of metallic ties as inspected on-field. The assessment of the conventional strength of the buildings demonstrated that the 77% of the buildings have a favourable distribution of their resisting elements in plan (Classes A and B). Only two buildings of the stock located in the Sotomayor square (99 and 100) are categorized in Class C. This condition is attributed with the slender shape of the buildings in plan (Figure 7-24a), which is also penalized in the Parameter 5 “Plan regularity”. Furthermore, both these buildings have header positions in the structural aggregate, which contribute to increase their vulnerability. The building labelled as 95, 110 and 40 also present higher vulnerabilities mainly attributed to their isolated condition and visible damage on existing masonry (Figure 7-24b).
