**Suelo-Paisaje-Erosión. Erosión por cárcavas y barrancos en el  
Alt Penedès – Anoia (Cataluña).**

**Soil-Landscape-Erosion. Gully erosion in the Alt Penedès –  
Anoia (Catalonia).**

Memoria presentada por:

Para optar al grado de Doctor

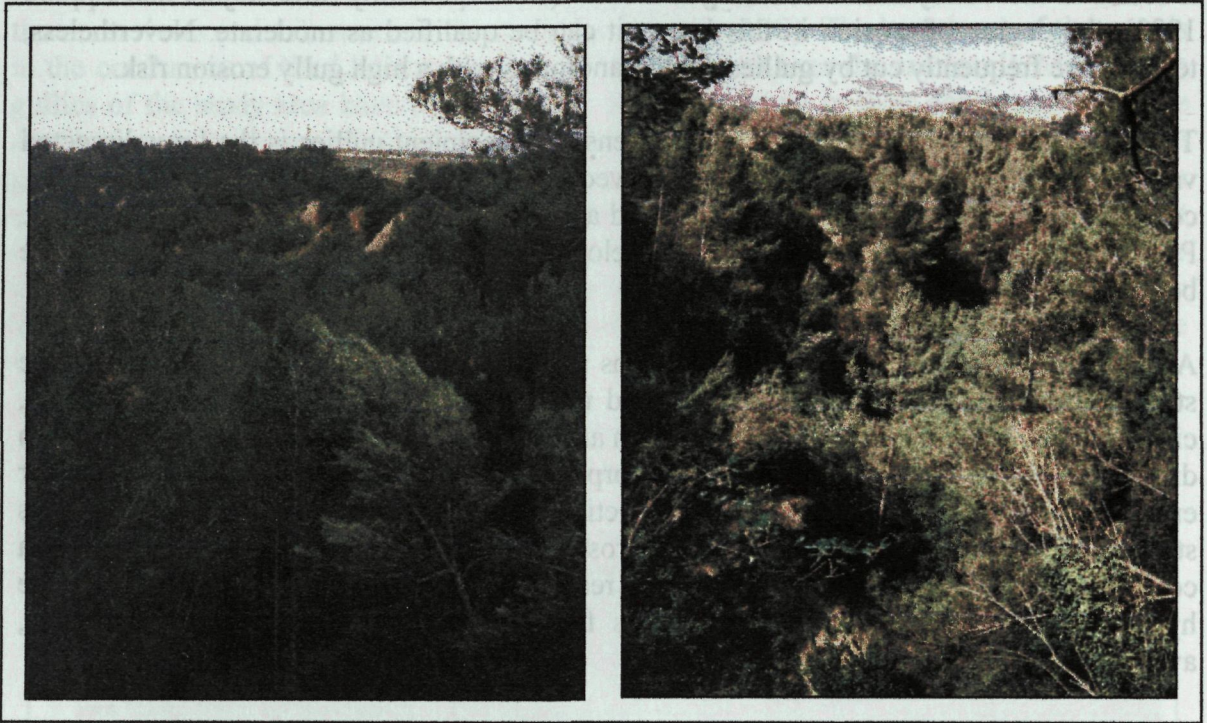
**Figure 4.13. Examples of gully walls classified as Semi-active – Stable (> 60% vegetation cover).**

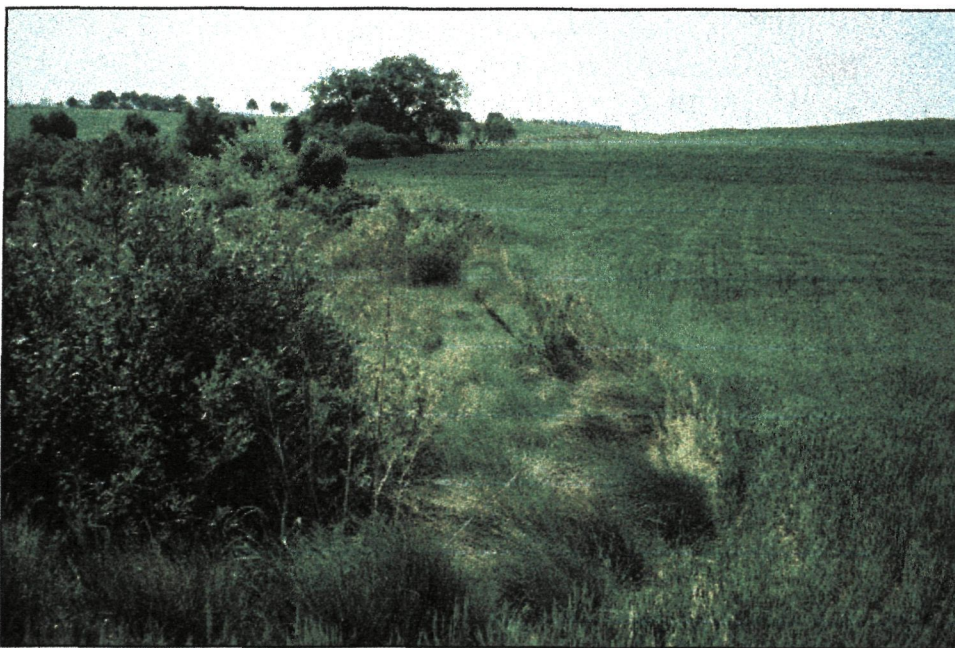
**Figure 4.16. Processes in the gully borders that contribute to the lateral retreat of gullies. Example of a circular slip.**

The areas classified as Semi-active – Stable are liable to the actuation of processes as wall failure or circular slips, that can reactivate erosion on sidewalls and contribute to the lateral expansion of gullies (Figure 4.16).

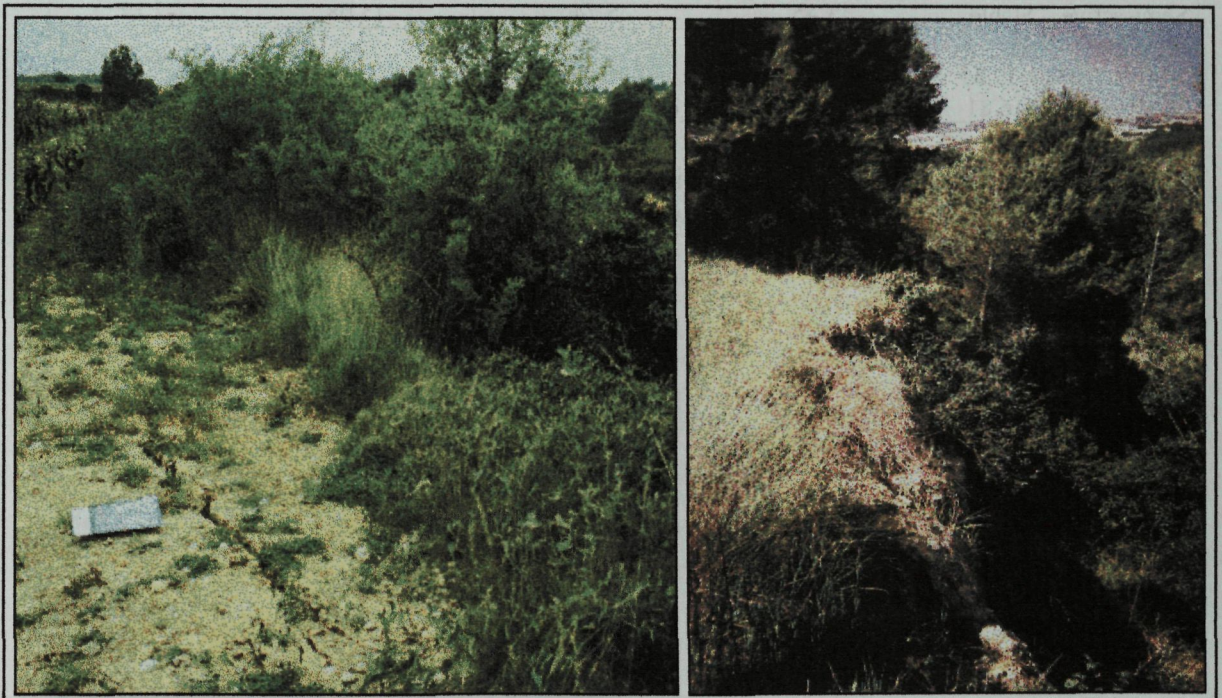
**Figure 4.18. Left: Fissure produced in border between a parcel and a gully. Right: Slip that produces gully wall retreat.**

A greater part of this problem has its origin in the vineyard parcels. The drainage system of the parcels concentrates the flow in few outlets. Water is conducted up to the border of gullies. The free fall of runoff water during high intensity precipitation events undercuts the base of gully walls and produces the wall failure (Figure 4.17). Accumulation of runoff at gully bordering areas produces soil saturation in other cases. This later favours circular slips (Figure 4.18), that result on the retreat of gully walls.

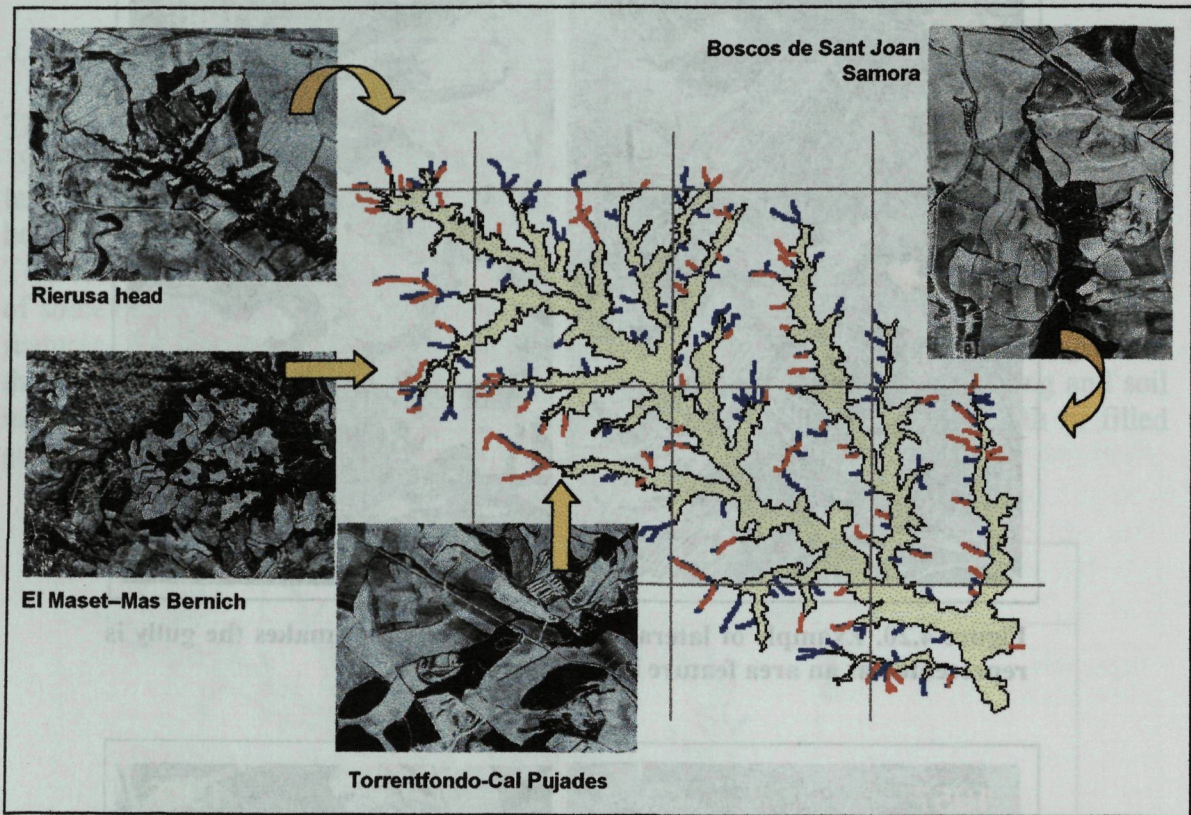
**Figure 4.22. Main active areas of gully erosion (small and medium-size gullies) in the studied period.**

In the studied period, the most active areas were the main head of the Rierusa gully, the area of the Maset – Mas Bernich, the area of Torrentfondo – Cal Pujades and the area of Sant Joan Samora (Figure 4.22). Of those, the area of Torrentfondo – Cal Pujades experimented one of the most significant changes. This gully is capturing the neighbour catchment to its west and presented a fast linear retreat. In the middle term, it makes this area presents one of the highest degrees of erosion risk.

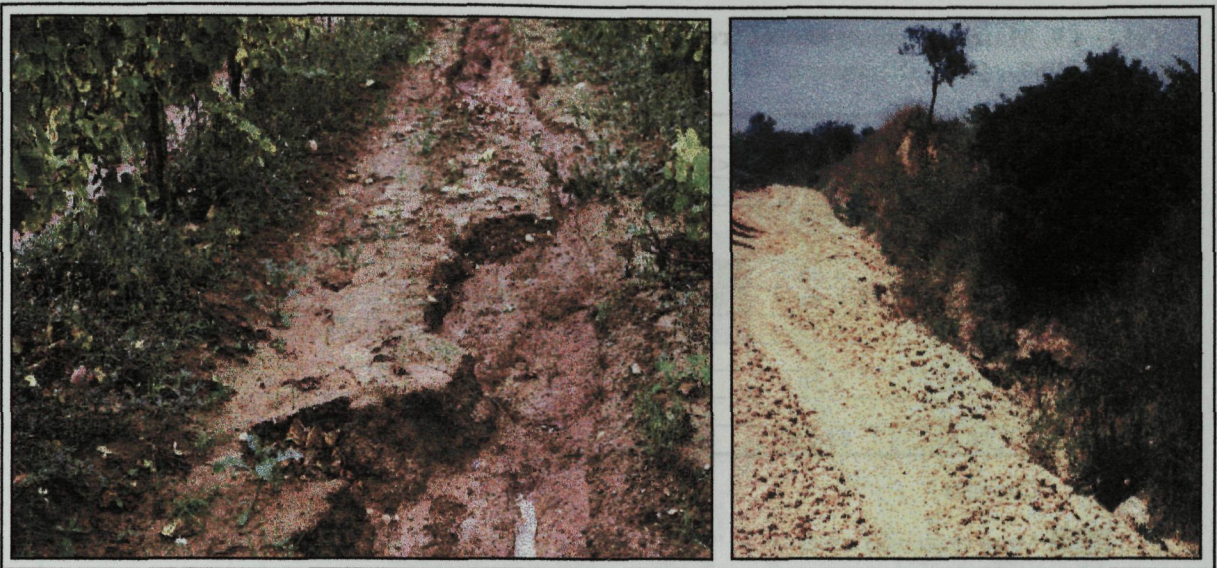
Figure 4.23. Left: ephemeral gully formed during a high intensity precipitation event and that is later removed by tillage operations. Right: Gully developed in the border of a parcel that is periodically filled.

Provided that farmers only use to remove ephemeral gullies within their own parcels, gullies take advantage of no-man's land to grow, where the runoff of the parcels is often concentrated. Then, boundaries between parcels or properties or between parcels and pathways are places where gullies growth, without very much man intervention. At present, these places constitute the main ways of linear retreat of the gully network (Figure 4.23).
